### Canadian Aviation Service Difficulty Reports

The following content was published between January 1, 2020 and April 1, 2020

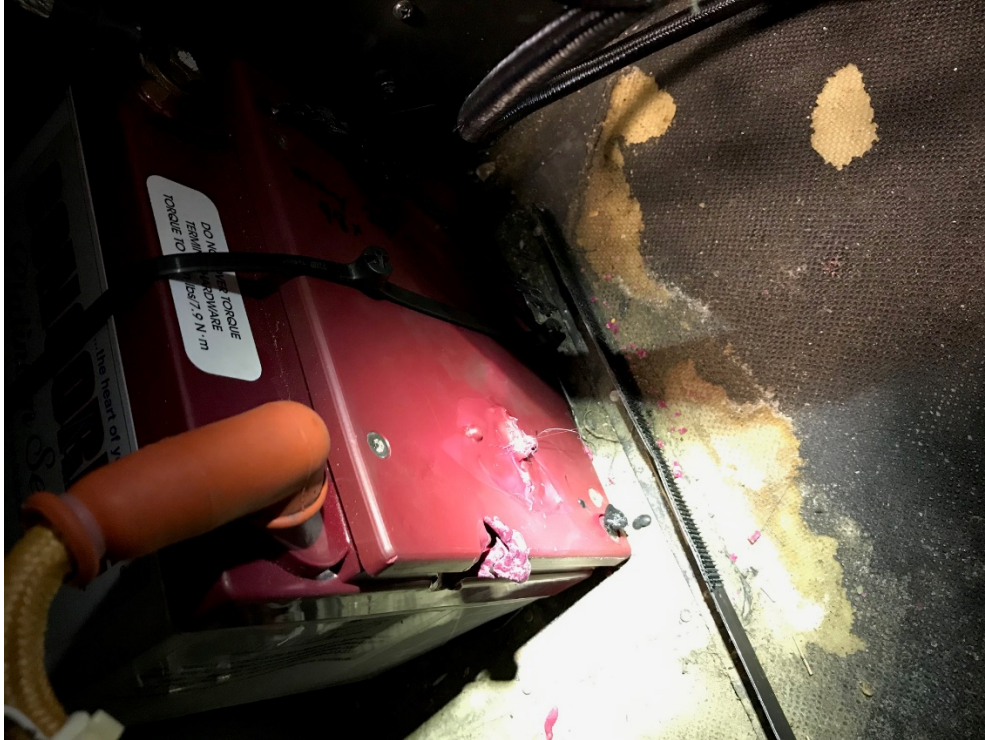
Concorde batteries can be commonly found installed in many different aircraft makes and models. Inspection instructions for the battery are often found in the aircraft manufacturer's publications; however, it is important to note that battery manufacturers also publish instructions for continued airworthiness. The instructions for continued airworthiness for the battery should be consulted when each maintenance program is developed. For this battery installation, no internal checks are required and it appears that no external defects were noted prior to the battery failure. If a similar situation is encountered, Transport Canada encourages operators and maintainers to continue to submit Service Difficulty Reports in order to further evaluate this potential defect.

Image 1: Battery as it was found during inspection when it was installed in the aircraft.

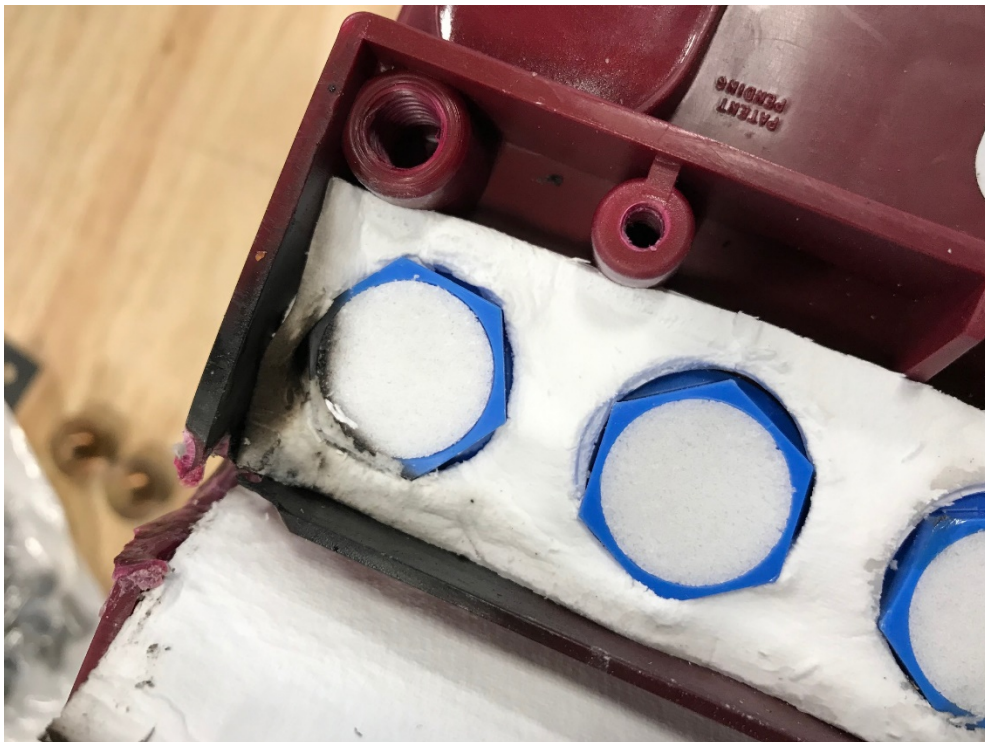
Image 2: Battery opened for inspection and the subsequent electrical short observed.

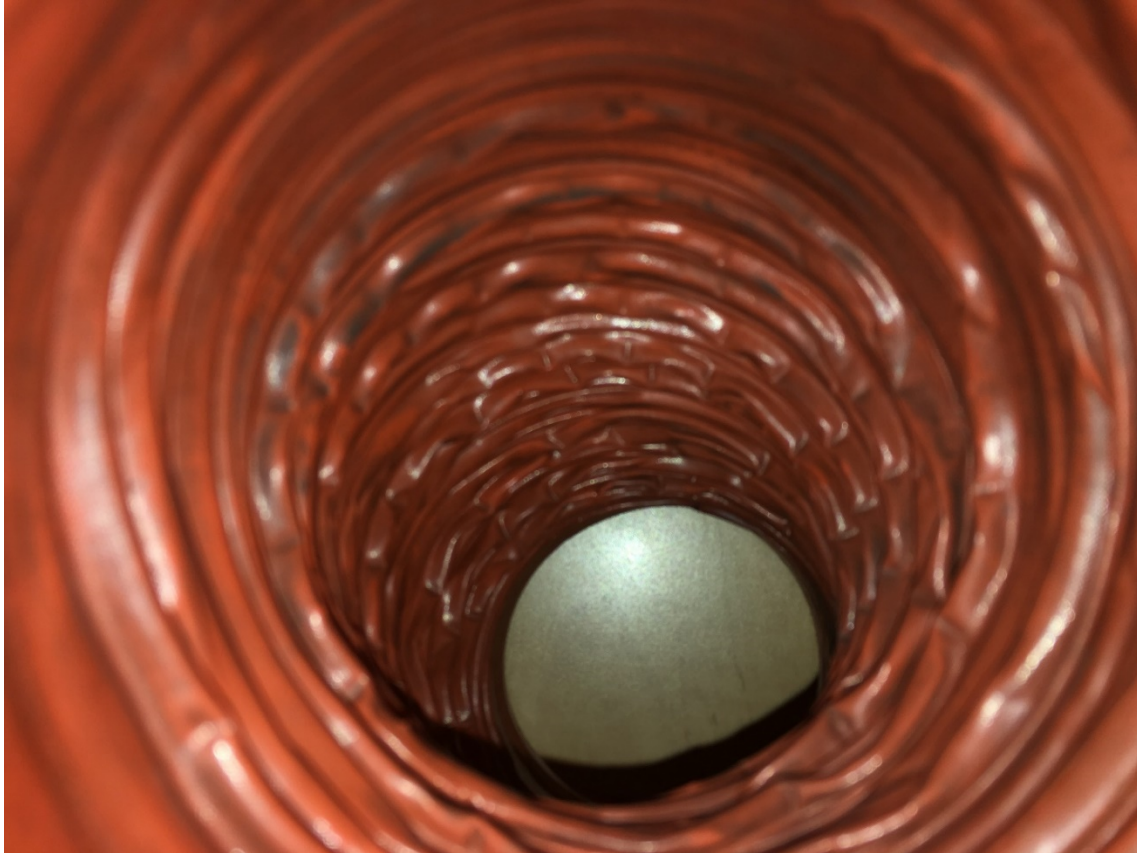
RHC issued SB-97 as a corrective action following reports of separation between the inner and outer layers of the engine air induction hose. The separation of the inner layer could block engine induction air flow. The Federal Aviation Administration (FAA) has mandated SB-97 with Airworthiness Directive (AD) 2019-12-18. Service Difficulty Report (SDR) 20190611012 describes the identification of a defective hose however, the aircraft serial number and installation date of the air induction hose are not within the required actions of FAA AD 2019-12-18. Transport Canada Civil Aviation (TCCA) has subsequently contacted the FAA regarding AD 2019-12-18 with this information. At the time of writing, this is the only SDR of a defective air induction hose. TCCA will continue to monitor and would like to remind operators and maintainers to submit an SDR for any reportable service difficulty found.

Image showing the inner layer of the engine air induction hose.
