AIR TRANSPORTATION SAFETY INVESTIGATION REPORT A17O0264

COLLISION WITH TERRAIN

Hydro One Networks Inc.
Airbus Helicopters AS 350 B2 (helicopter), C-GOHS
Tweed, Ontario, 8 NM NNE
14 December 2017

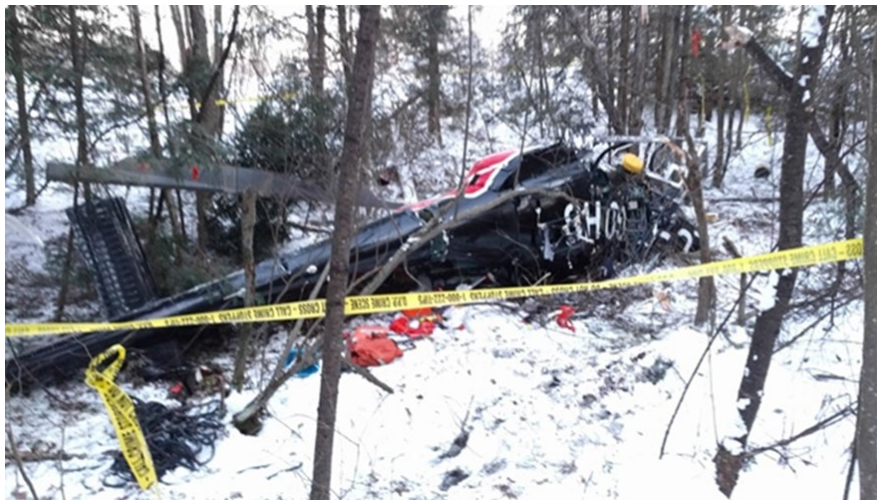
Figure 2. Main wreckage site (Source: TSB)

When the preform bag and carabiner struck and damaged the tail rotor, the dynamic unbalance created by the loss of the blade tip and balance weight caused intense vibration. The vibration subsequently caused a total failure of the whole tail rotor assembly, which separated from the tail boom, followed by the vertical fin.

The loss of the tail rotor and vertical fin resulted in the helicopter becoming uncontrollable, and during its uncontrolled rapid descent it struck nearby trees and then the ground. The helicopter was destroyed during the accident sequence (Figure 2).

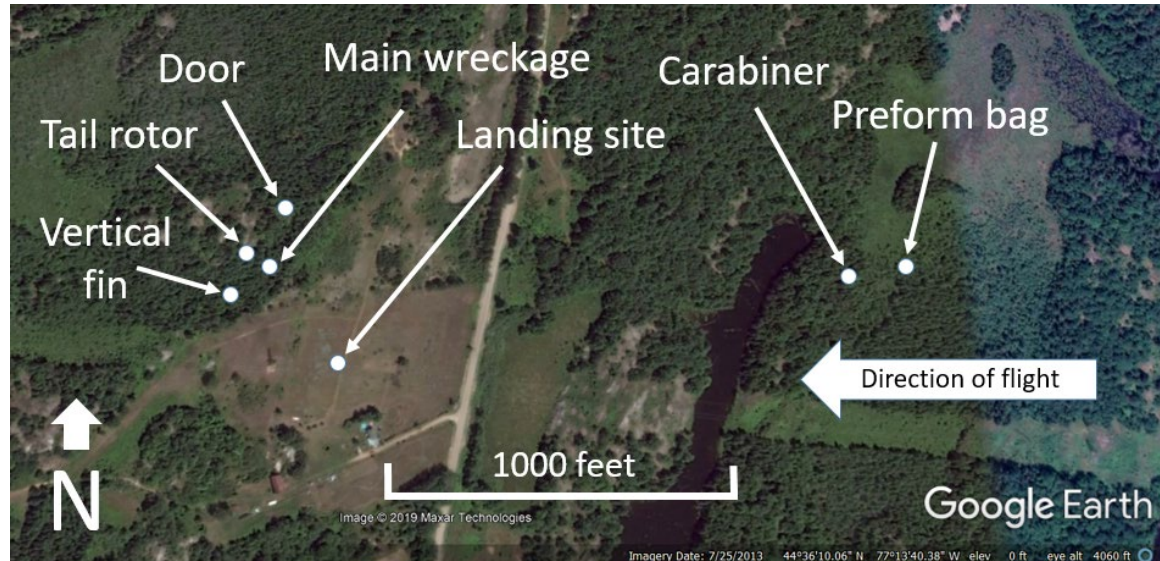
Figure 4. Wreckage area (Source: Google Earth, with TSB annotations)

The helicopter crashed in a forested area approximately 400 feet northwest of the intended landing site (Figure 4). The tail rotor gearbox was found 67 feet north-northwest of the main wreckage site with the tail rotor blades attached, and the vertical fin was found 144 feet southwest of the main accident site with the end of the tail boom still attached.

A broken carabiner with part of a preform bag attached was found about 1900 feet east of the accident site. The rest of the preform bag was found about 310 feet further to the east.

One tail rotor blade was missing approximately 10.75 inches of the outer portion, including the blade balance weights. Although most of the outer portion of the blade was recovered, the tip and balance weights were not. There were signs of damage, likely caused by the carabiner striking it, on the leading edge of the tail rotor blade where the outer portion of the blade had fractured.

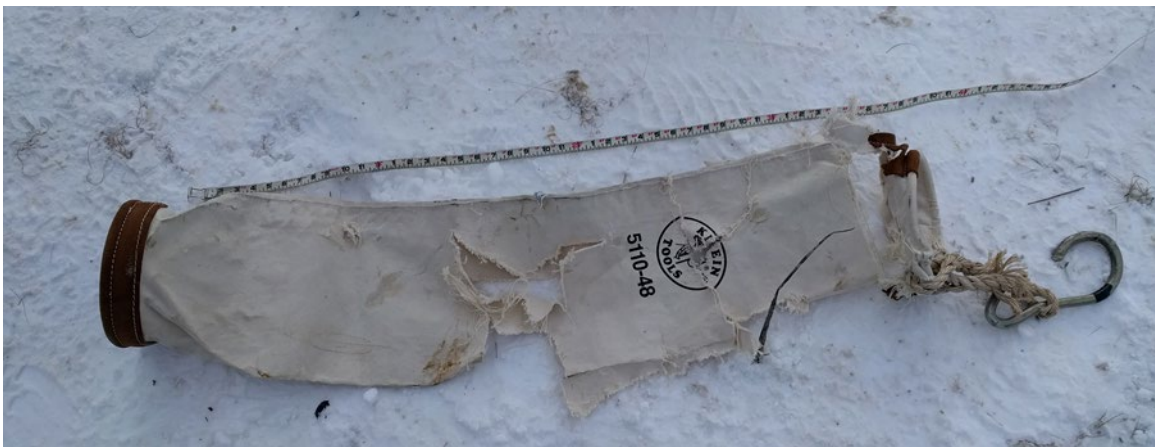
Figure 5. Preform bag at the accident site (Source: TSB)

The preform bag, which was used to carry line maintenance supplies, was approximately 43 inches long, tube-shaped and made of a light canvas-type material. The bottom of the bag was made of black plastic, and the top and bottom edges of the bag were reinforced with leather (Figure 5). The top of the bag had 2 loops made of a polypropylene-type rope attached to each side of the bag as handles. One of the loops had detached from the bag and was missing.

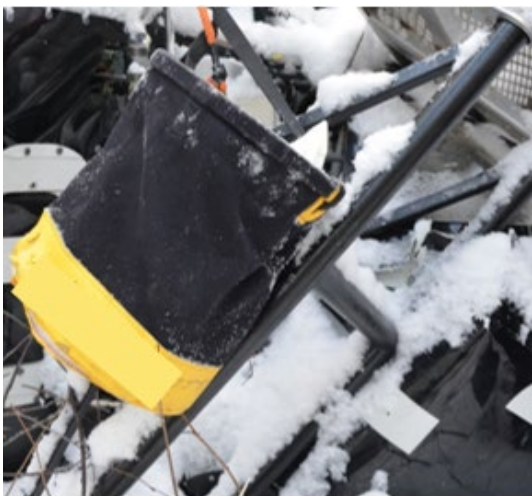
Figure 7. Nose bag attached to the handrail of the Air Stair (Source: TSB)

Two nose bags were found at the accident site. One was attached to the handrail of the Air Stair with a large carabiner (Figure 7) and was fully intact. The other was heavily damaged and located among the debris at the accident site (Figure 8). This bag had torn from its associated carabiner, which was still attached to the handrail of the Air Stair.
