AIR TRANSPORTATION SAFETY INVESTIGATION REPORT A18Q0030

RUNWAY OVERRUN ON LANDING

Strait Air (2000) Ltd.
Beechcraft King Air A100, C-GJXF
Havre St-Pierre Airport, Quebec
26 February 2018

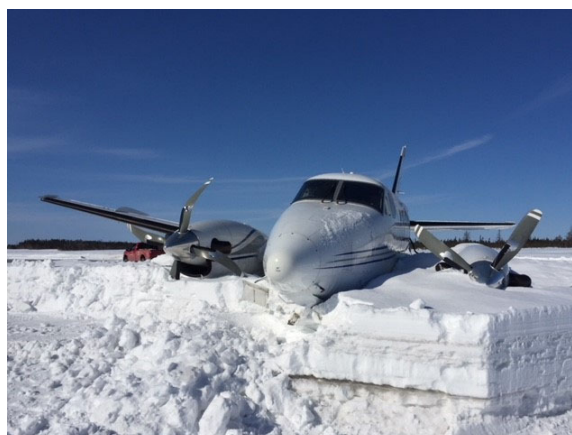
Figure 2. Wreckage of the occurrence Beechcraft King Air A100 (Source: TSB)

The force of the impact with the snowbank caused the propellers to halt abruptly and the blades to bend backward. It also caused substantial damage to the left landing gear and wings (Figure 2).

Despite the substantial damages to the landing gear and the wing structure caused by the impact with the snowbank, the deceleration forces did not jeopardize occupant survivability.⁴⁵ However, half of the occupants received minor injuries.

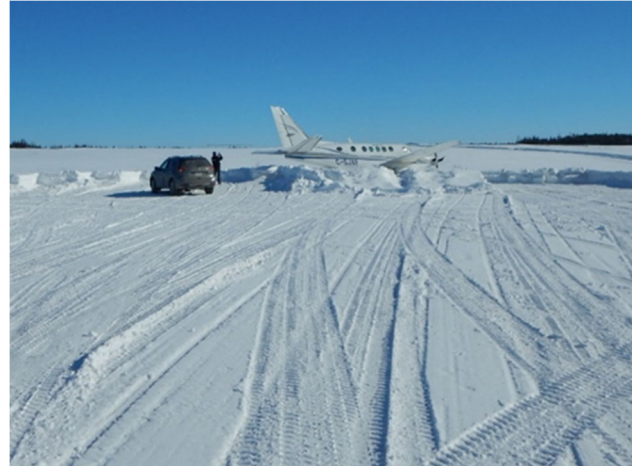
Figure 6. Position of the wreckage at the end of the runway (Source: TSB, photo taken 2 days after the accident)

When they arrived on the scene, TSB investigators noted that the flaps were raised, the fuel system was cut and the electrical system was off. The pitch of both propellers was practically zero (0°), and all of the propeller blades were bent backwards. The landing gear collapsed and bent backwards, and the engine air inlets were blocked by compacted snow.

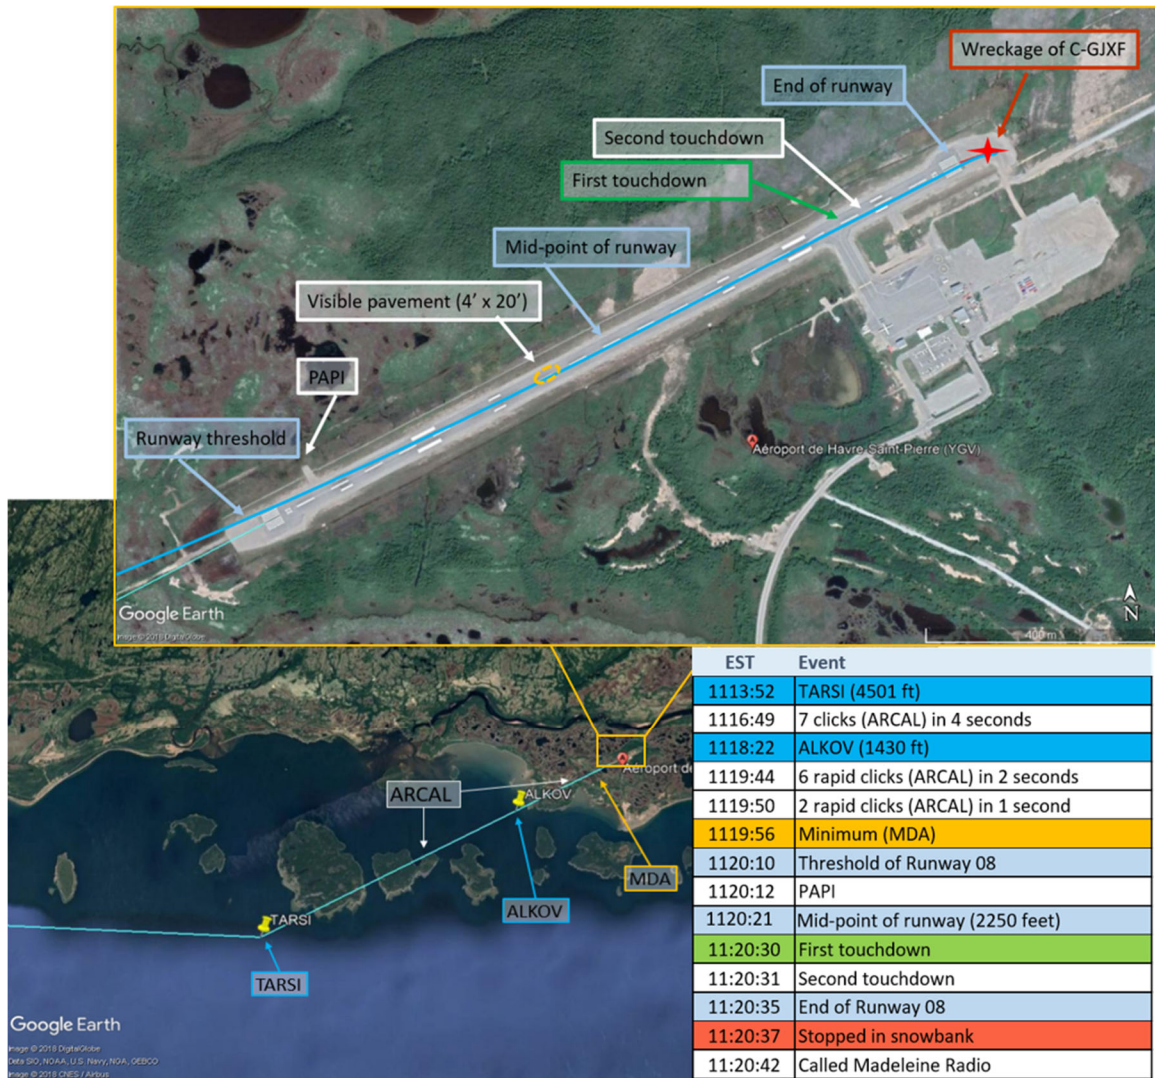
Figure 7. Approach path of the aircraft on final and over the runway (Source: Google Earth, with TSB annotations)

Given the lack of GPS data, the aircraft's approach and landing path was calculated using radar data, recordings of conversations with ATC, observation of the touchdown point, and testimonies. These calculations assisted in determining the aircraft's position and speed during approach, the moment when the aircraft crossed the runway threshold and the length of time the aircraft was flying over the runway before touching down (Figure 7).

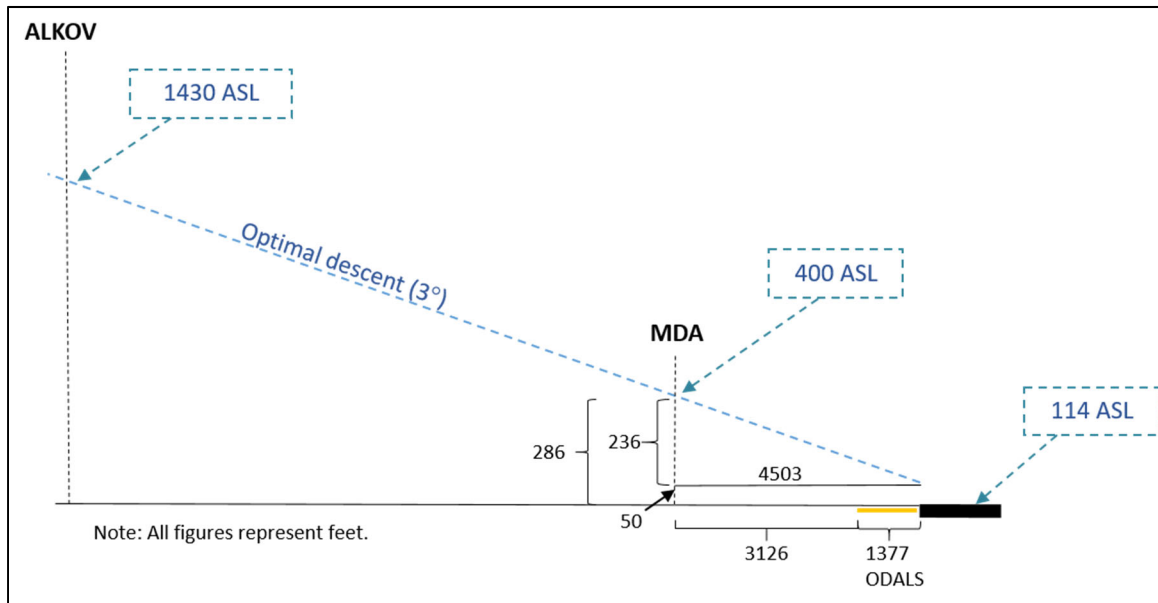
Figure 12. Distance from the threshold and the omnidirectional approach lighting system at the minimum descent altitude (Source: TSB)

It was unlikely that the flight crew could see the visual references required at the MDA given that a visibility of $\frac{1}{4}$ SM corresponds to 1320 feet. Also, given that the runway and surrounding area were covered with snow, the runway surface would have been difficult to see, reducing the probability of a landing at CYGV.
