AIR TRANSPORTATION SAFETY INVESTIGATION REPORT A18A0085

RUNWAY OVERRUN

Sky Lease Cargo

Boeing 747-412F, N908AR

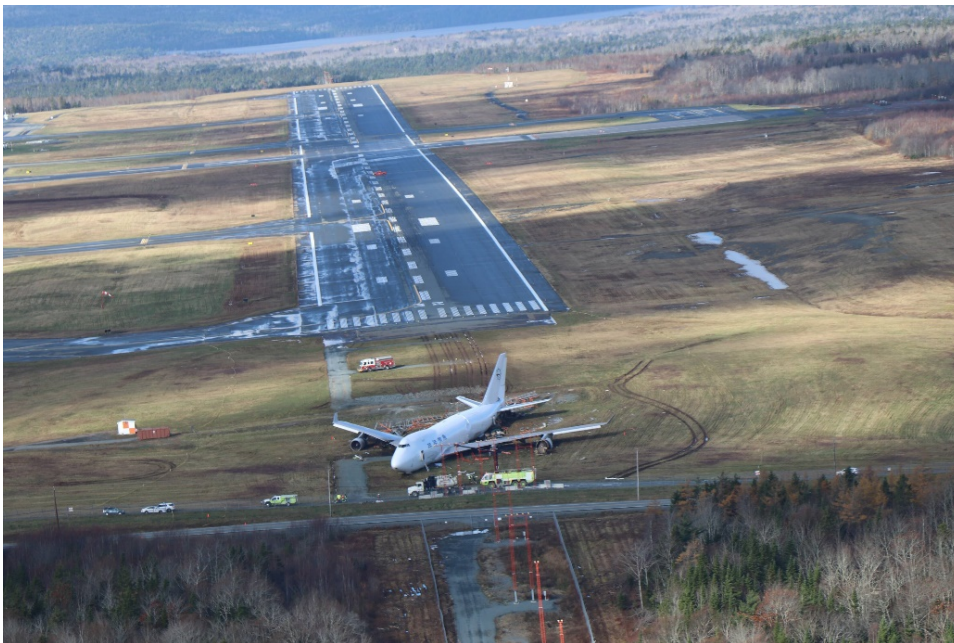
Figure 2. Occurrence aircraft’s final position (Source: Steve Lawrence / CBC Licensing)

The nose of the aircraft came to rest 270 m (885 feet) past the runway threshold, 21 m (70 feet) to the right of the extended centreline, and 47 m (155 feet) from a public road (Figure 2). The aircraft was on a heading of 166°M (23° right of the runway heading).

The No. 2 engine separated from the wing and was jammed under the left horizontal stabilizer and tail section, causing a fire in the tail section of the aircraft after the impact. ARFF extinguished the fire and laid foam to prevent spilled fuel from igniting. The emergency locator transmitter activated, and the tower controller requested that ARFF shut off the device. With the assistance of ARFF, the crew evacuated through the main deck entry door (1L) using a ladder.

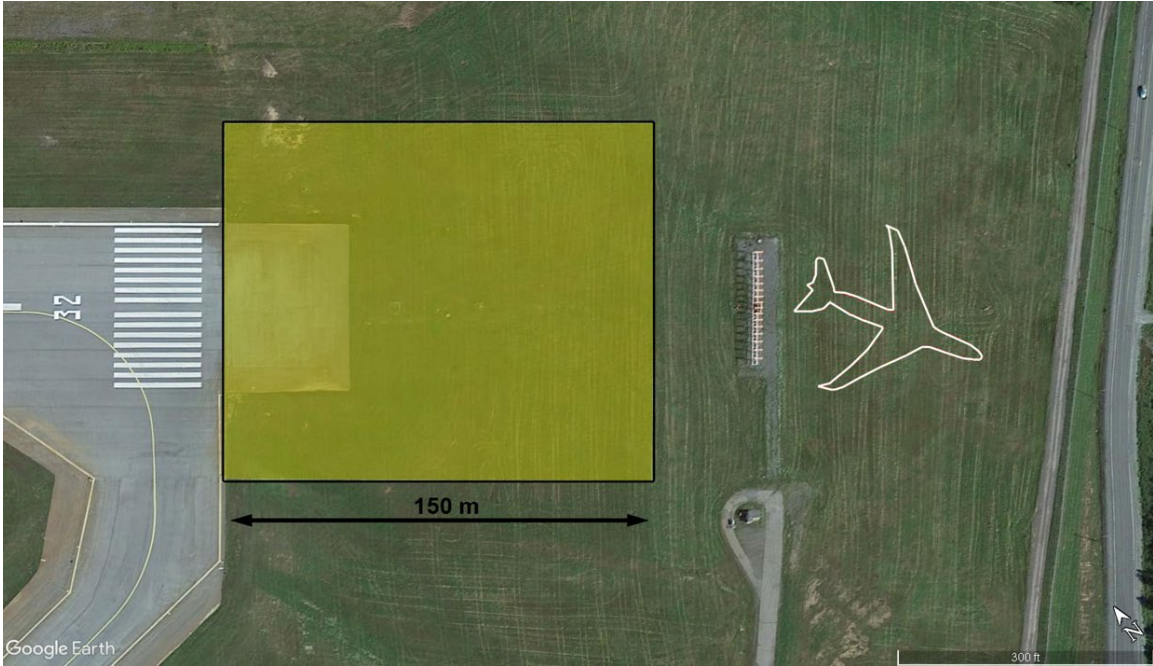
Figure 7. Depiction of Transport Canada's current requirement for runway end safety area on the occurrence runway with the location of the occurrence aircraft after the runway overrun (Source: Google Earth, with TSB annotations)

Runway 14 at CYHZ has a RESA that extends to 150 m (495 feet) past the runway end. This length had an average downward slope of 0.2%. These dimensions meet TC's and ICAO's standards for a 150 m (492 feet) RESA (Figure 7).

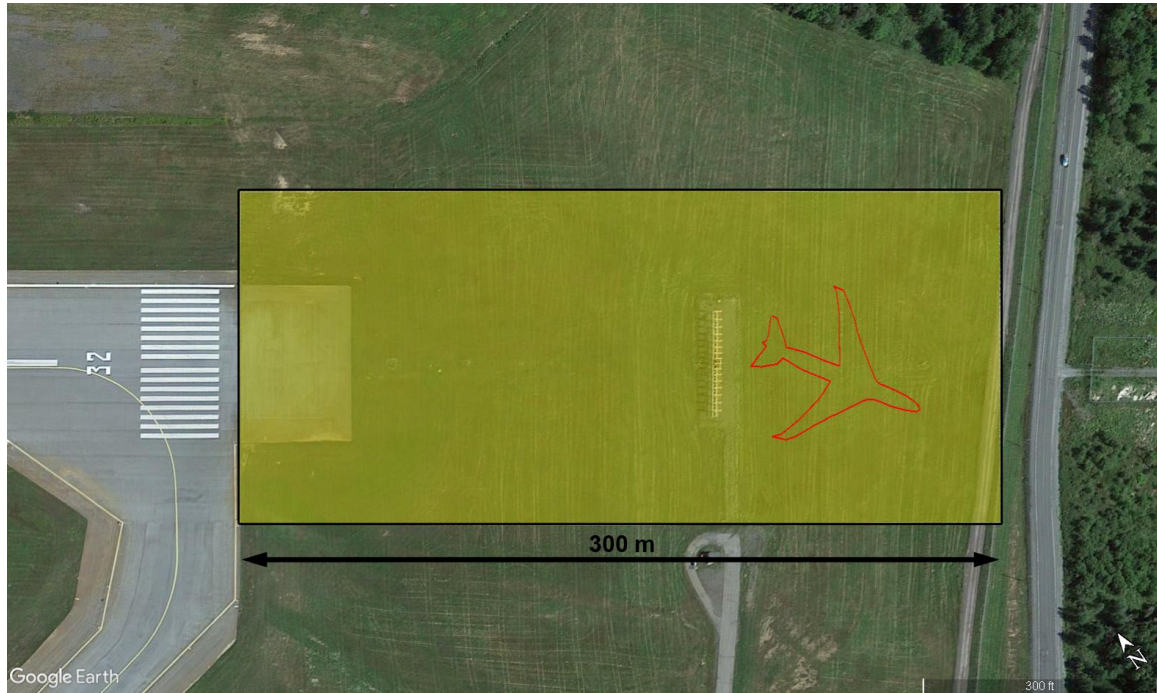
Figure 8. Depiction of International Civil Aviation Organization and TSB recommendation for runway end safety area on the occurrence runway, with the location of the occurrence aircraft after the runway overrun (Source: Google Earth, with TSB annotations)

Approximately 166 m (544 feet) past the end of Runway 14, there is a significant drop of 2.8 m (9 feet), with a downward slope of 73%. This slope does not meet ICAO's recommendations for a 5% longitudinal slope for a RESA that extends to 300 m (984 feet) past the runway end (Figure 8).
