AIR TRANSPORTATION SAFETY INVESTIGATION REPORT A19Q0091

LOSS OF CONTROL ON TAKEOFF AND COLLISION WITH GROUND

Cargair Ltd.
Piper PA-23-250 Aztec, C-GDUL
Trois-Rivières Airport, Quebec
18 June 2019

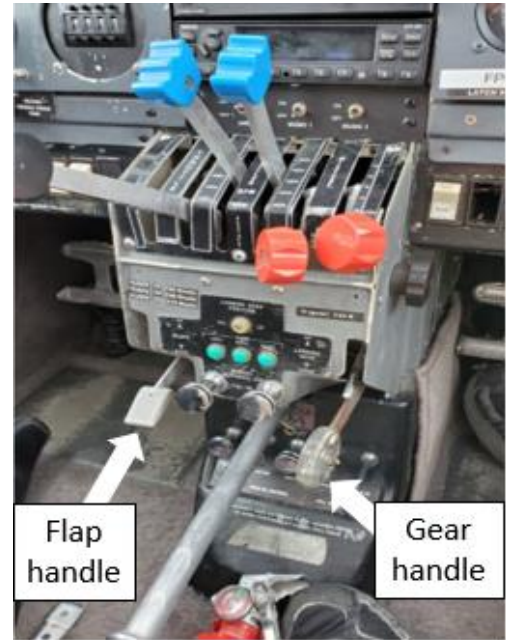
Figure 2. View of landing gear and flap handles (Source: TSB)

During the occurrence flight, for an undetermined reason, the landing gear handle did not return to the neutral position, blocking retraction of the flaps (Appendix B). On some Cargair Ltd. Piper PA-23-250 aircraft, the landing gear handle would sometimes not return automatically to the neutral position. Generally, the problem was intermittent: the instructor would move the landing gear handle back to the neutral position, then the handle would return to the neutral position during subsequent movements of the landing gear. An examination of the technical records for the occurrence aircraft revealed that a similar problem with the landing gear handle had been recorded in December 2018. No other similar problems were recorded after that.

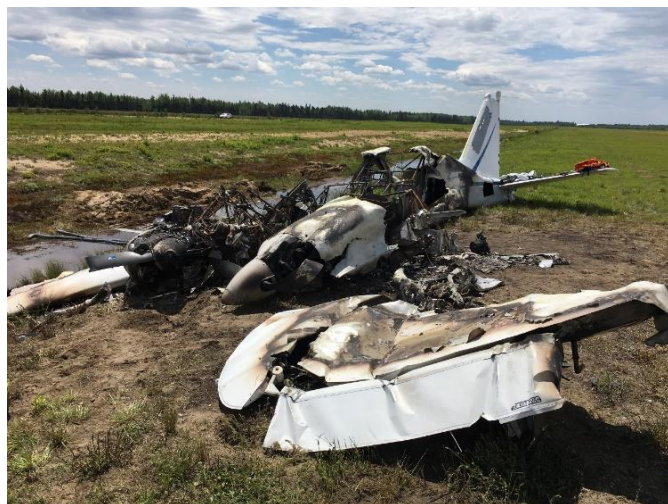
An examination of the wreckage determined that the landing gear was up and the flaps were in the UP position at the time of the occurrence. Both blades of the left

Figure 8. Wreckage of the occurrence Piper PA-23-250 (Source: TSB)

propeller were bent backward and both blades of the right propeller were severed approximately 29 cm from the tip of each blade. Consequently, given the nature of the damage, and the differences in the damage to the left and right propellers, engine traction became asymmetrical.

The hydraulic power pack was recovered. However, it was impossible to determine the cause of the issue with the landing gear handle due to the damage caused by the post-impact fire.

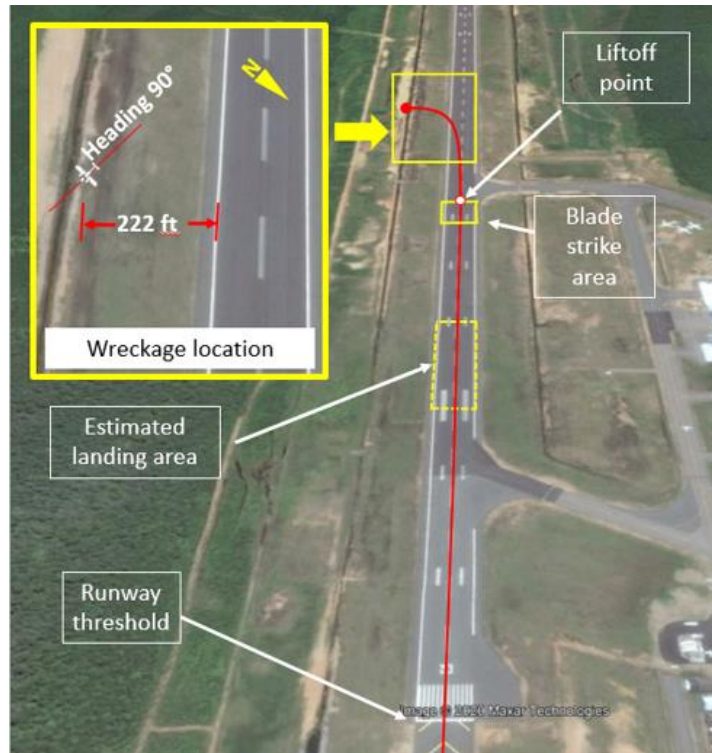
An examination of Runway 23 revealed 73 impact marks caused by the left engine propeller blades, and 65 impact marks caused by the right engine propeller blades. The first marks were found 2980 feet from the runway threshold and subsequent marks extended over a distance of approximately 200 feet (Figure 9).

Figure 9. Runway 23 at CYRQ, with the inset image showing the location of the wreckage (Source: Google Earth, with TSB annotations)

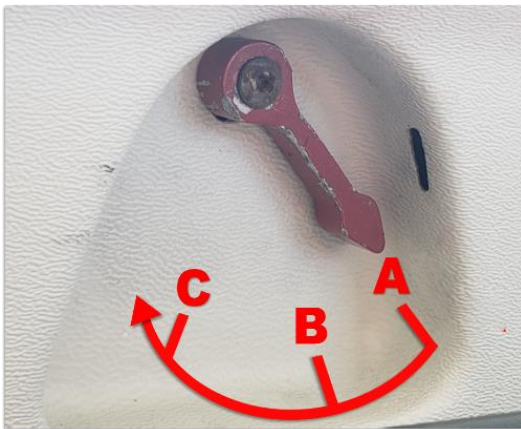
- Moving the handle from point A to point C (Figure 10) causes 2 pins to retract, which dislodges the emergency exit window from the fuselage.
- There is more resistance around point B, which requires the application of much more force to move the handle to point C, so that the pins are completely retracted.
- The handle can be turned more easily from the seat next to the handle (Figure 11).
- The headrest on the left front seat makes it difficult to turn the handle from that seat.

Figure 10. Movement of the emergency exit window handle from point A to point C, with resistance at point B (Source: TSB)

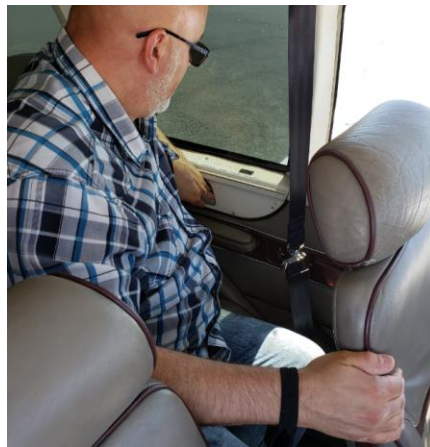
Figure 11. Location of emergency exit window handle during testing (Source: TSB)
