AIR TRANSPORTATION SAFETY INVESTIGATION REPORT A19Q0109

MAIN ROTOR BLADE FAILURE IN FLIGHT

Robinson R44 (helicopter), C-FJLH

10 July 2019

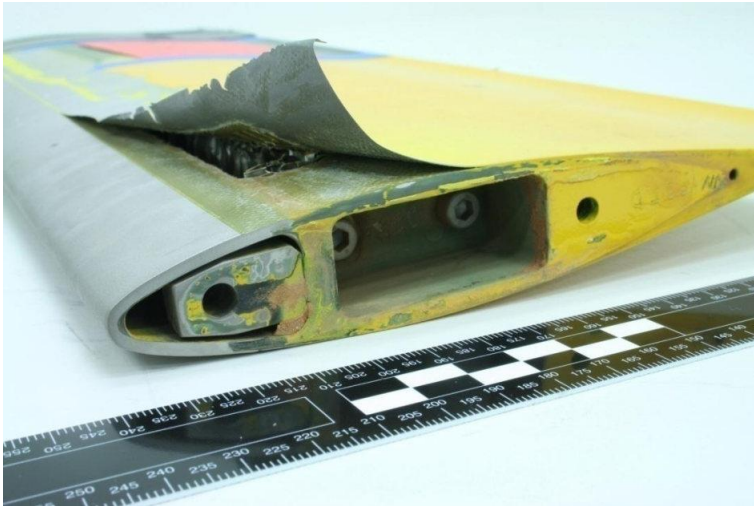
Figure 3. Debonding of the joint (Source: Australian Transport Safety Bureau investigation report AO-2009-002)

These blades had a known tendency to debond⁶ at the adhesive bond joint between the skin and the spar at the tip of the blade. Skin debonding can occur when the adhesive bond joint becomes exposed as a result of the top coat eroding or when corrosion appears below the internal aluminum tip cap. A blade is not considered airworthy if debonding, including microperforation, is detected along the bond joint.⁷

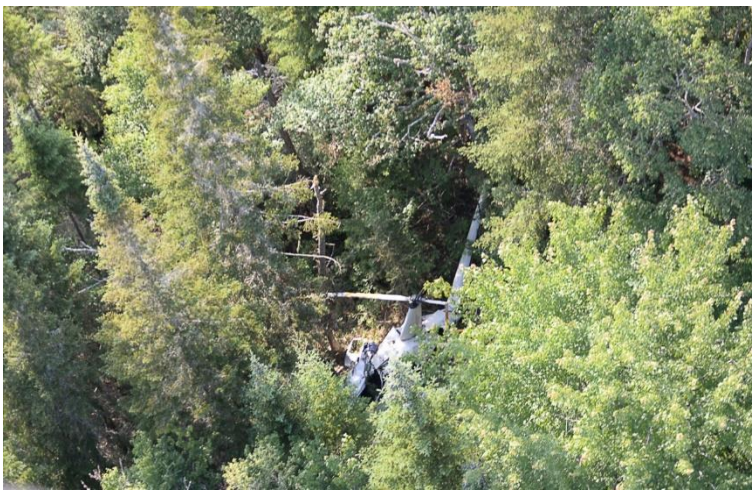
Figure 6. Aerial view of C-FJLH (Source: Sureté du Québec)

The aircraft was found in a vertical position on a rocky outcrop in a densely wooded area (Figure 6). The landing gear, the cabin roof, and the floor at the front of the cabin had collapsed. The windshield had shattered; the rear doors and the door on the pilot side had ejected, leaving only the passenger door still attached to its frame. The seat backs had collapsed backward and the seat cushions had sunk down. The front passenger safety belt, which included a lap belt and a shoulder harness, was found undone. There was fuel in both tanks.

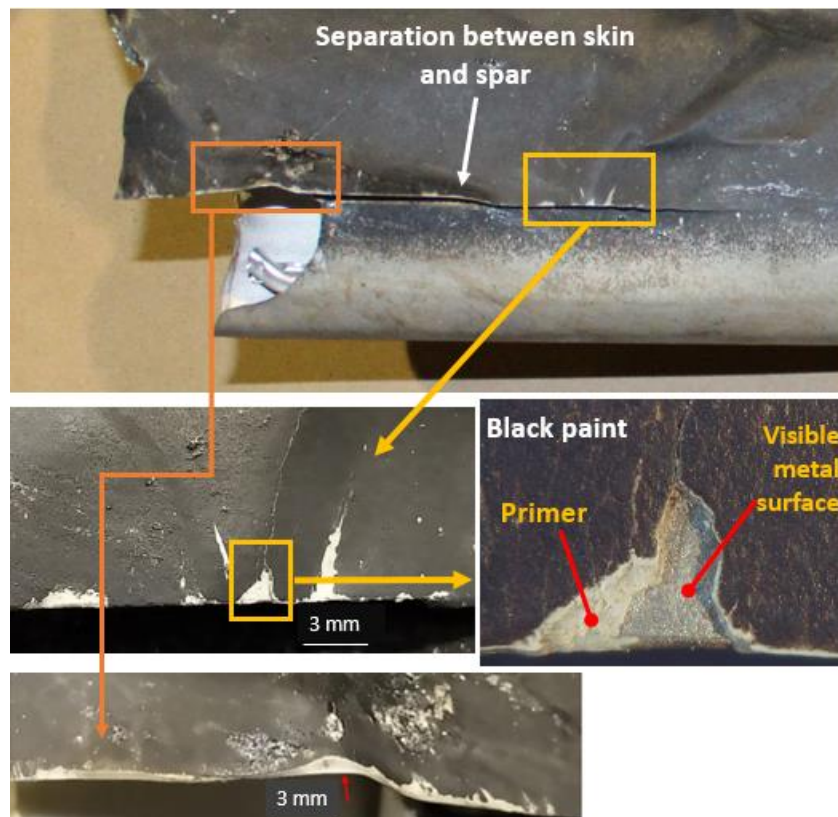
Figure 9. Enlargement of visible metal surfaces (Source: TSB)

Close visual observation revealed that the metal surface of the joint was visible in a few locations along the spar near station RS161. Signs of debonding and gaps in the skin at the spar bonding joint were also noted. Although the lower skin had debonded from the spar after fracturing, the enlargement of these areas shows that air had caused the paint and its underlying layer to erode over time, and that the erosion was not the result of paint suddenly chipping as the skin separated at the spar bonding joint (Figure 9). It is highly likely that the metal surfaces in these areas were visible and detectable before takeoff of the occurrence flight. The visual pre-flight inspection should be done in adequate lighting and at a suitable distance for signs of debonding to be identified, which may require equipment such as a stepladder and a flashlight.

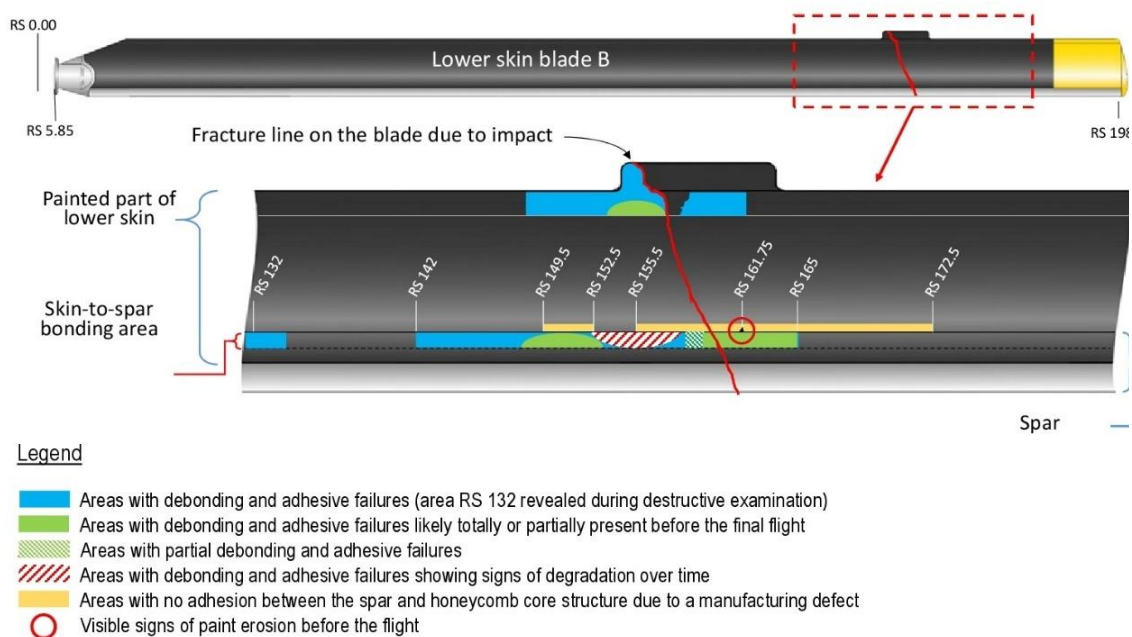
Figure 10. Various areas where debonding was present (Source: TSB)

A destructive inspection of the blade was performed to confirm the observed debonding of the skin. Separation of upper and lower skin samples confirmed the presence of several adhesive failures, of variable sizes, between stations RS132 and RS165 (Figure 10).

The examination revealed that, in some areas, debonding of the skin had allowed humidity to infiltrate below the skin and weaken the adhesion to the bonding joint over time.

In addition to the adhesive failures, there were several places where the adhesive on the surface between the honeycomb core structure and the trailing edge of the spar did not have the usual imprints found when there is contact between them. This was true over a cumulative length of 20 inches (yellow area), indicating that the condition had been present since the blade was assembled and was the result of a manufacturing defect.

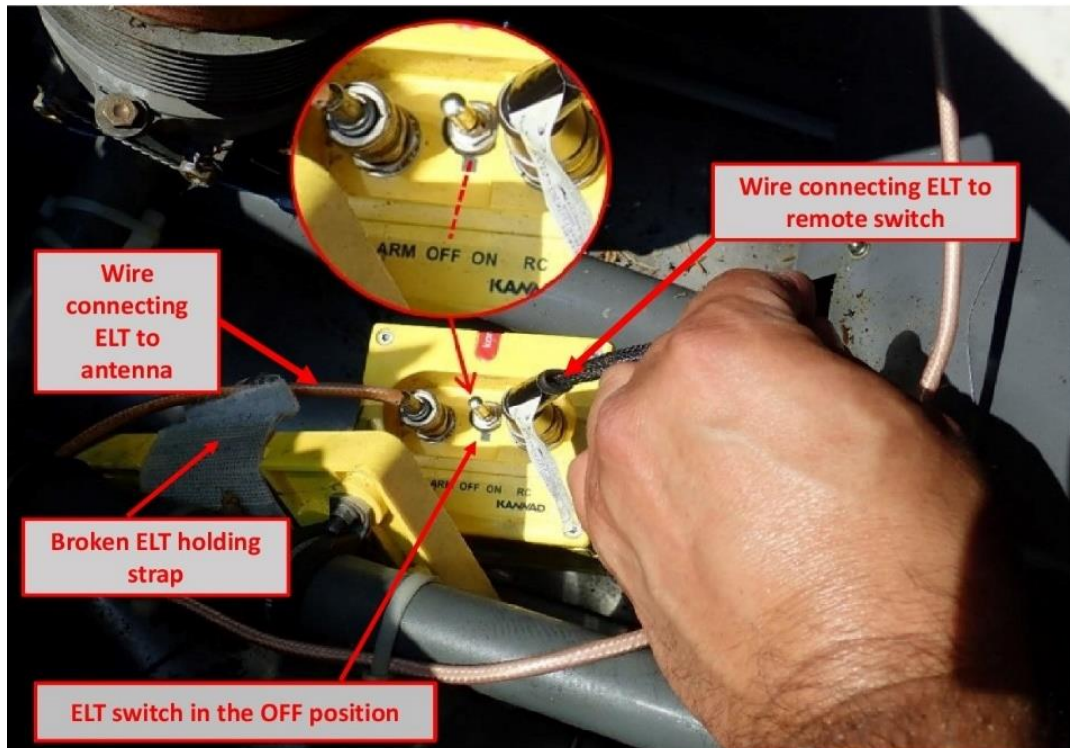
Figure 11. Emergency locator transmitter switch as found (Source: TSB)

The ELT was not accessible from inside the cabin, but it could be activated by the switch on the remote control panel located between the pilot's seat and the front passenger's seat. The 3 positions on the switch are ON, ARMED and RESET/TEST. The switch cannot be kept at the RESET/TEST position, and once it is released, it automatically returns to the ARMED position. Like the ELT switch, the remote switch has a locking system that prevents it from being accidentally moved from the ARMED position to the ON position. It should be noted that the remote switch has no effect on the ELT if the ELT switch is set to the OFF position and that the remote control panel does not indicate the ELT switch position.
