AIR TRANSPORTATION SAFETY INVESTIGATION REPORT A20Q0013

HARD LANDING AND AFT FUSELAGE STRIKE

Air Inuit Ltd.
de Havilland DHC-8-314 (C-GXAI)
Schefferville Airport, Quebec
20 January 2020

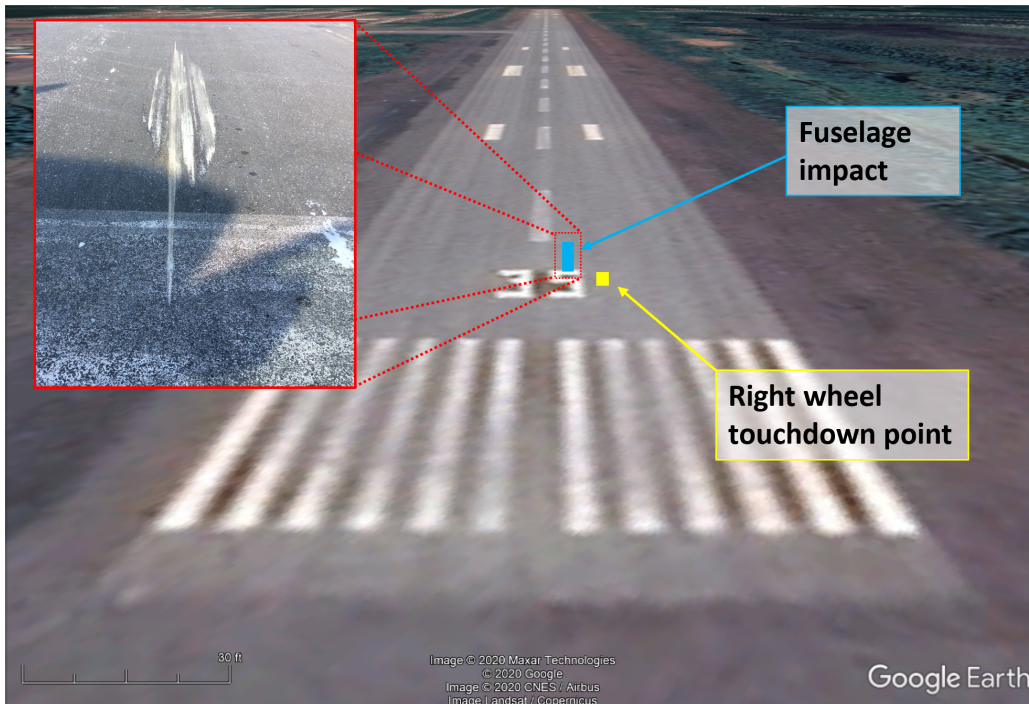
Figure 3. Wheel touchdown and fuselage impact points (Source of main image: Google Earth, with TSB annotations. Source of inset image: Schefferville Airport manager)

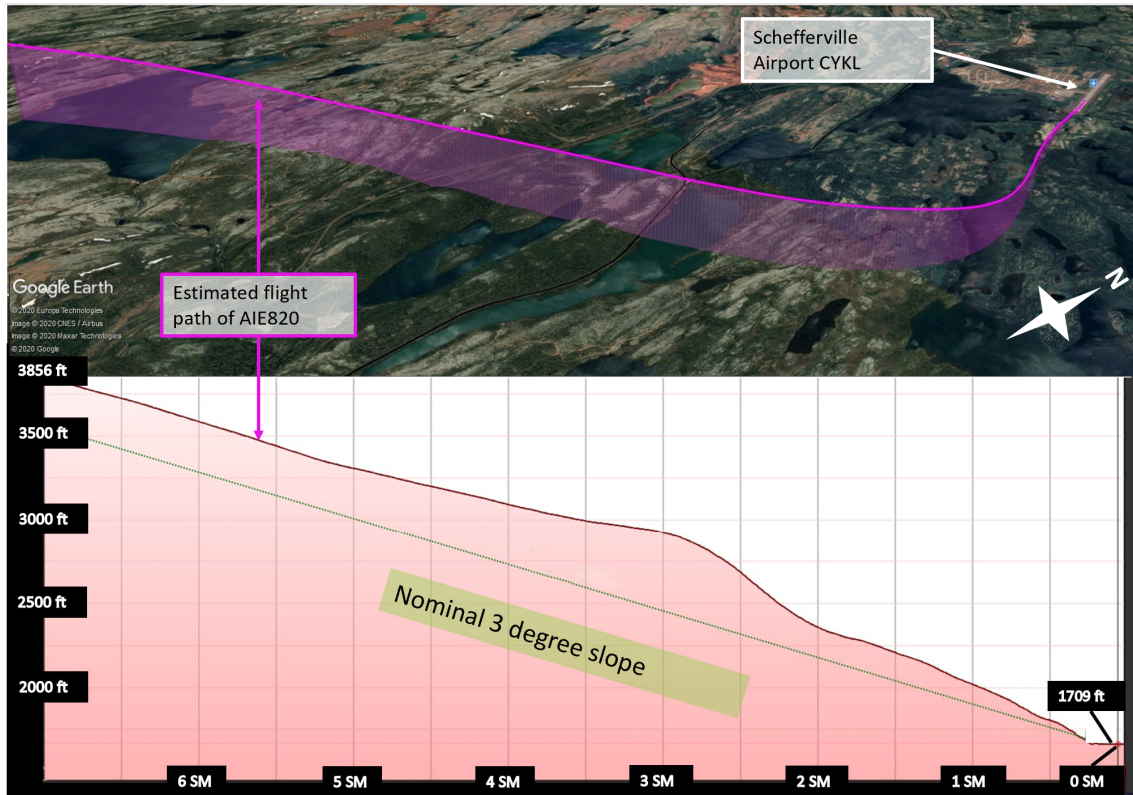
Because the FDR model used in the occurrence aircraft does not record the position from the global positioning system (GPS), the TSB Engineering Laboratory compared the data from the radio altimeter with the topography of the terrain to establish an estimated descent path. The laboratory created a visualization of the aircraft’s vertical path in relation to the nominal 3° slope (Figure 4).

Figure 4. Estimated flight path of AIE820 (altitude above sea level, in feet, and remaining distance of the approach path, in statute miles) (Source: Google Earth, with TSB annotations)
