AIR TRANSPORTATION SAFETY INVESTIGATION REPORT A20W0016

LOSS OF PITCH CONTROL ON LANDING

Canadian Pacific Railway Company
Bombardier CL-600-2B16 (Challenger 605), C-GKCP
Calgary International Airport, Alberta
23 February 2020

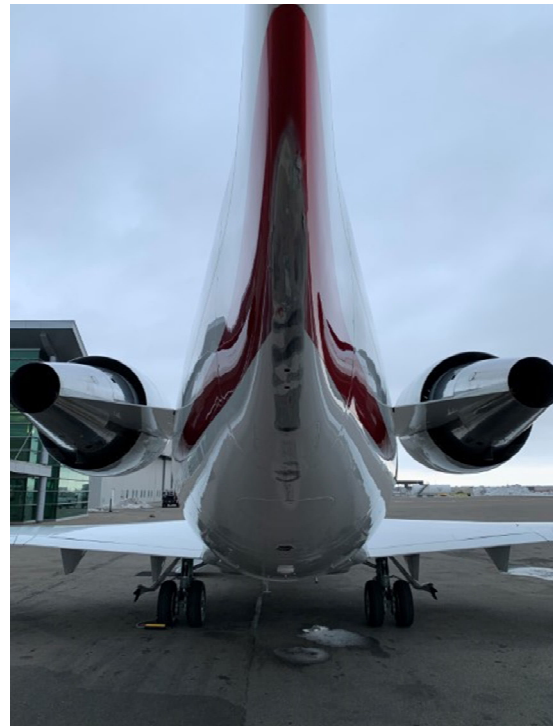
Figure 1. Rear fuselage damage (Source: Canadian Pacific Railway Company)

During the landing roll, the rear fuselage and tail cone made contact with the runway surface. As a result, the aft fuselage fuel drain mast broke off the aircraft and the lower skin of the tail fairing received significant abrasion damage (Figure 1).

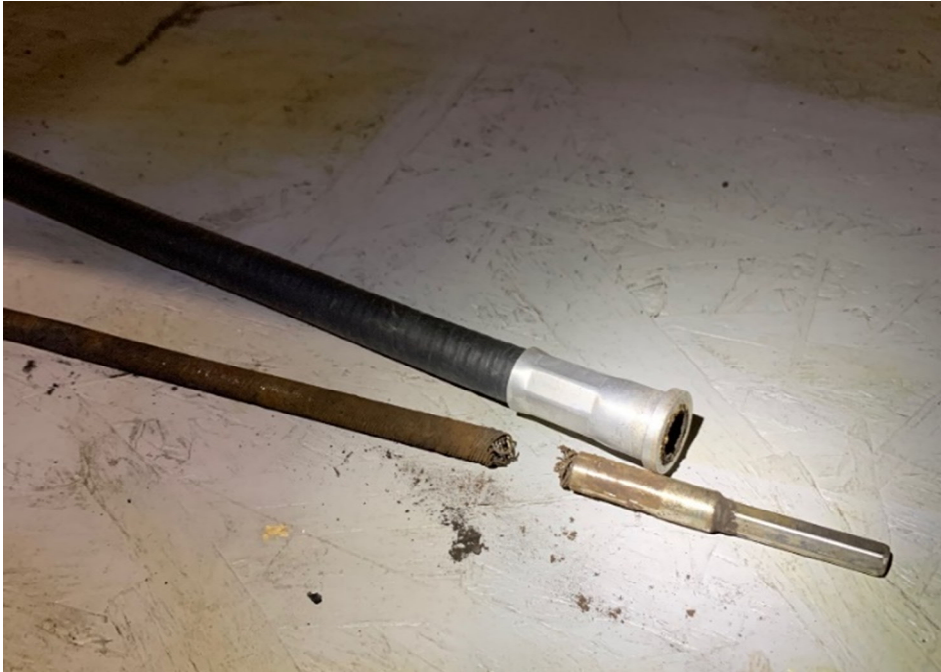
Figure 2. Occurrence aircraft's failed flap flexible drive shaft (Source: Canadian Pacific Railway Company)

The TSB Engineering Laboratory conducted a detailed examination of the part, which revealed 2 puncture holes in the protective outer casing under the data plate for the part. These holes were likely introduced as an unintended consequence during the manufacturing process of the drive shaft assembly, when the data plate was being installed. These holes would have allowed water moisture to enter the flap flexible drive shaft housing cavity, allowing corrosion to begin. In addition, both the inboard and outboard segments of the inner drive shaft showed significant corrosion and lack of lubrication.

Following the occurrence, the TSB Engineering Laboratory's detailed examination of the failed flap flexible drive shaft revealed 2 puncture holes in the protective outer casing under the data plate. These holes allowed the cavity to breathe with repeated changes in altitude, introducing contaminants and condensation that led to corrosion over time. Also likely contributing to the significant corrosion of the ends of the flexible drive shaft core, was moisture ingress into the drive shaft casing from the drive shaft to flap actuator interface.

Moisture entered the flap flexible drive shaft casing, likely through the undetected puncture holes and the drive shaft casing to flap actuator interface, which led to the subsequent corrosion and failure of the inner drive shaft.

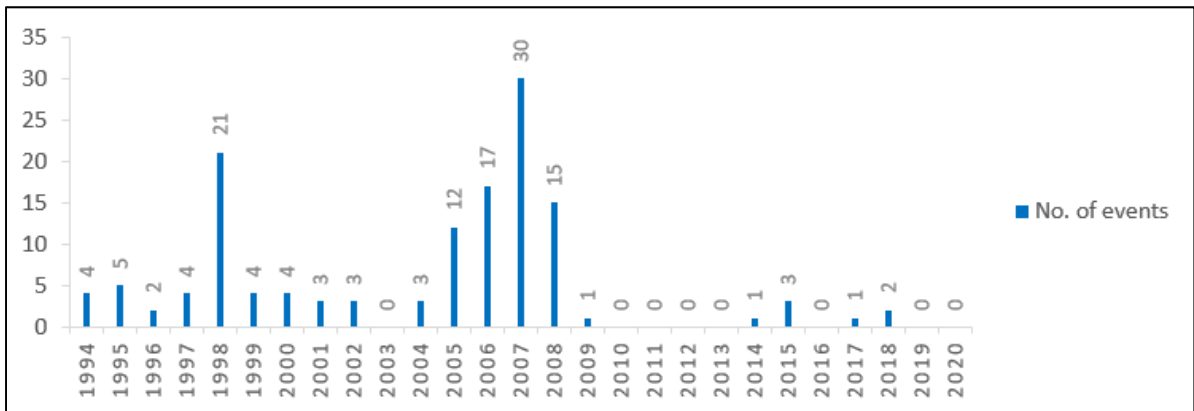
Figure 3. Canadair Regional Jet 100/200 series flap malfunction events due to flap flexible drive shaft failure, per year (Source: TSB)

A search of service difficulty reports related to flap malfunctions directly attributable to flap flexible drive shaft failure yielded the data presented in Figure 3. Although the number of service difficulty reports decreased significantly starting in 2009, it could not be determined if this was as a result of the service bulletin actions, or as a result of reduced worldwide fleet utilization.
