Transportation
Safety Board
of Canada

Air Transportation Safety Investigation Report A20A0027

LOSS OF CONTROL AND COLLISION WITH TERRAIN

Privately registered
Robinson R44 Raven II (helicopter), C-FPBL
Thorburn Lake, Newfoundland and Labrador
20 July 2020

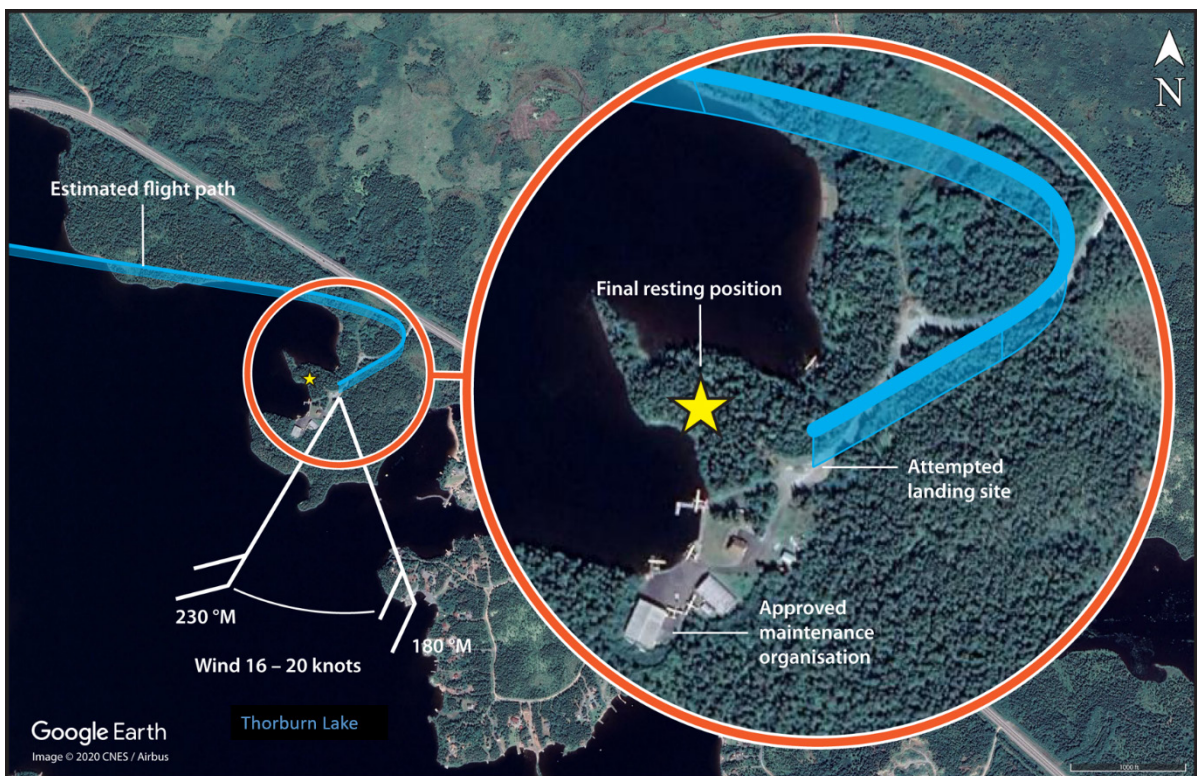
At approximately 1535, the occurrence helicopter made a right base leg turn onto the final approach heading of 240° magnetic (M). The wind direction at the time varied from 180°M to 230°M at an estimated speed of 16 to 20 knots. The occurrence pilot continued his approach to the landing site and entered an out-of-ground-effect hover over the landing site, just below the tree tops (Figure 1). Once established in the hover, the pilot determined there was not enough room to continue with the landing and initiated a vertical climb.

Figure 1. Estimated flight path, derived from global positioning system data (Source: Google Earth, with TSB annotations)

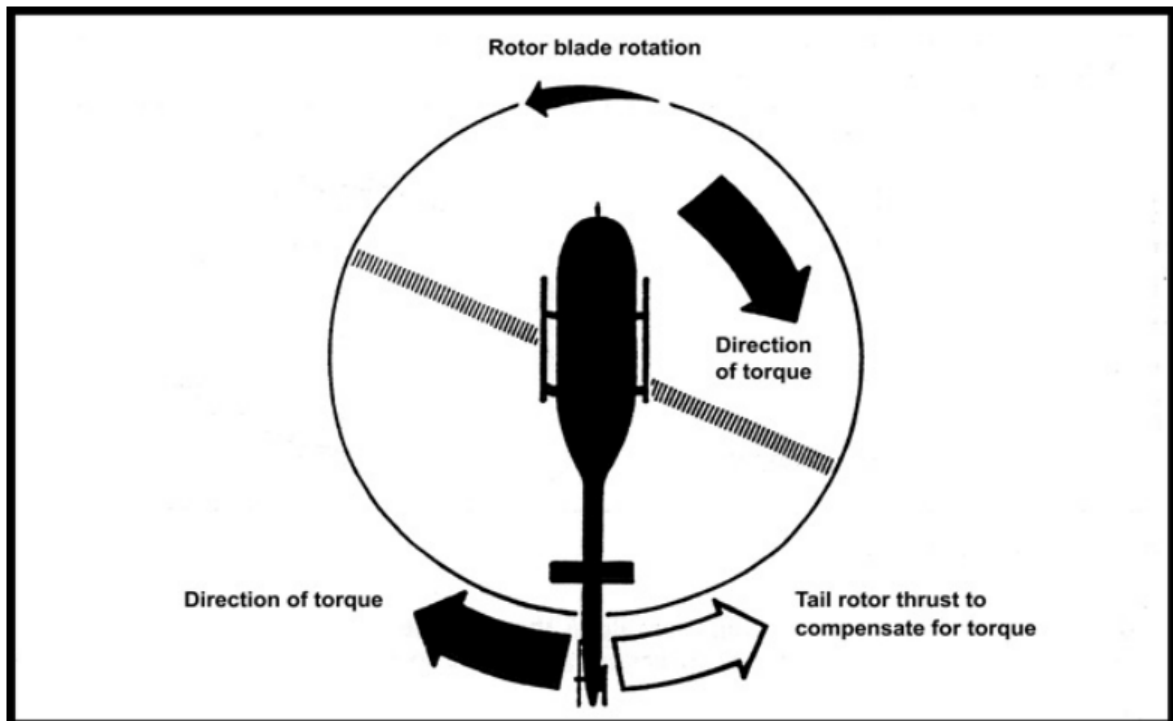
When seen from above, the main rotor blades of the Robinson R44 turn counterclockwise. Due to this rotation, the helicopter experiences a torque reaction in the opposite direction, which results in the helicopter yawing to the right (Figure 2).

Figure 2. Torque effect (Source: Transport Canada, TP 9982, Helicopter Flight Training Manual, Second Edition [June 2006], Figure 3-3)
