# Air Transportation Safety Investigation Report A20W0072

## COLLISION WITH POWER LINE

Privately registered  
Harmon Rocket II, C-FZXS  
Hugget/Goodwood Field Aerodrome, Alberta  
26 September 2020

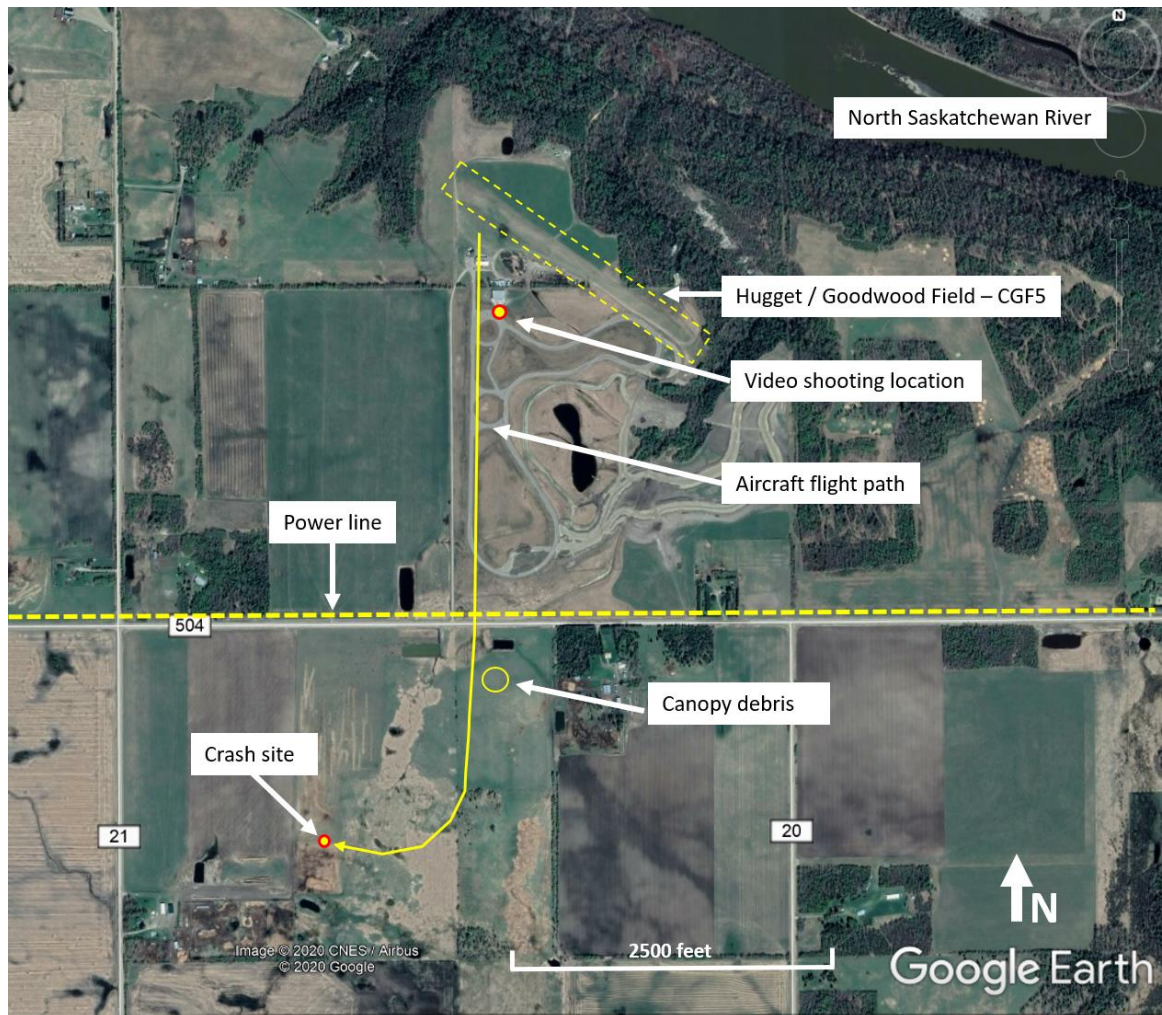
After the 2nd circuit, the aircraft turned left, descended to approximately 25 feet above ground level (AGL) and flew over the racetrack straightaway from north to south. Based on videos recorded by observers on the ground, at the south end of the straightaway the aircraft initiated a climb and struck the upper of 2 wires of an unmarked power line on the north side of Township Road 504 at between 32 and 35 feet AGL (Figure 1). The aircraft pitched up steeply, climbed to approximately 700 feet while rolling right to an almost inverted attitude and changing heading to the west. When the aircraft began to descend, it rolled left to a wings-level attitude, and continued to descend until it struck the ground, in a 40° nose-down attitude.

Figure 1. Map showing the occurrence aircraft's flight path, the power line and the accident site (Source: Google Earth, with TSB annotations)
