Rail Transportation Safety Investigation Report R19E0150

MAIN-TRACK TRAIN DERAILMENT

Canadian National Railway Company
Freight train G86341-28
Mile 80.45, Vegreville Subdivision
Chipman, Alberta
29 September 2019

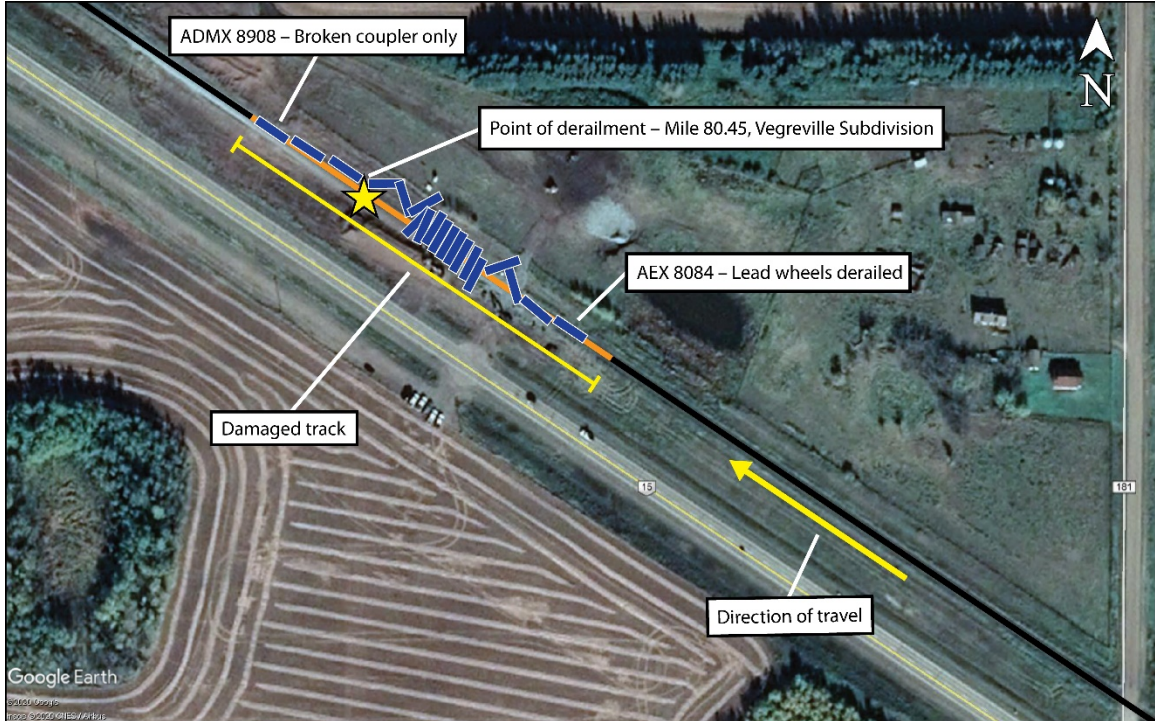
Figure 2. Satellite image of derailment location (Source: Google Earth, with TSB annotations)

Most of the derailed cars were in a jackknife position, consistent with a sudden, catastrophic rail failure. The point of derailment was determined to be about Mile 80.45 of the Vegreville Subdivision. Approximately 600 feet of track was damaged or destroyed, with repairs needing to be made an additional 20 feet beyond both ends of the derailment site (Figure 2).

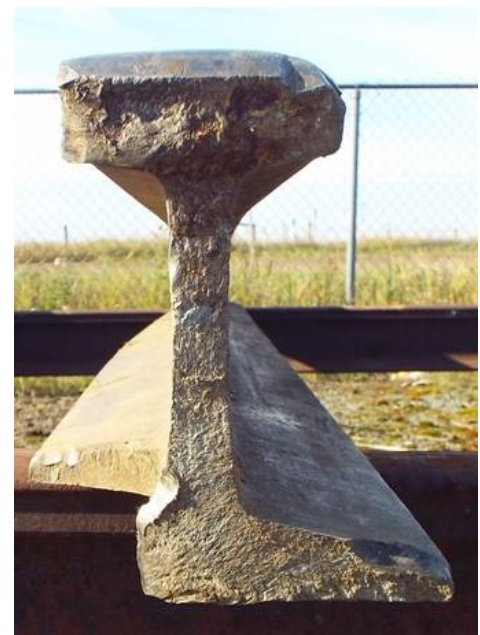
Figure 4. Broken rail showing rail end batter (Source: Canadian National Railway Company)

One of the pieces was observed to have rail end batter consistent with a number of wheels having impacted the rail head (Figure 4). Rail end batter generally occurs when a piece of rail has fractured, allowing successive wheels to contact the exposed head of the remaining rail.

The investigation was unable to conclusively determine why the rail broke. This piece of rail was not examined by a laboratory, and therefore it is unknown if a more detailed examination would have found pre-existing anomalies.

After the derailment, CN inspected the Vegreville Subdivision with a heavy track geometry inspection car and found no defects. On 11 September 2020, CN installed a WILD on its Prairie North Line, at Mile 18.2 of the Blackfoot Subdivision.
