# Marine Transportation Safety Investigation Report M17C0108

## GROUNDING

Tanker *Damia Desgagnés*

15 June 2017

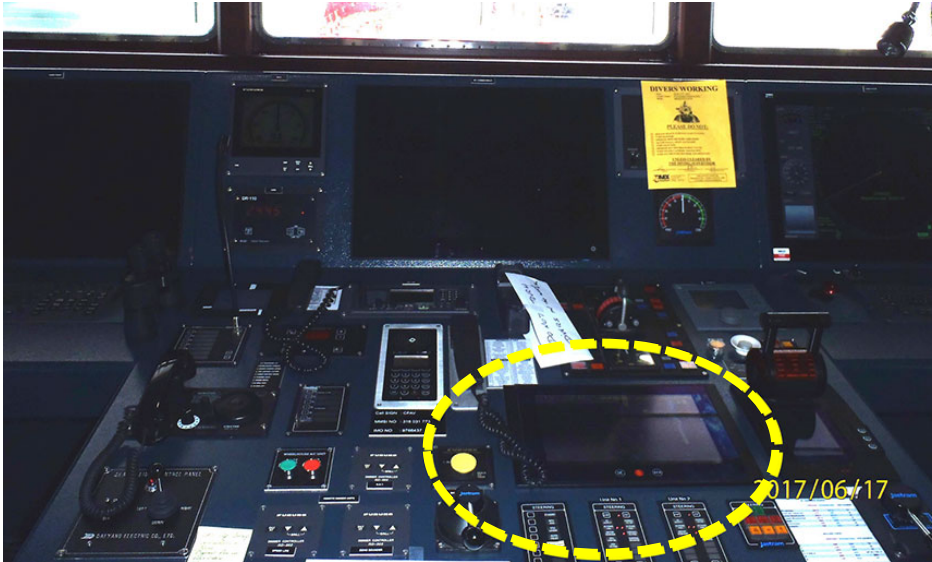
The investigation found that the main engine had been inadvertently shut down by the accidental activation of the main engine shutdown button on the integrated alarm monitoring and control system touch screen on the bridge. The touch screen was mounted horizontally in the centre bridge console near the steering and propulsion controls (Figure 2). At the time of the loss of propulsion, 4 crew members were within 2 m of the screen. Post-occurrence testing showed that the touch screen was reactive to a variety of mediums including the telephone cord situated next to it. In Figure 2, the telephone cord is visible near the face of the screen.

Figure 2. Centre bridge console on the *Damia Desgagnés*, showing the horizontal mounting location of the integrated touch screen that was activated and caused the accidental main engine shutdown

In this occurrence, the touchscreen on the centre bridge console was mounted horizontally near the steering and propulsion controls, increasing the probability of the operator accidentally activating ship controls. The message on the touchscreen did not provide sufficient information to the bridge operator to respond to or manage the alarm. The alarm could not be acknowledged by the operator, because the message on the touchscreen did not provide the possibility to positively confirm the accidental activation of the main engine shutdown button. The shutdown was activated by a single movement (action) on the touchscreen.

Also on 17 June, the managing company installed a plastic cover over the vessel's touch screen to prevent the recurrence of an inadvertent shutdown. On 21 December, after a thorough review, the equipment manufacturer disabled the main engine shutdown function of the touch screen and the plastic cover was removed under the supervision of the managing company. Because the touch screen was highly sensitive, certain functions were removed from the wheelhouse without reducing the ability to properly control the ship. As of February 2018, these adjustments have been made to both company ships that are similarly equipped. In case of an emergency, the main engine can still be shut down from the bridge via the traditional shutdown button.

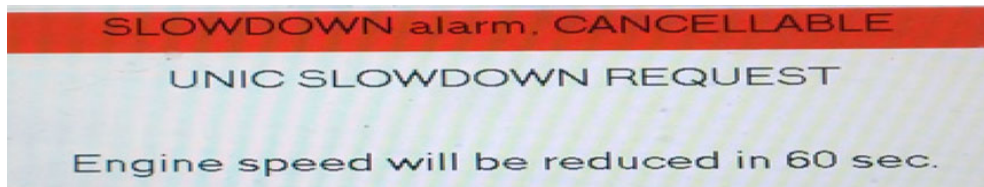
Figure 3. Message following main engine shutdown on touch screen on bridge

When the main engine shutdown button was activated on the touch screen, a generic system status message appeared on the touch screen, stating "SLOWDOWN alarm. CANCELLABLE UNIC<sup>2</sup> SLOWDOWN REQUEST[.] Engine speed will be reduced in 60 sec"<sup>3</sup> (Figure 3). The message did not specify that the engine was about to shut down, nor did it indicate how the shutdown was activated or from where (bridge, engine room, emergency stop, etc.).<sup>4</sup>

Although the bridge team noticed this message, none of the bridge team crew members were aware of its meaning or that propulsion could be shut down in this manner. A similar message appeared on the alarm screen in the engine control room (Figure 4). Approximately 60 seconds after the message appeared on both screens, the engine shut down.

Since the message displayed on the touchscreen was ambiguous and did not clearly identify the abnormal situation or the source of the alarm, it caused distraction.
