MARINE TRANSPORTATION SAFETY INVESTIGATION REPORT M18A0001

BOTTOM CONTACT

Passenger ferry *Deer Island Princess II*
Little Letete Passage, New Brunswick
02 February 2018

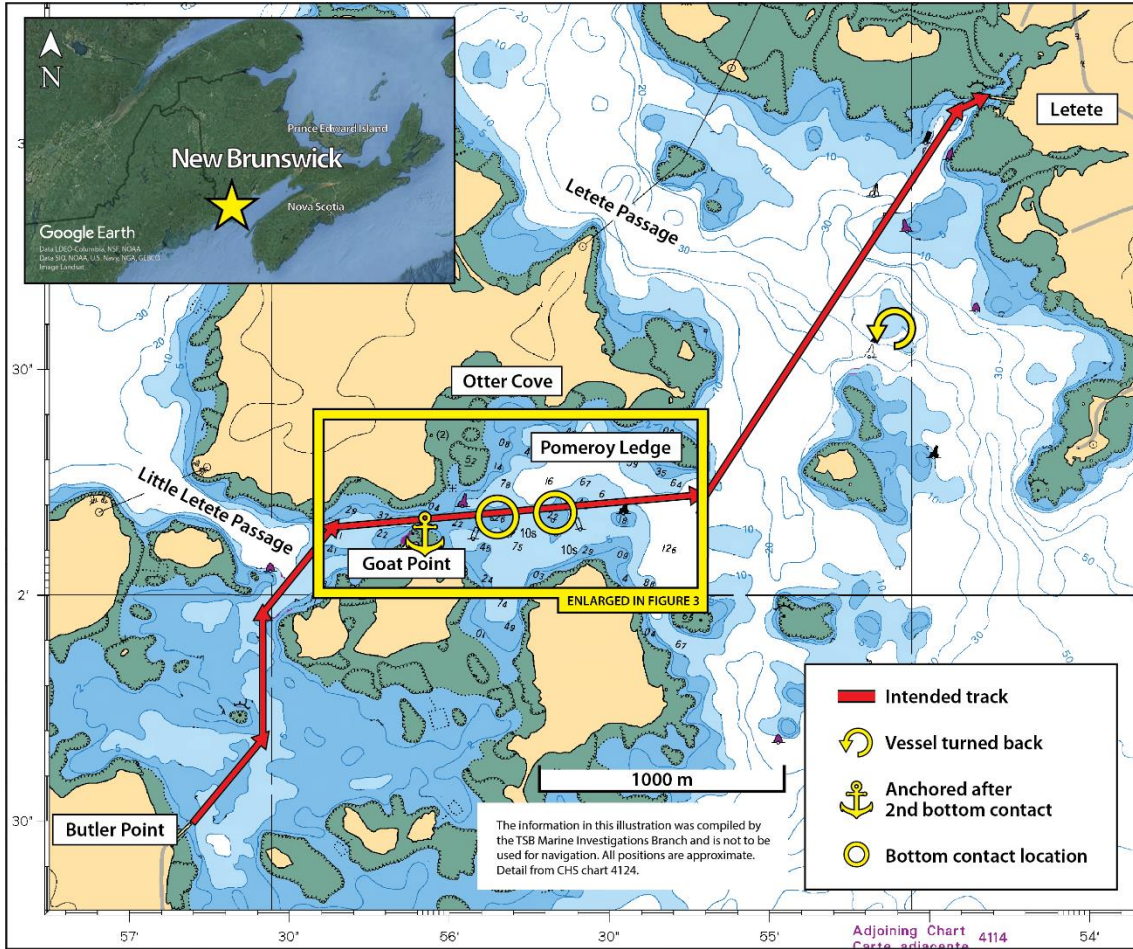
Figure 2. Nautical chart showing the *Deer Island Princess II*'s intended track and the location of the bottom contacts. The inset image shows the general location of the occurrence. The fourth leg of the voyage (outlined) is enlarged in Figure 3 (Source of main image: Canadian Hydrographic Service, Chart 4124: Letete Passage, Letang Harbour and/et Blacks Harbour, with TSB annotations; source of inset image: Google Earth, with TSB annotations)

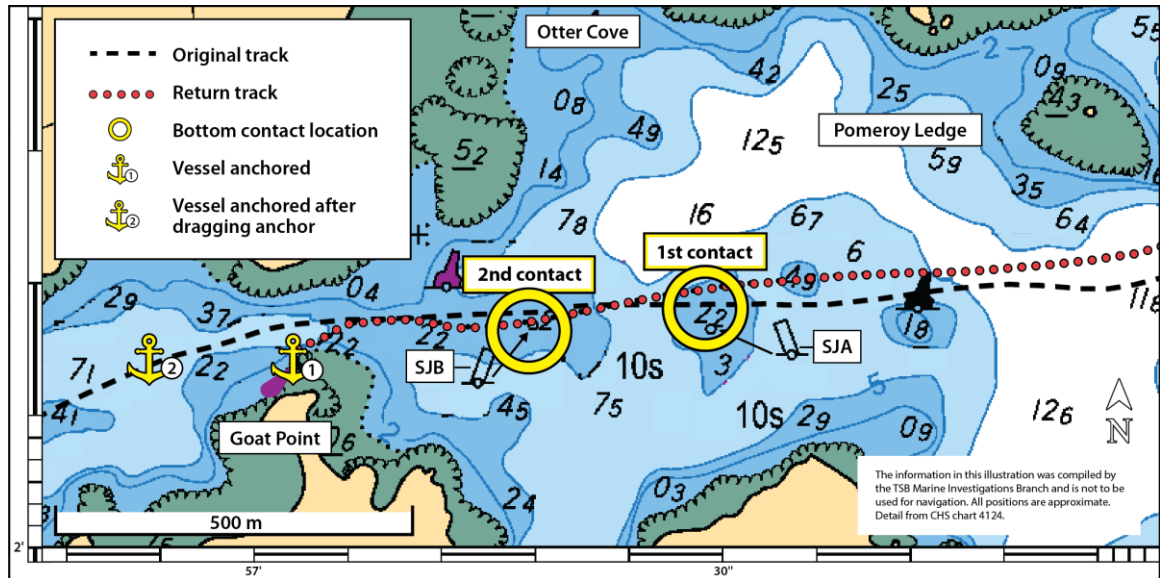
Figure 3. Close-up of the fourth leg of the route depicted in Figure 2, showing the normal location of buoys SJA and SJB; the *Deer Island Princess II*'s actual original track and actual return track; the locations of the bottom contacts; and the location where the vessel was anchored. (Source: Canadian Hydrographic Service, Chart 4124 Letete Passage, Letang Harbour, and/et Blacks Harbour, with TSB annotations)

The shoal where the *Deer Island Princess II* made contact the second time was ordinarily marked by isolated danger buoy SJB. However, the buoy was missing from its charted position⁴⁵ and had been for some time, without it being reported to the CCG.

A strong northwesterly wind was blowing out of Passamaquoddy Bay at the time of the occurrence. This likely created a negative surge that further lowered the water level at the occurrence site below predicted levels, allowing the vessel to make contact with the 2.6 m shoal normally marked by missing isolated danger buoy SJB.

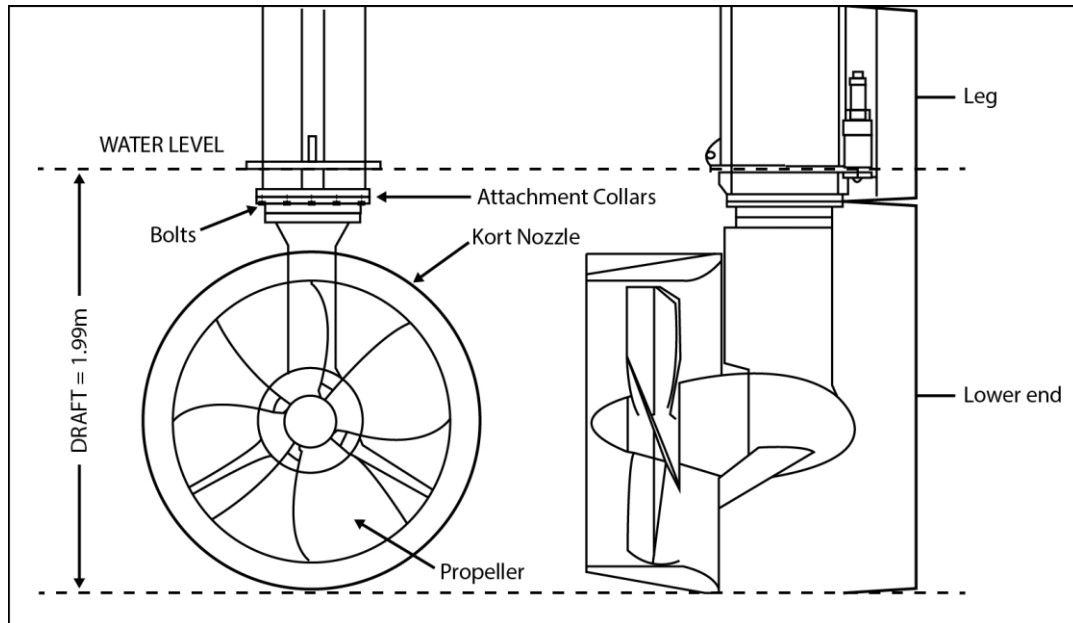
Figure 4. Diagram of a Z-drive thruster unit (Source: Coastal Transport Limited, with TSB annotations)
