MARINE TRANSPORTATION SAFETY INVESTIGATION REPORT M19P0057

STRIKING OF THE ANCHORED VESSEL *PAN ACACIA*

Bulk carrier *Caravos Harmony*
Vancouver Harbour, British Columbia
17 March 2019

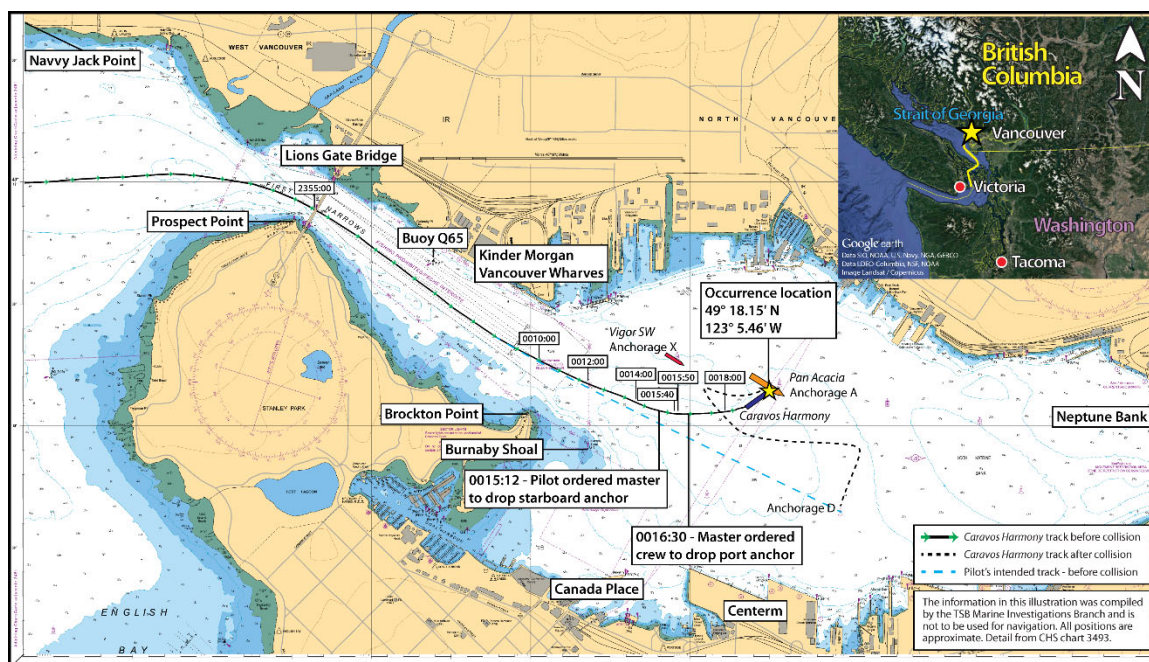
As the *Caravos Harmony* entered First Narrows, the strong current and eddies caused the vessel to move to port. The pilot gave full ahead and starboard helm orders in an attempt to increase water flow across the rudder and correct the vessel's course. Because the second officer was not familiar with the bridge control automation he was pausing about 4 seconds at each intermediate step for fear of overloading the engine. The pausing of 4 seconds at each intermediate step meant that the main engine responded to each of the intermediate steps in sequence as typical engine orders rather than as a single order.

As the vessel was not responding as quickly as expected and the vessel was still moving to port, the pilot ordered the starboard anchor to be deployed and to apply emergency astern. Unaware of the 2 conditions to be met to initiate astern propulsion, the second officer's repeated attempts to initiate emergency astern were unsuccessful. As a consequence of the second officer's lack of familiarity with the main engine bridge control automation, the engine orders were ineffective and the vessel was slow to respond and continued moving to port.

The pilot then ordered the starboard anchor to be released in order to swing the vessel to starboard. However, because neither anchor had been previously prepared for deployment by lowering them to 1 m above the water as requested by the pilot, the crew found the starboard anchor stuck in the stowed position and could not release it.

With only the port anchor available and having a differing understanding of the situation from the pilot, the master ordered the port anchor to be dropped in order to stop the vessel, but this caused the *Caravos Harmony* to move further to port until it struck the *Pan Acacia*.

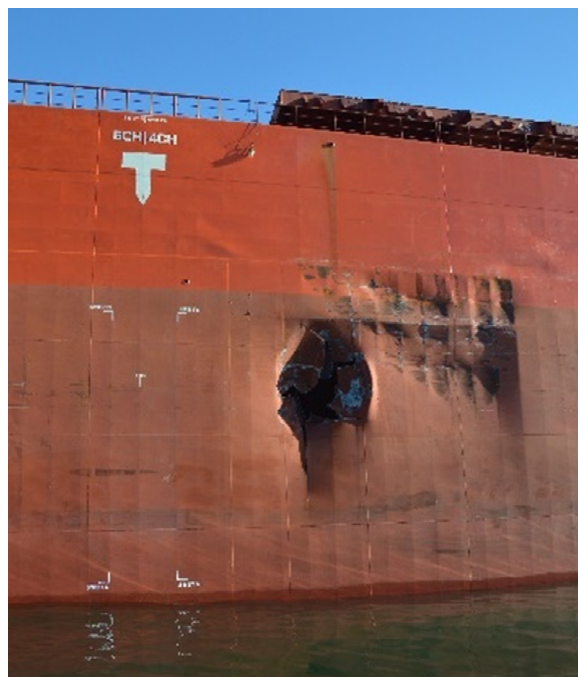
Figure 4. Damage to the *Pan Acacia* (Source: TSB)

The starboard side of the *Pan Acacia* was dented and punctured through to the No. 4 cargo hold (Figure 4). The *Caravos Harmony* sustained dents and damage to its port bow hull structure (Figure 5).

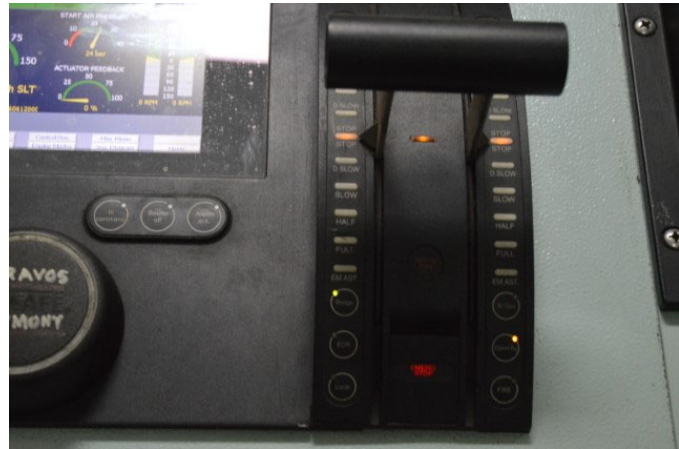
Figure 6. Combined lever and telegraph unit (LTU) on the *Caravos Harmony* (Source: TSB)

The *Caravos Harmony's* LTU has a propulsion order for emergency astern, which allows the operator to initiate a command for astern propulsion quickly. A command for emergency astern bypasses the engine's safety interlocks³⁶ to reduce the likelihood of the engine failing and to enable it to start in the astern direction. In order for emergency astern to activate on the *Caravos Harmony*, 2 conditions have to be met. The 1st condition is that a propulsion command has to be given whereby the engine rpm would change from at least 65 or more ahead to at least 50 astern. That is, the LTU lever has to be moved from a position of above half ahead to a position of slow astern or below. The 2nd condition is that the LTU lever has to be moved through this command within a 2-second timeframe.

In this occurrence, the 2 conditions required to initiate emergency astern had not been covered in the familiarization for the master or the bridge officers. There was no information on the bridge about these 2 conditions, nor were they mentioned in the vessel's documentation. None of the bridge team members or engineers was aware of them, and the bridge team and the engineers believed that the main engine would be overloaded if the rpm was increased or decreased rapidly between full ahead and emergency astern.
