# Marine Transportation Safety Investigation Report M20P0110

## STRIKING

Roll-on/roll-off passenger ferry *Spirit of Vancouver Island*  
Tsawwassen, British Columbia  
18 April 2020

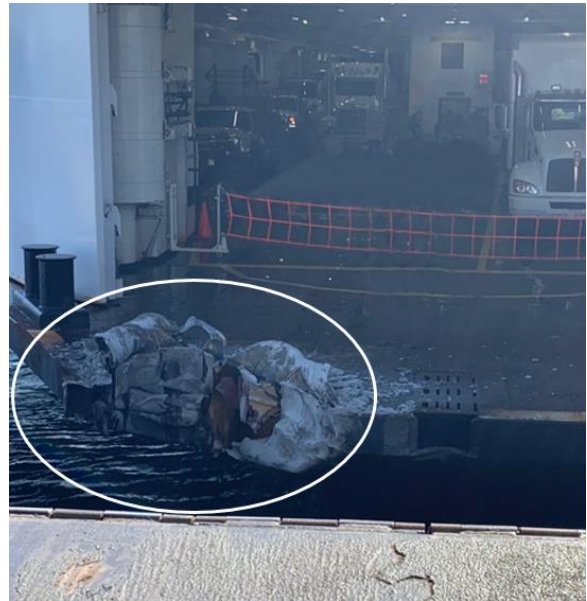
Figure 2. Damage to the vessel (circled) (Source: BC Ferries, with TSB annotations)

At 1626:32, the vessel struck the concrete abutment on the wall of berth 3 at a speed of approximately 5.4 knots. The master stopped the engines and thrusters, and the crew conducted a damage assessment. Although no warning was broadcast to notify passengers about the impending striking, no injuries were reported immediately following the occurrence; the next day, 2 crew members and 1 passenger reported minor injuries.

The vessel sustained damage to the deck plate, rubbing strake, and the forepeak tank above the waterline (Figure 2). The concrete abutment of the berth wall was also damaged (Figure 3). The vessel docked at berth 3 at 1637. Vehicles on the upper car deck and foot passengers offloaded at 1802, and the remaining vehicles on the main car deck offloaded at 2058.

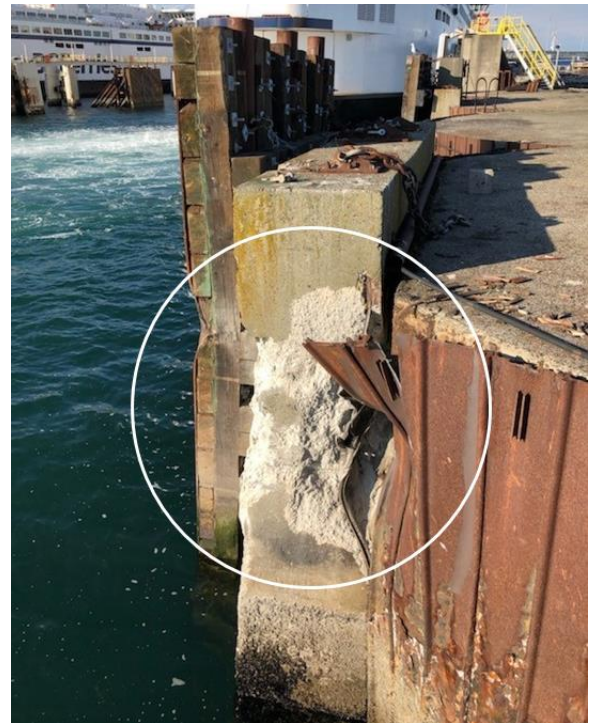
Figure 3. Damage to the concrete abutment (circled)  
(Source: BC Ferries, with TSB annotations)

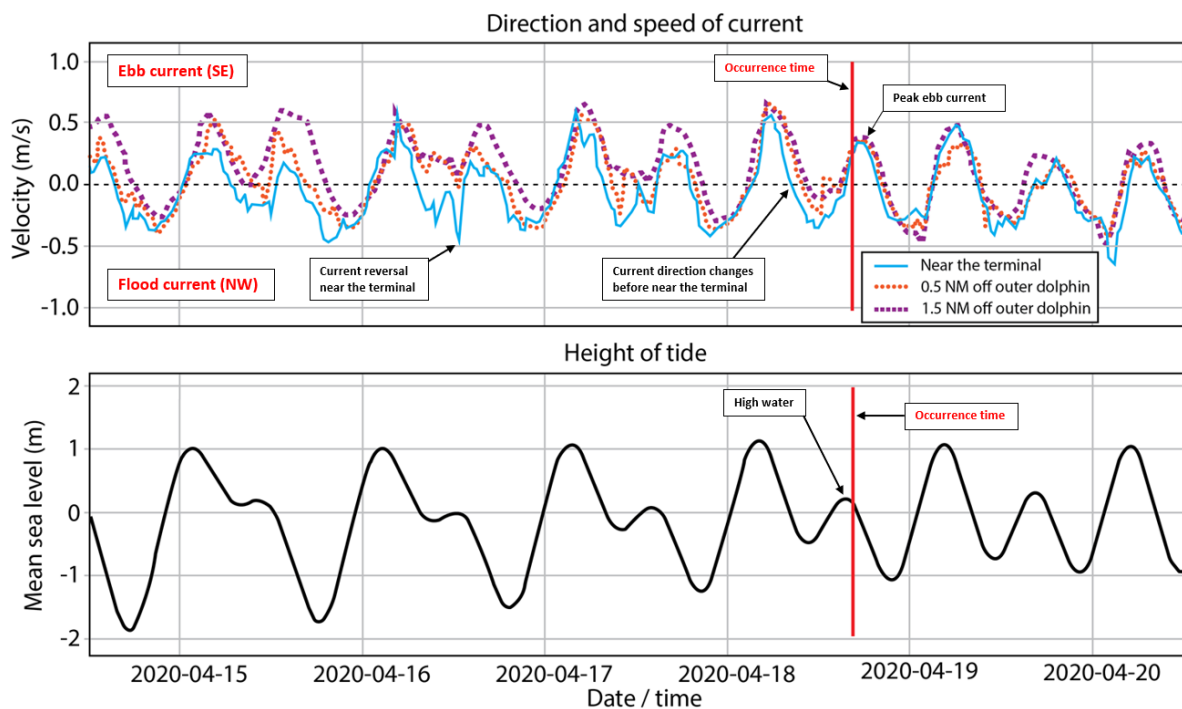
Figure 5. Model predictions for direction and speed of current (top graph) and model predictions for height of tide (bottom graph) (Source: Ocean Modeling and Predictions Section, Institute of Ocean Sciences)

Figure 5 shows the model's recreations of the direction and speed of the currents (top graph) in correlation with the height of the tide (bottom graph), leading up to the occurrence time. The model showed unexceptional currents at the time of the occurrence; according to the model, the current was at peak ebb and, with currents near the terminal (solid line, top graph) similar to those further out in

the channel, there was no current reversal. The current near the terminal generally changes from ebb to flood slightly before the currents farther away (dotted line and line of squares, top graph), but this occurs as the currents are approaching zero (slack tide), not immediately after peak ebb.

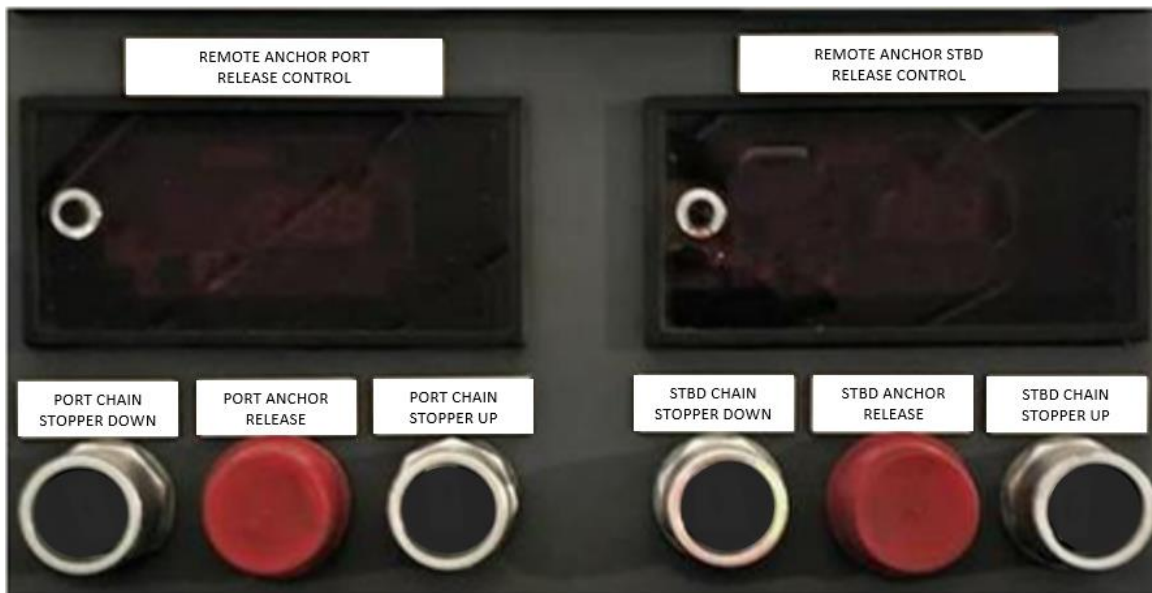
The anchors on the *Spirit of Vancouver Island* can be released remotely from the wheelhouse (Figure 6). This capability is particularly useful during emergencies, as it allows the anchors to be released quickly without having to manually operate the windlasses.

The process to release an anchor remotely involves 2 steps. First, the CHAIN STOPPER UP button, which raises the chain stopper that secures the anchor while at sea, needs to be pressed. Second, the ANCHOR RELEASE button needs to be pressed and held until the anchor releases and the required amount of chain pays out.<sup>16</sup> There is a delay of 4 to 6 seconds before the anchor starts to deploy, during which the anchor brake is remotely disengaging. At the time of the occurrence, there were no labels or instructions on the control panel to notify operators of this delay.

Figure 6. Remote release controls for the anchors (Source: BC Ferries, with TSB annotations)

On the day of the occurrence, the chain stoppers for both anchors had been raised remotely as part of the pre-arrival checks. In the final moments before the striking, the master instructed the chief officer to release the port anchor and, when it did not release, to release both anchors. The investigation could not determine how long the release buttons were pressed or why the anchors did not release. When tested by the crew after the occurrence, the remote anchor release for each anchor worked successfully. Subsequent testing of the anchors on 05 May 2020 identified an issue with overtightening of the anchor brakes, which may affect their operation. The senior master issued a directive<sup>17</sup> providing instructions to crew about securing the anchor brakes after operation.

- The anchor documentation and training manual were updated to clarify the anchor release method and all crews have been practicing proper stowage of the anchors on board Spirit-class vessels.

- Instructions on the remote release of the anchors were posted.
