# Marine Transportation Safety Investigation Report M20A0258

## SINKING AND LOSS OF LIFE

Unnamed fishing vessel

28 July 2020

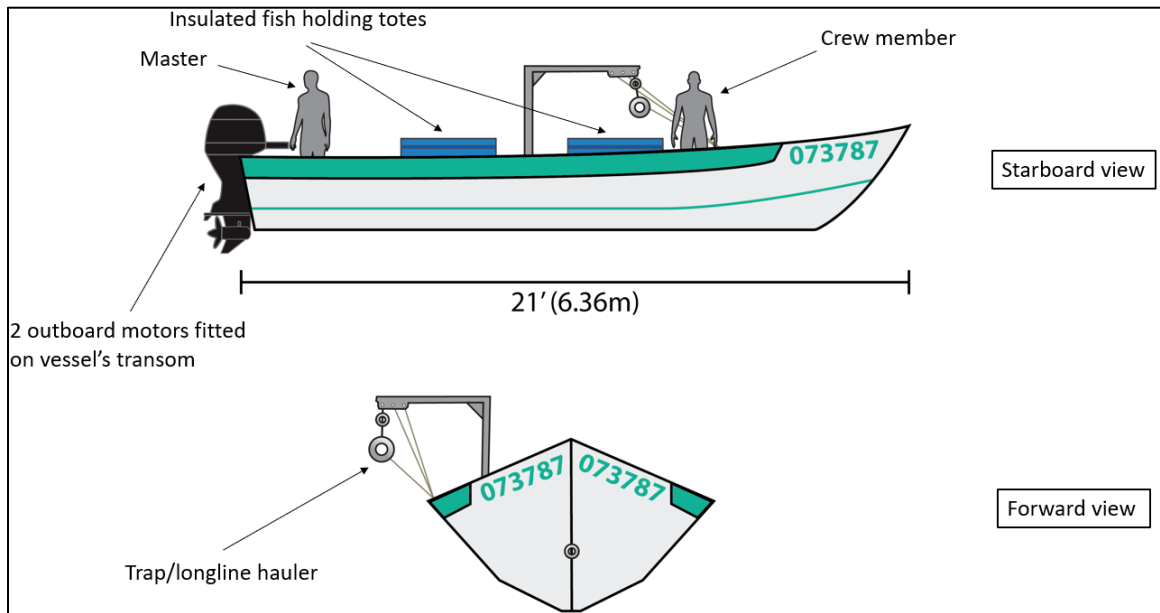
The occurrence vessel was a fibreglass fishing vessel of open construction that was 6.36 m long with a flat bottom (Figure 1). The vessel was powered by 2 gasoline outboard motors (60 hp/4-stroke and 50 hp/2-stroke) and had a trap/longline hauler located amidships. The vessel was carrying 2 insulated fish totes with tie-down lids. The unnamed vessel was not registered with Transport Canada (TC), but was registered with Fisheries and Oceans Canada (vessel registration number 73787).

Figure 1. Diagram of the occurrence vessel, showing on-board equipment and position of the master and crew member at the time of the occurrence (Source: TSB)

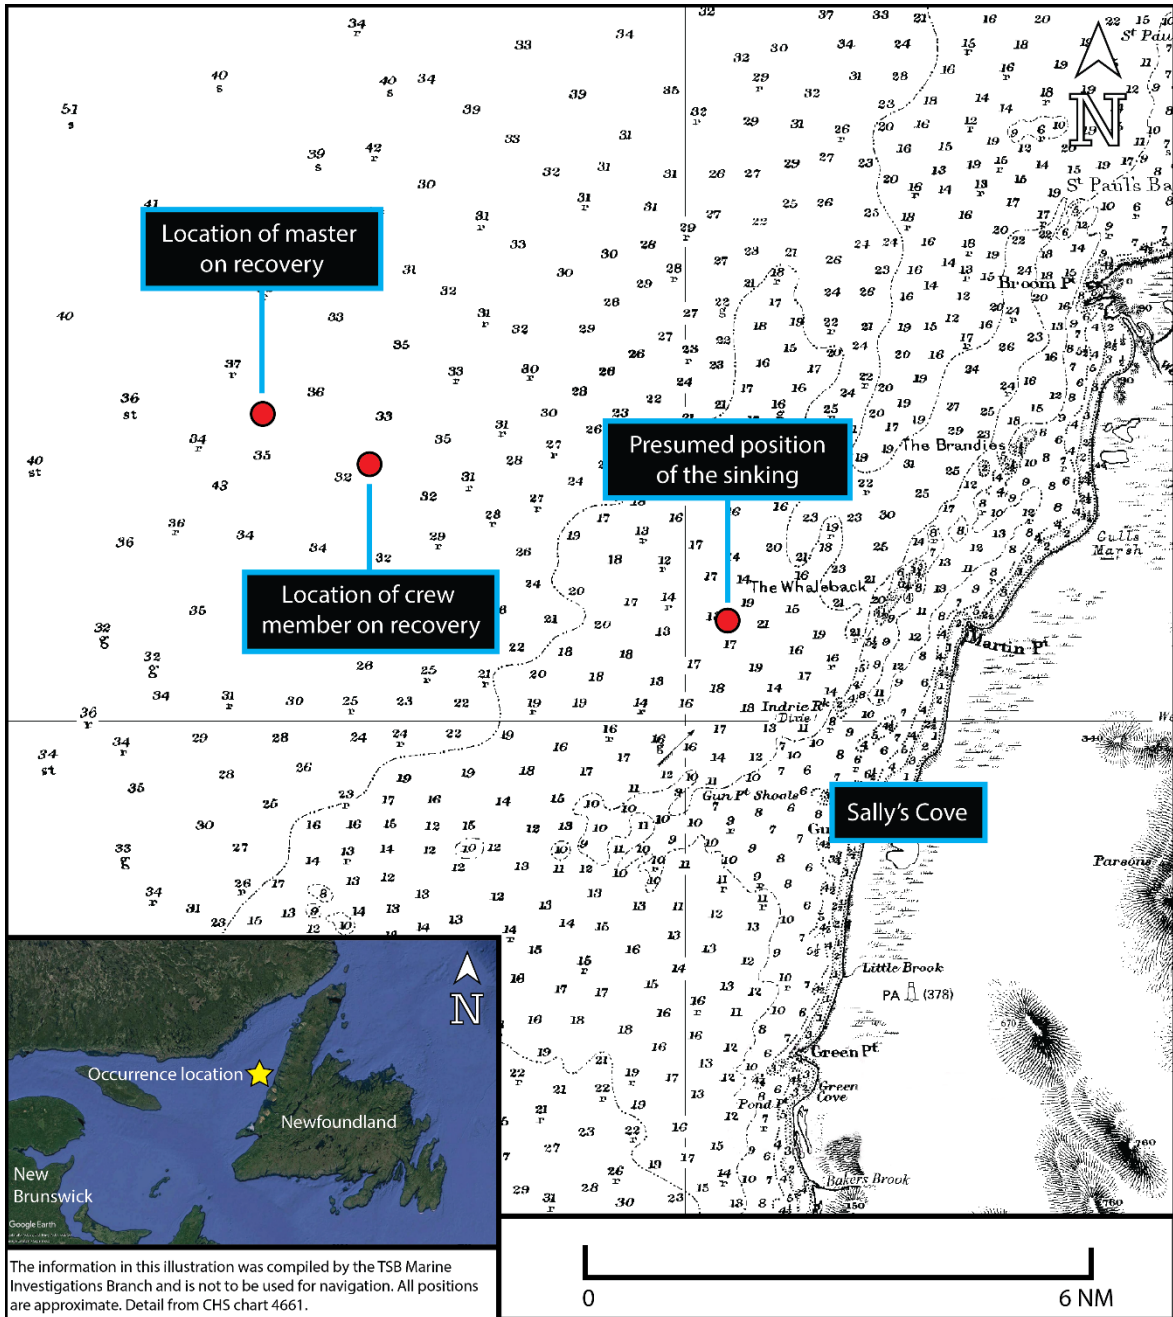
A large wave swamped the stern. The master immediately started the bilge pump and the 60 hp motor, and then attempted to turn the vessel's bow into the waves, but was unsuccessful. The incoming waves flooded the vessel and it sank rapidly by the stern in presumed position 49°46.20' N, 057°59.20' W (Figure 2). Once in the water, the crew member, who was wearing a personal flotation device (PFD), held on to a portable gasoline container. The master, who was not wearing a PFD, held on to the lid of one of the fish totes by inserting his wrist through the rubber tie-down strap. The crew member attempted to use his cellphone to call for help but the device, which had been underwater, failed to activate. After a few hours, the master and crew member drifted apart and lost sight of each other.

Figure 2. Chart of the occurrence area indicating the presumed position of the sinking and where the master and crew member were recovered (Source of main image: Canadian Hydrographic Service, Chart 4661. Source of inset image: Google Earth, with TSB annotations)
