Transportation  
Safety Board  
of Canada

# Pipeline Transportation Safety Investigation Report P20H0023

## RELEASE OF CRUDE OIL INCIDENT

Trans Mountain Pipeline ULC  
Sumas Pump Station  
Abbotsford, British Columbia  
12 June 2020

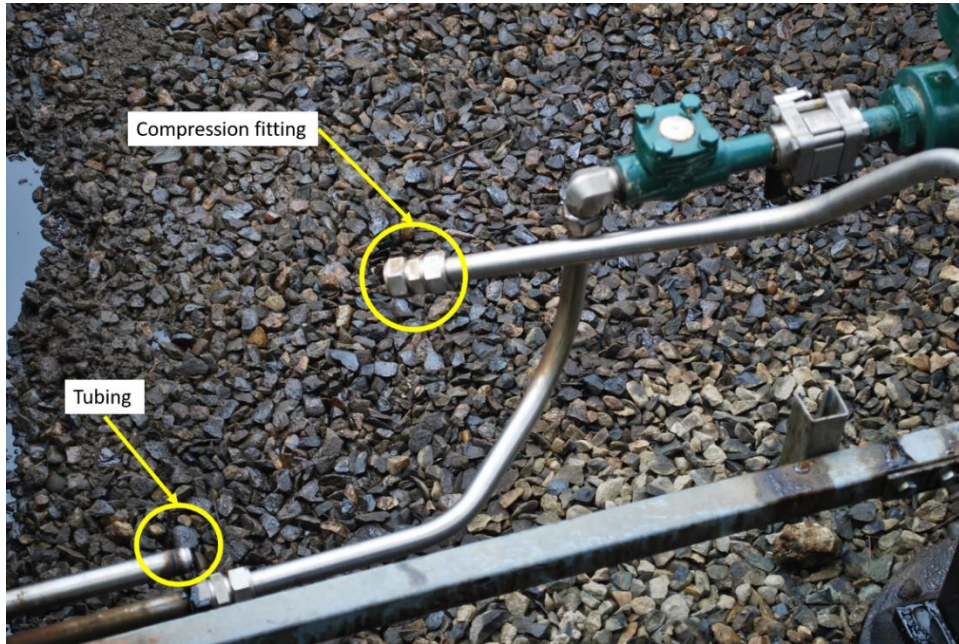
Figure 2. Occurrence compression fitting (Source: TSB)

The crude oil released from a 1-inch compression fitting that had separated from tubing on a section of above-ground piping adjacent to the building that houses the equation-of-state (EOS)<sup>2</sup> system (Figure 2).<sup>3</sup> The failed compression fitting was used to join tubing from the discharge mainline to the EOS system.

In this occurrence, the tube had pulled free from the compression fitting. A preliminary analysis determined that the occurrence tube had marks of progressive sliding between the two ferrules, which suggested insufficient tightening of the compression fitting at the failure location.

The laboratory analysis concluded that the compression fitting failed because of a loss of ferrule grip due to improper tightening during installation.

- Develop a procedure to verify the integrity of the existing tubing systems.
- Develop an internal standard outlining the requirements for the construction and quality assurance of new tubing systems, as well as a procedure for the installation of tubing systems by Trans Mountain personnel.

It is important for pipeline companies to establish standards and procedures that incorporate inspections to ensure that tubing systems are properly installed.

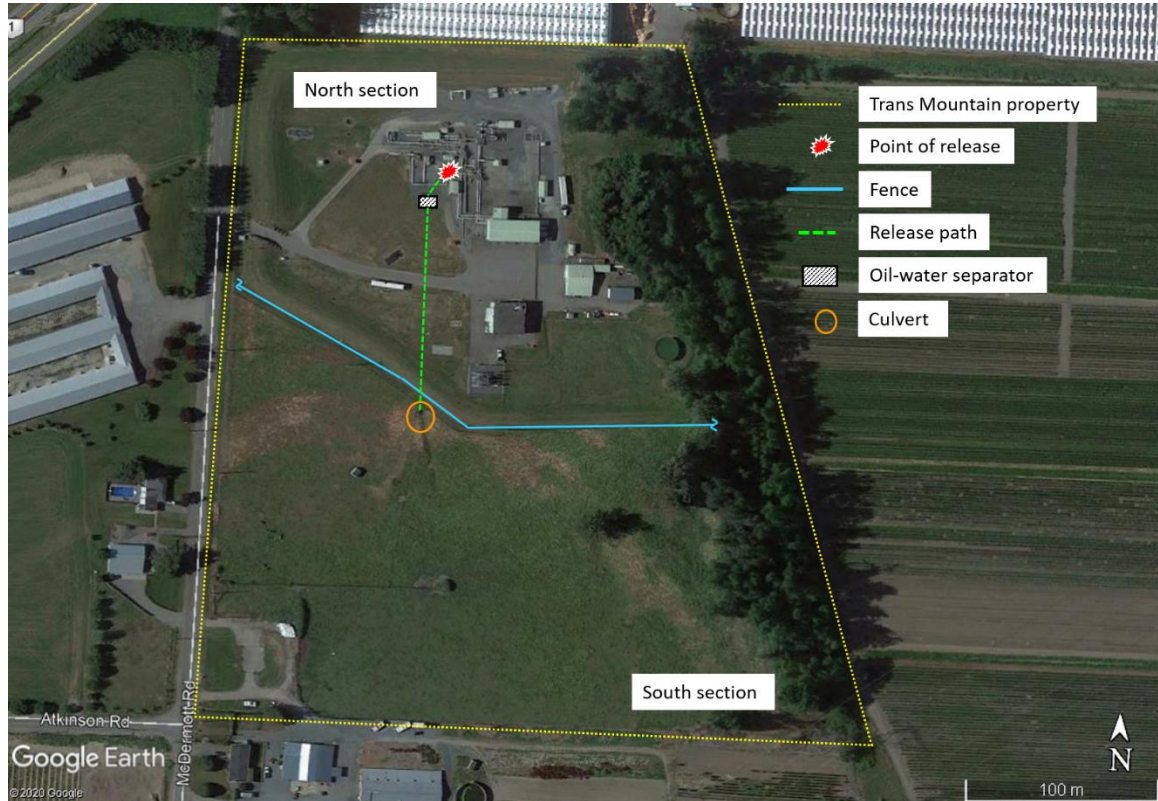
Figure 3. Path of the released oil (Source: Google Earth, with TSB annotations)

From the point of release, the oil had followed a path into the pump station's surface drainage system, through an oil-water separator, and into a culvert that discharges surface water into the south section of the property (Figure 3). As a result, 7 m<sup>3</sup> of the released oil had migrated to the agricultural field in the south section.

In this occurrence, by the time the oil releasing from the EOS system reached the oil-water separator and triggered an alarm at 2342, the Sumas Pump Station was already in emergency shutdown. The oil, which was still flowing from the failure location, continued to accumulate in the separator until it could no longer be trapped effectively.<sup>11</sup>

The separator is not equipped with an automated isolation system, nor does it have manual isolation valves. Therefore, once oil began flowing into the agricultural field, there was no means to stop it until operators could isolate the source of the release on the EOS system.

- Initiate a project, to be completed by summer 2021, to upgrade the Sumas Pump Station, including the installation of:
  - containment and drainage features;

- a new oil-water separator, which will discharge to a new PVC culvert, manhole and collection basin system before ultimately discharging through a final isolation valve; and

- a lined containment area around the station's above-ground piping.

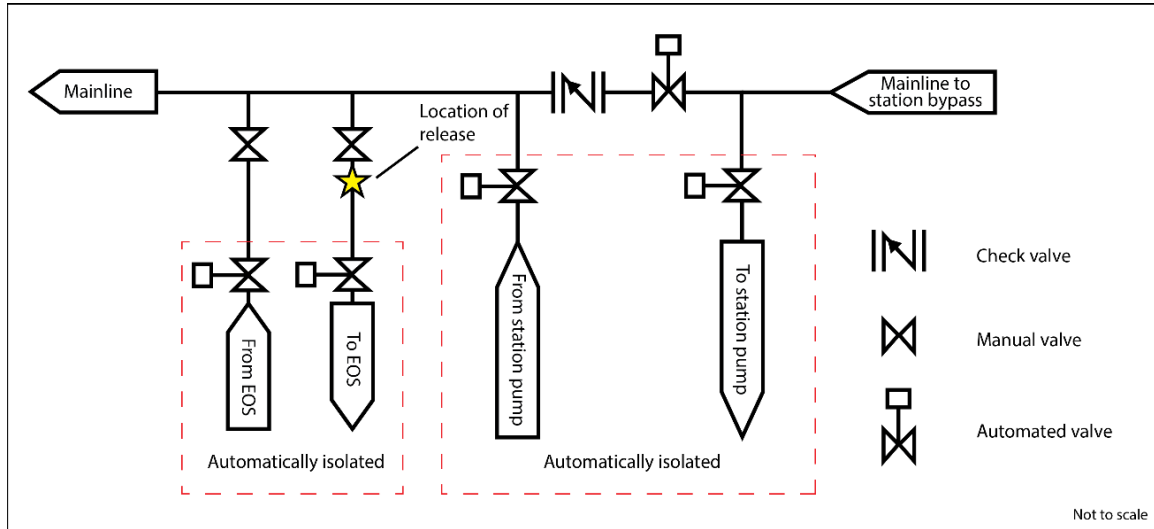
Figure 5. Schematic of bypass valves in an emergency shutdown at the Sumas Pump Station (Source: TSB)

When the combustible gas reached its lower explosive limit of 20% in the pump building, an ESD of the Sumas Pump Station was automatically initiated. In an ESD, the relevant valves are automatically set to allow the flow from the mainline to bypass the station and, once set, they are locked into position.<sup>9</sup>

The ESD procedure isolated the EOS system building by closing the automatic valves at the inlet and outlet tubing of the building. However, the compression fitting that failed in this occurrence was in a section of above-ground tubing between the building and the station bypass line. The valves required to isolate this section of tubing were manual valves, and therefore were not part of the automatic shutdown sequencing (Figure 5). They remained open, allowing the product to continue to release from the failed compression fitting. To stop the release, the valves for that section of EOS system tubing had to be closed by hand, which Trans Mountain personnel did when it was safe to enter the site, approximately 5 hours after the CCO received the initial alarm.

- Add an automated isolation valve on the inlet of the EOS tubing system and a check valve on the outlet.
- Reconfigure the ESD logic to allow select automated valves to be actuated remotely after an ESD.
