Environmental Screening Follow-up Report

FRASER RIVER FLOOD CONTROL PROJECT No.19

**Nicomen Island Bank Protection
Quaamitch Slough**

September , 1985

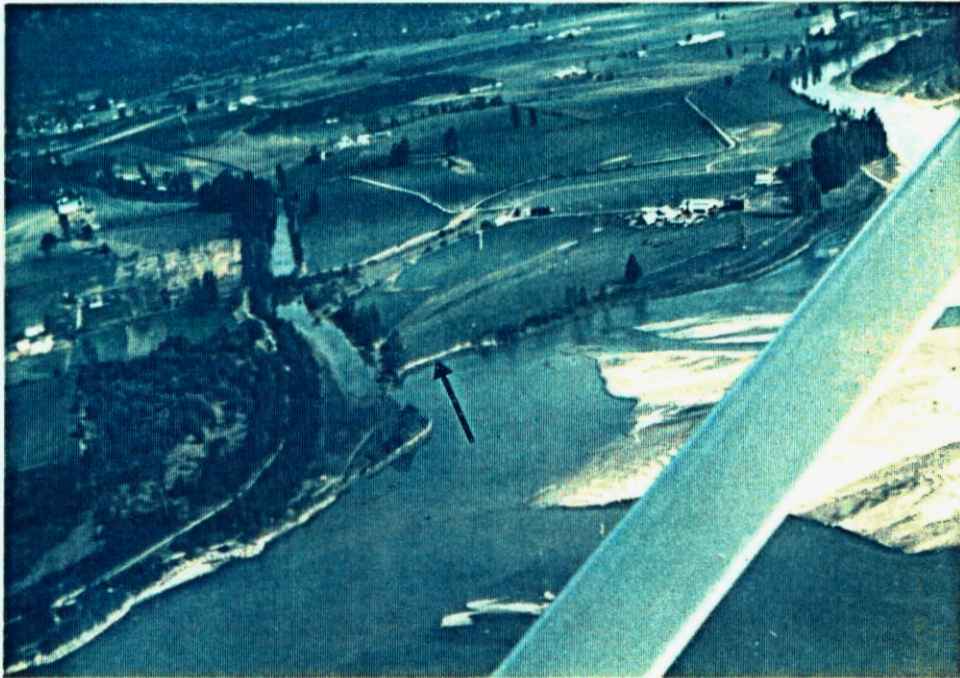
Aerial views of the project area are shown in Plates 1 to 3 of Attachment 3 and illustrate the erosion problem, its proximity to the existing dyke, and the flow pattern of the Fraser River in the area. In particular, Plate 3 shows the scouring activity of the river and the breaching of the Slough as evident by the discontinuation of a line of trees and shrubs on the south side of the Slough. A close-up photo of this breach taken on March 7, 1985 is shown in Plate 4 and it illustrates the progressing erosion as noted by the eroding channel into the mud flat of the Slough.

Plate 1 Aerial view of Quaamitch Slough and the overbank erosion problem (arrow), looking north above the Fraser River (September 19, 1984 with Fraser River discharge at Hope of $2480 \text{ m}^3/\text{s}$).

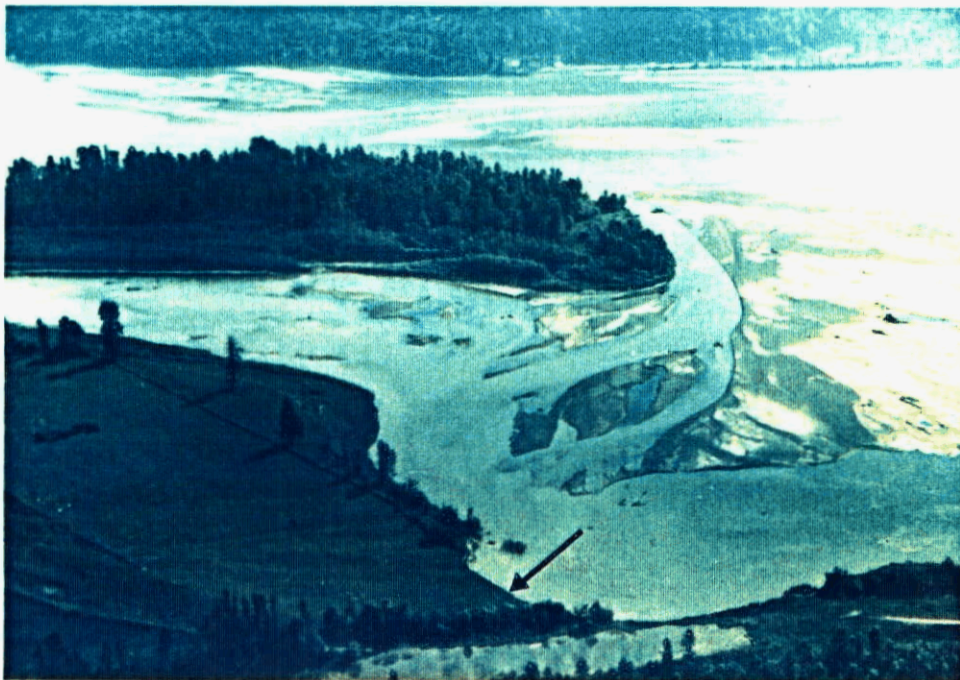
Plate 2 Aerial view of overbank erosion (arrow) near mouth of Quaamitch Slough. Note the flow pattern of the Fraser River in the erosion area (September 19, 1984).

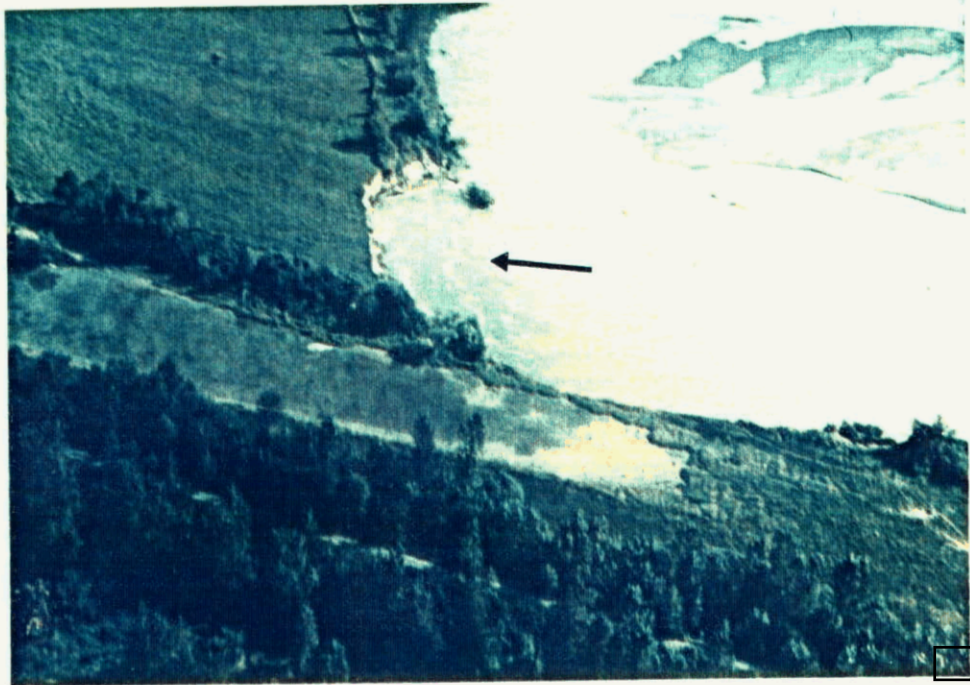
Plate 3 Close-up of the overbank erosion (arrow) near the mouth of Quaamitch Slough (September 19, 1984).

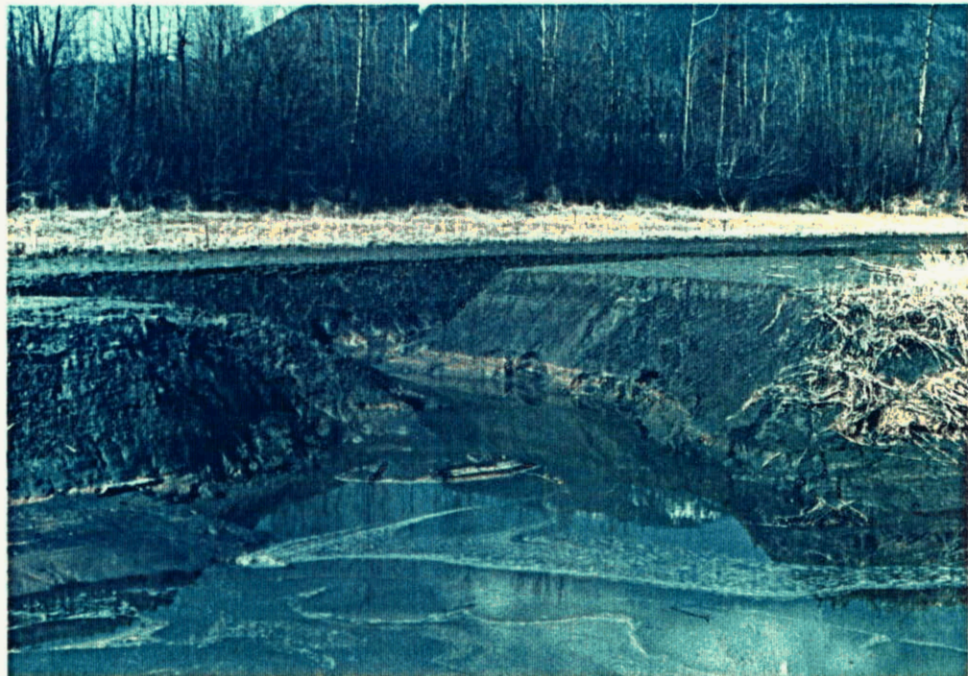
Plate 4 Close-up of the eroding channel cutting into Quaamitch Slough (March 7, 1985 with Fraser River discharge at Hope of $782 \text{ m}^3/\text{s}$). The flood control dyke is immediately behind the background row of trees.

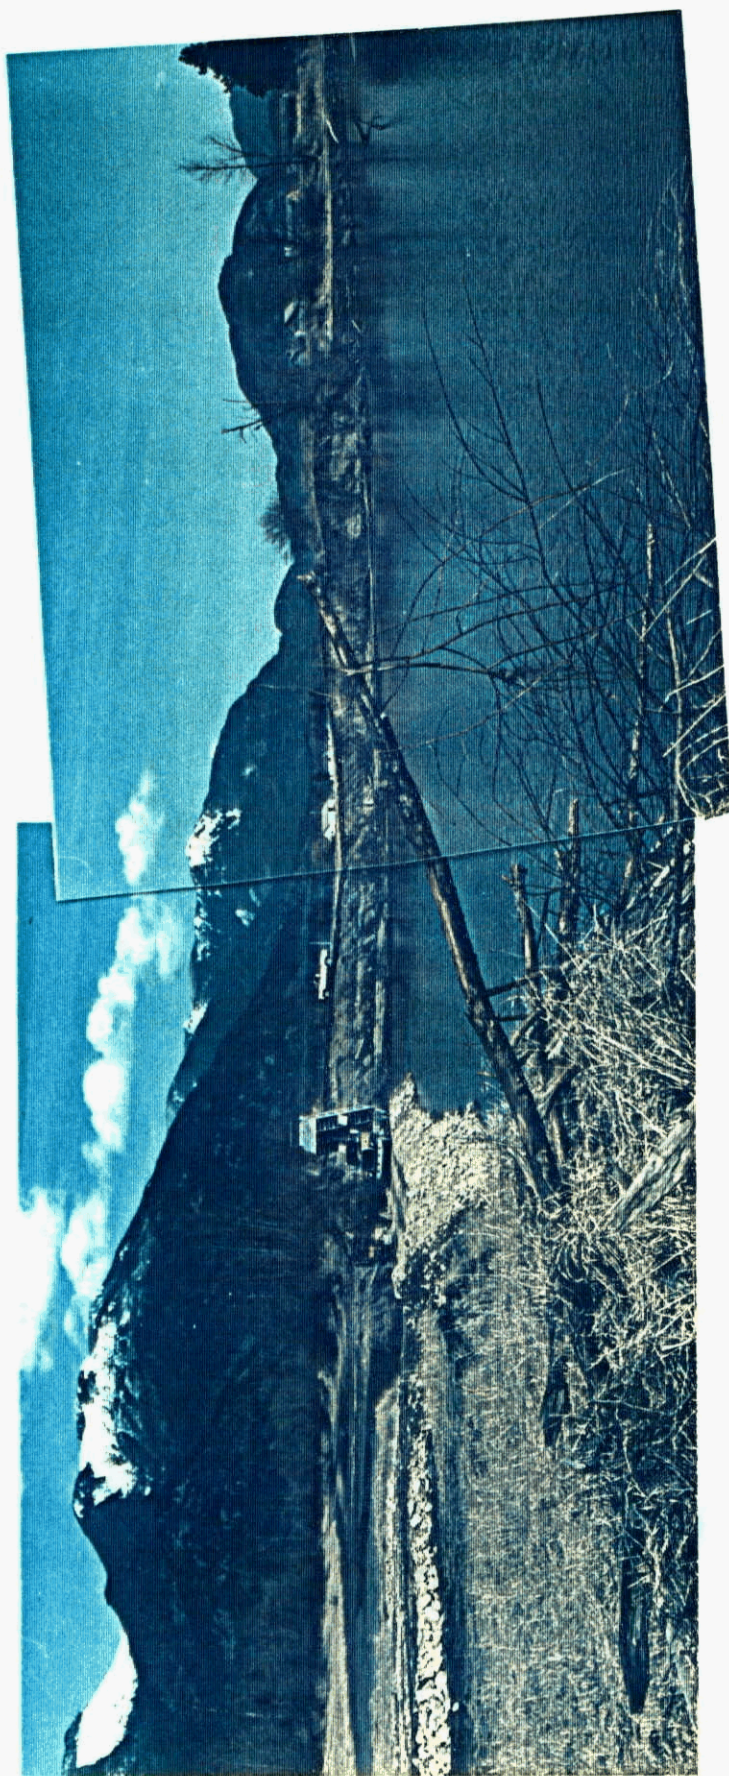
The project area was first visited on March 7, 1985 with construction well underway (Plate 5). The bank protection was started from the downstream end of the project area with end dumping of quarry tailings in an upstream direction across the scour hole. The decision to start from the downstream end was for logistic and cost factors. The existing dyke provided direct access to the downstream end of the project while the upstream end, preferred by DFO, would have required building of an access road across some private property. This also would have resulted in added cost and possible undesirable construction delays as the project had to be completed before the spring freshet. Subsequent discussions with DFO regional office lead to agreement on the change provided that any fish in the impoundment area had an escape route before the area was sealed off from the river. In conformance with this recommendation the impoundment behind the newly placed bank protection works (Plate 6) was also back-filled from the downstream end and moved upstream to allow water and any fish species to escape via the upstream end of the impoundment.

Plate 5 View of Quaaamitch Slough (left) and the start of the bank protection works looking north from the western end of project area (March 7, 1985 with Fraser River discharge at Hope of $782 \text{ m}^3/\text{s}$).

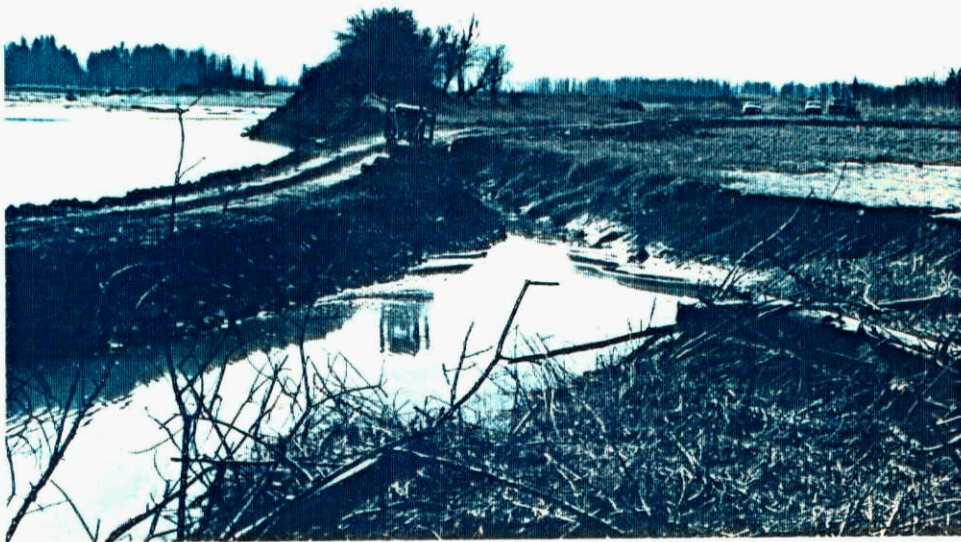
Plates 6 to 9 illustrate back-filling of the impoundment area during and at the end of the construction period. The elevation of the fill immediately adjacent to the Slough was level or slightly higher than the Slough (Plate 8), while the area adjacent to the eroded overbank was raised to elevation of 4.8 m (Plate 9), thus ensuring self draining of the impoundment area to the Slough.

Plate 6 View of the impoundment area remaining between the bank protection work alignment and the eroded overbank, looking south from the eroded overbank on March 7, 1985.

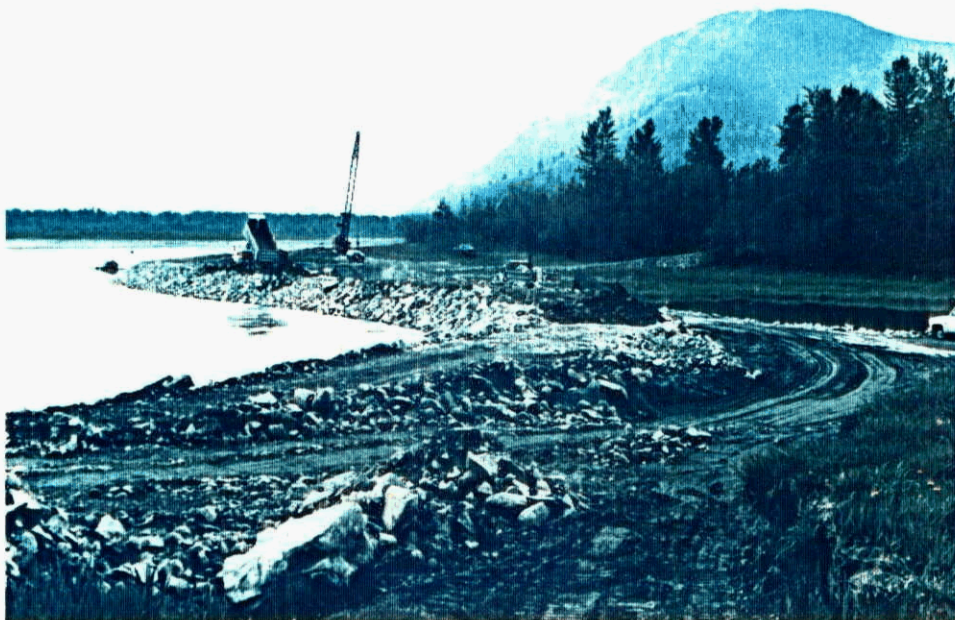
Plate 7 View of the back-filled impoundment area on May 2, 1985 when the Fraser River at Hope was at 2170 m³/s discharge. Note the higher ground elevation of the impoundment area relative to the Slough.

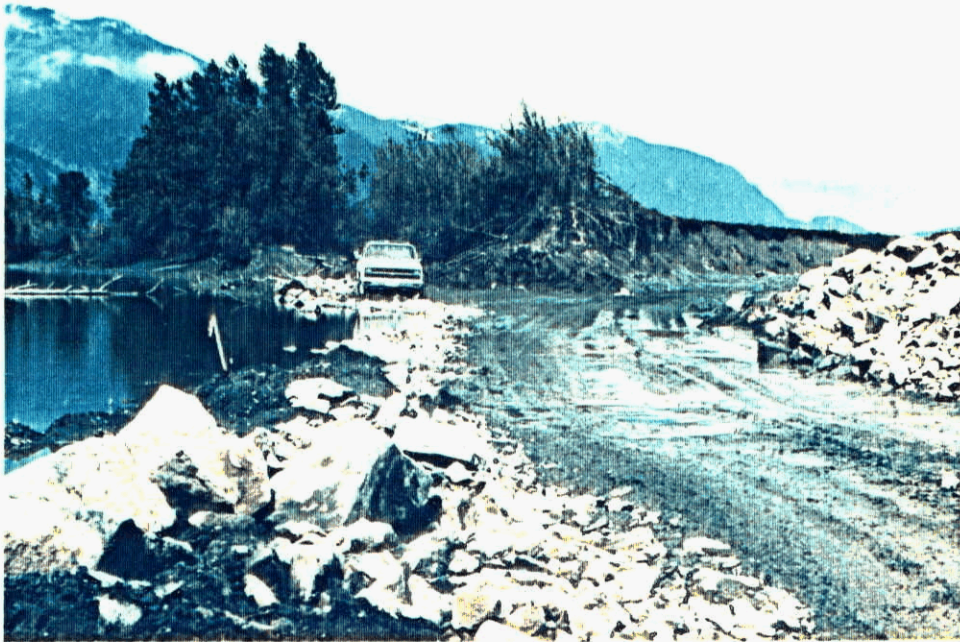
Plate 8 Backfilled impoundment area on May 2, 1985 viewed from the mouth of Quaamitch Slough and looking north.

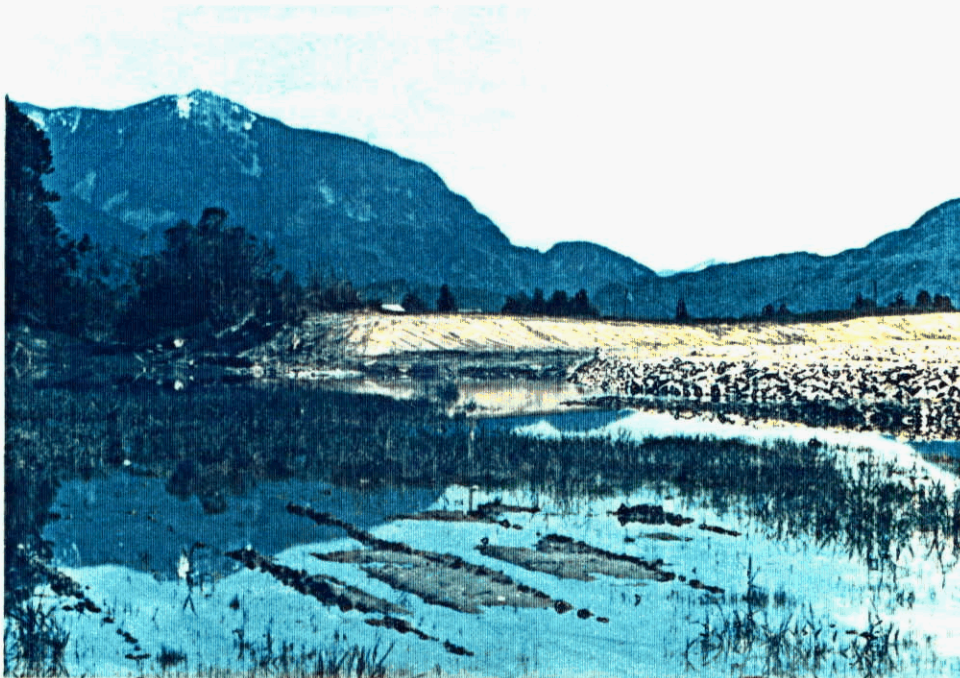
Plate 9 View of backfilled impoundment area at termination of construction, looking north from the Slough on May 17, 1985 when Fraser River discharge at Hope was $4010\text{m}^3/\text{s}$. The new elevation of the impoundment area adjacent to previously eroding overbank ensures self drainage to the Slough. Note the Slough is being filled with back-up water from Fraser River.

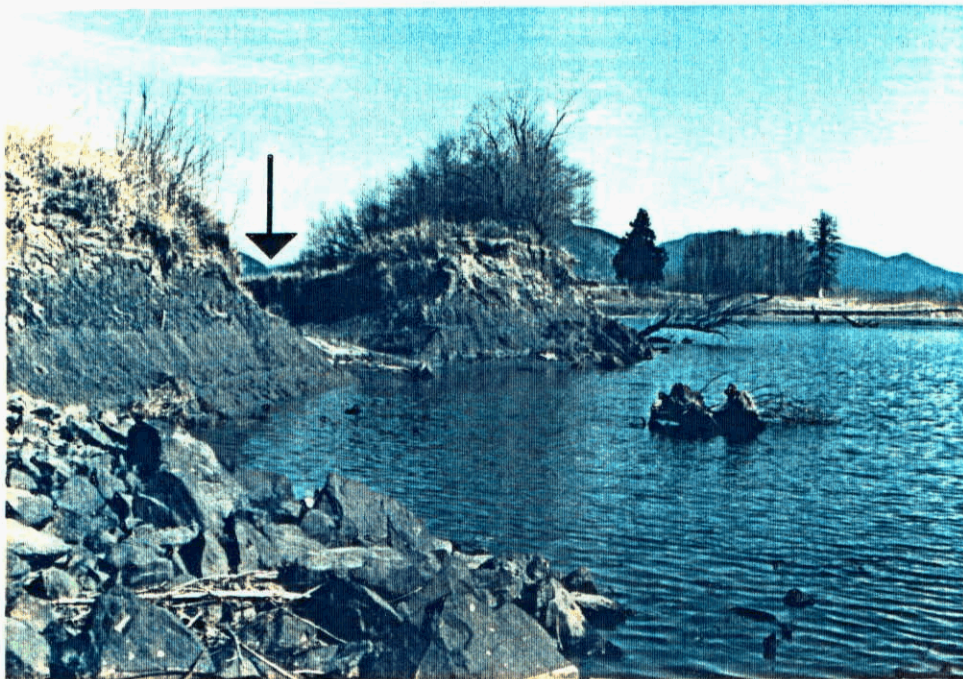
The normal outlet of Quaamitch Slough before and after construction is shown in Plates 10 to 13. The overbank on either side of the mouth of the outlet was excavated to elevation 4.8 and rip-rapped with 1 m minus quarried rock. A portion of the channel immediately upstream of the mouth was also protected but with smaller rocks of approximately 0.5 m or less. This channel connecting the Slough and the river was dredged with a back-hoe starting at elevation of approximately 3.0 m at the Slough (Plate 12) and sloped gently by 0.5 m to the mouth thus allowing freeflow for receding waters.

Plate 10 Outlet of Quaamitch Slough (arrow) prior to construction, on March 7, 1985 with Fraser River discharge at Hope of $782 \text{ m}^3/\text{s}$.

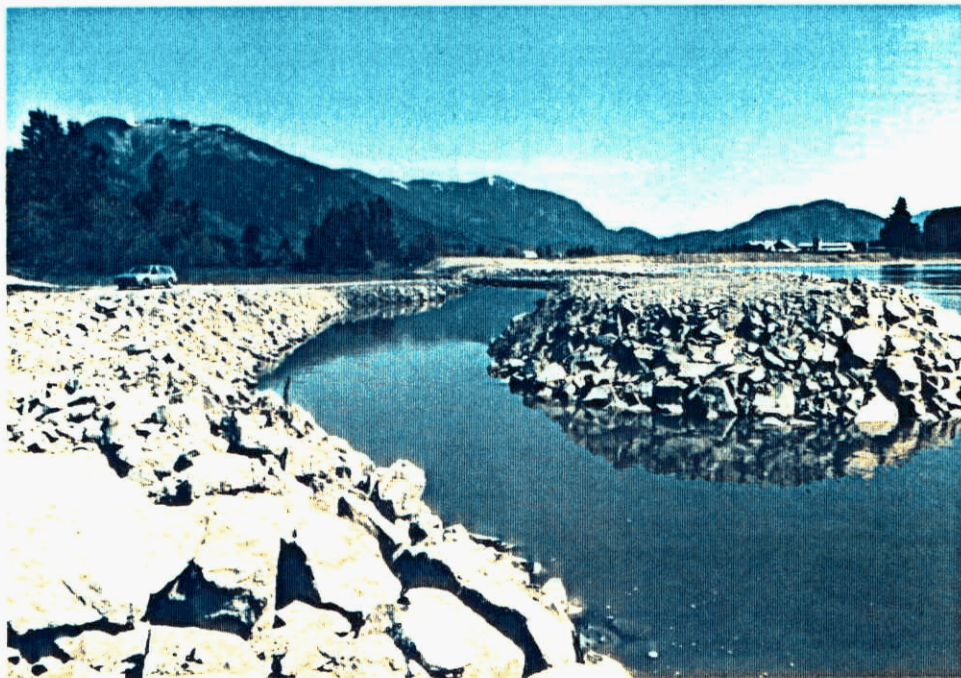
Plate 11 Outlet of Quaamitch Slough at the termination of construction on May 17, 1985 with Fraser River discharge at Hope of $4010 \text{ m}^3/\text{s}$. Note the rip-rap protection of the outlet and the dredged channel connection to the Slough.

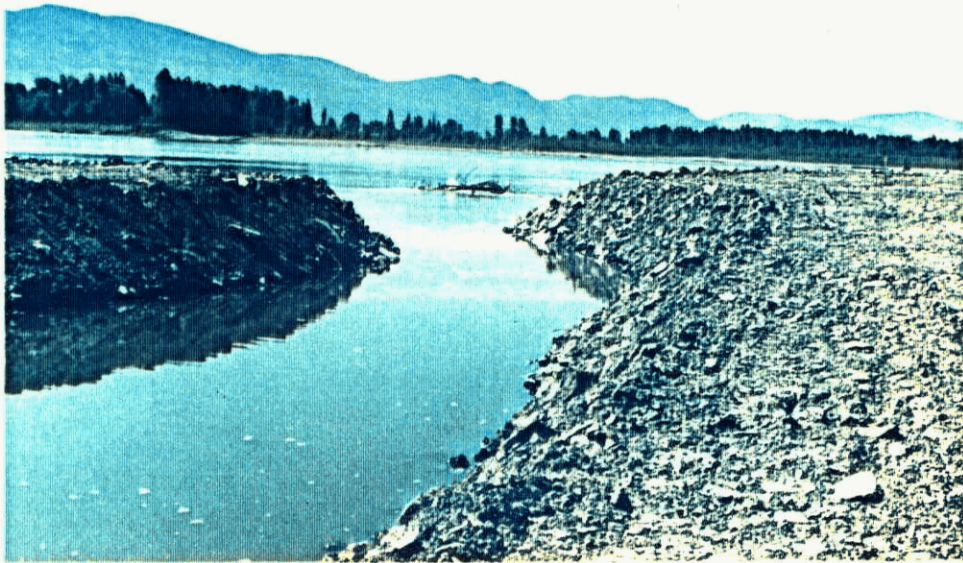
Plate 12 Looking south at the dredged outlet connection of the Slough to the river after project completion (May 17, 1985).

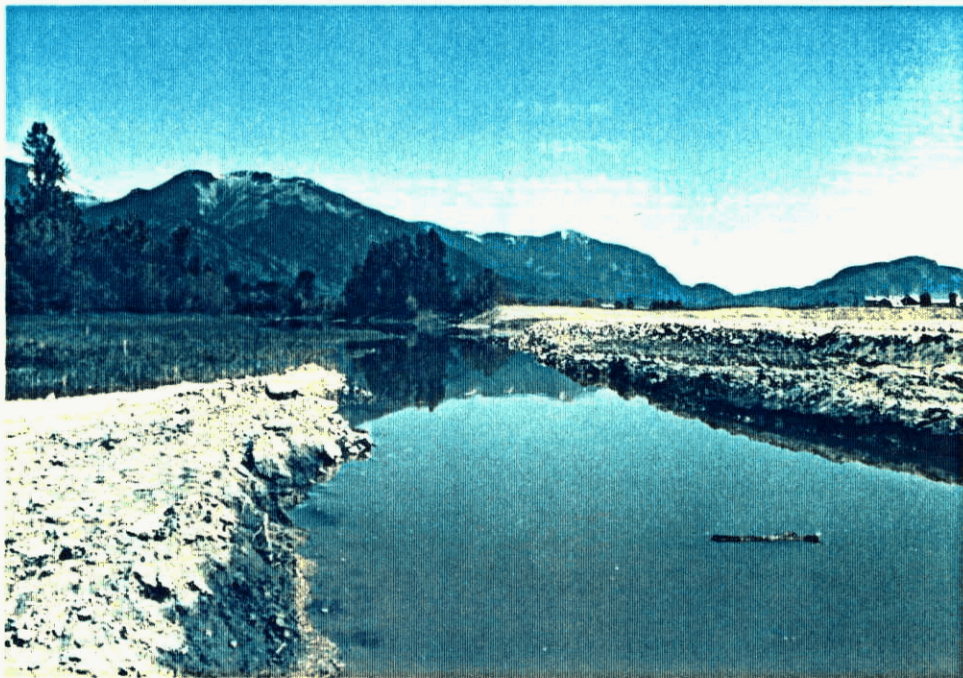
Plate 13 Looking north at the dredged outlet of the Slough to the Fraser River, after project completion (May 17, 1985).

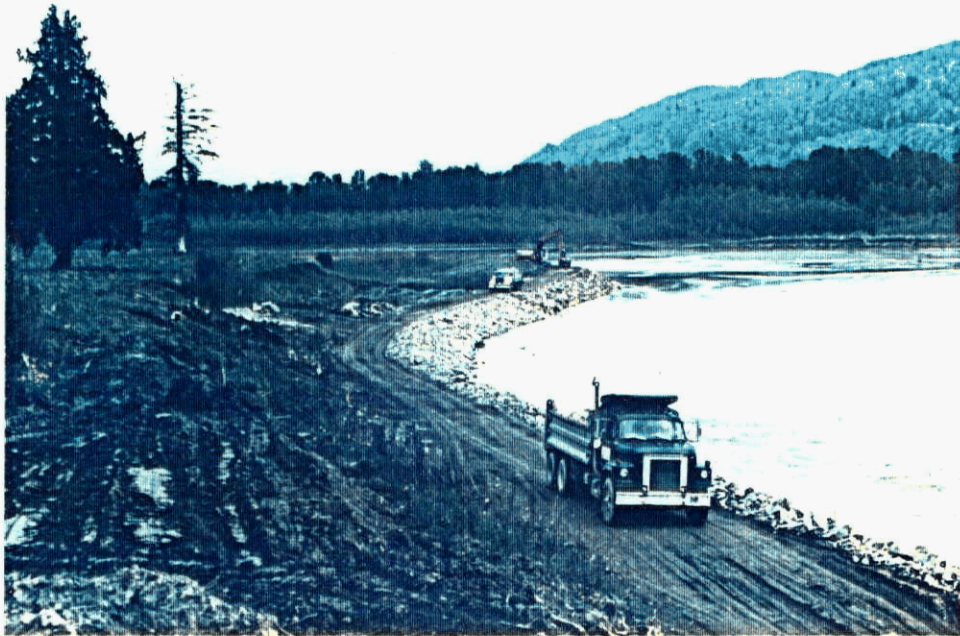
1. The bank protection alignment on the eastern end of the project was extended further upstream of that which is shown on the design plan of Attachment 2 (ie. the extension is shown by a broken line on the plan). It was extended to an area slightly above the convergence of the two side channels of the river (Plate 14). This decision was made during construction as overbank erosion in that area became evident (Plate 15). However, this additional construction did not raise any additional environmental concerns.

Plate 14 Looking west on the extension of the eastern end of the project area. Note the extension is visible by a difference in the shade of riprap (May 2, 1985).

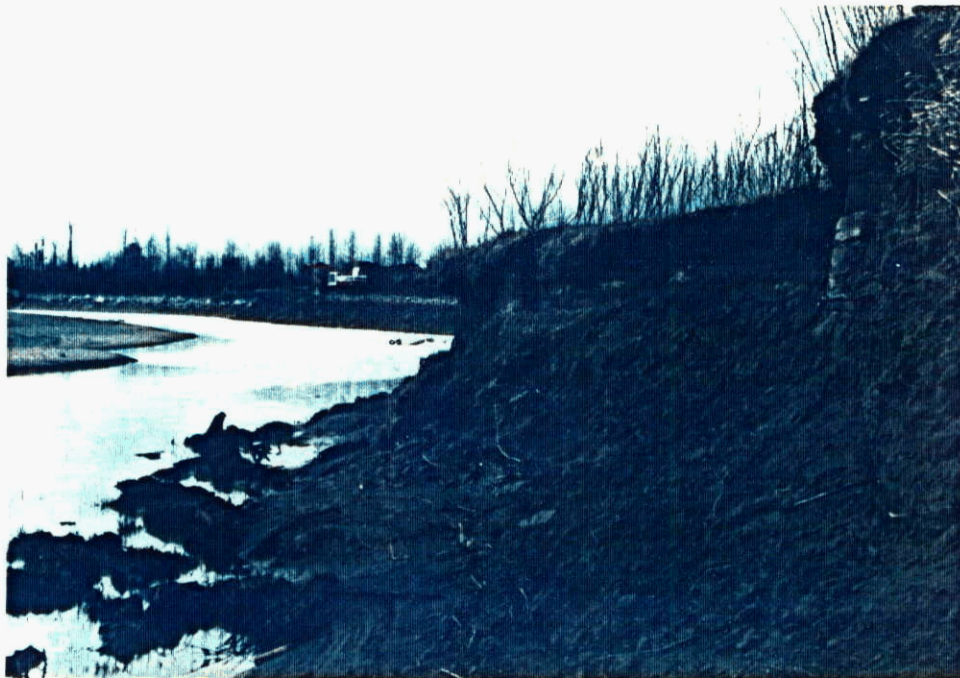
Plate 15 Overbank erosion of eastern end of project area prior to extension of the bank protection alignment (March 29, 1985).

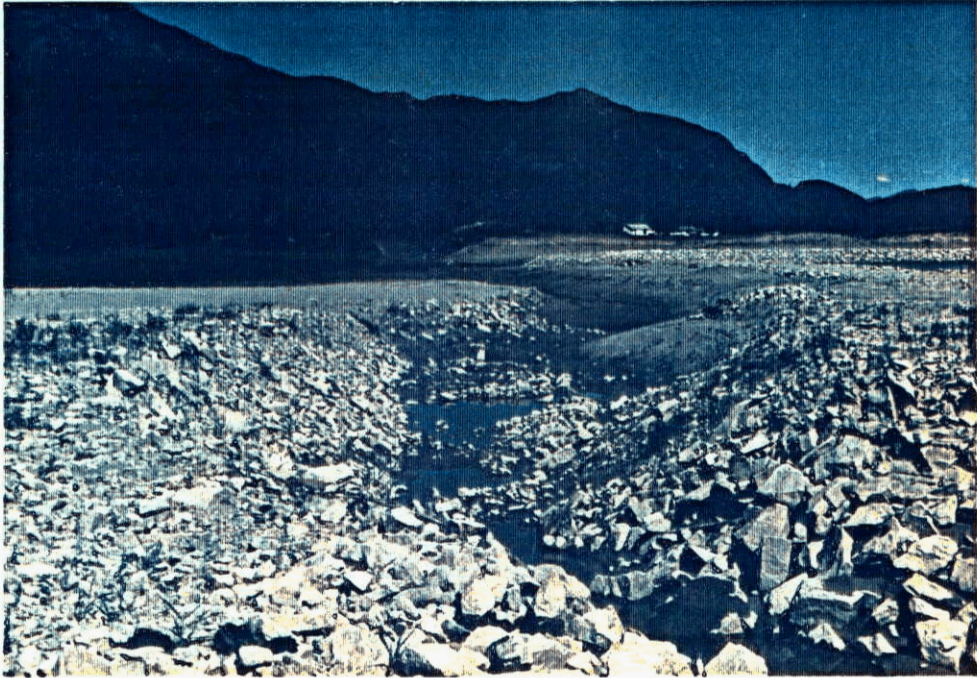
preliminary screening were conformed with and implemented in the construction of the protective works. However, as the protective works were designed to be topped during an average freshet and it was topped during this June, 1985 spring freshet, the project area was visited once the spring flood waters had receded to ensure that the mitigation was effective. Of particular concern was that no pools or depressions capable of trapping fish had been left over the impoundment area or in the dredged channel. Following the receding of flood waters these areas were found to have drained satisfactorily (Plates 16 and 17).

Plate 16 Outlet of Quaamitch Slough after the receding of spring freshet waters, August 16, 1985.

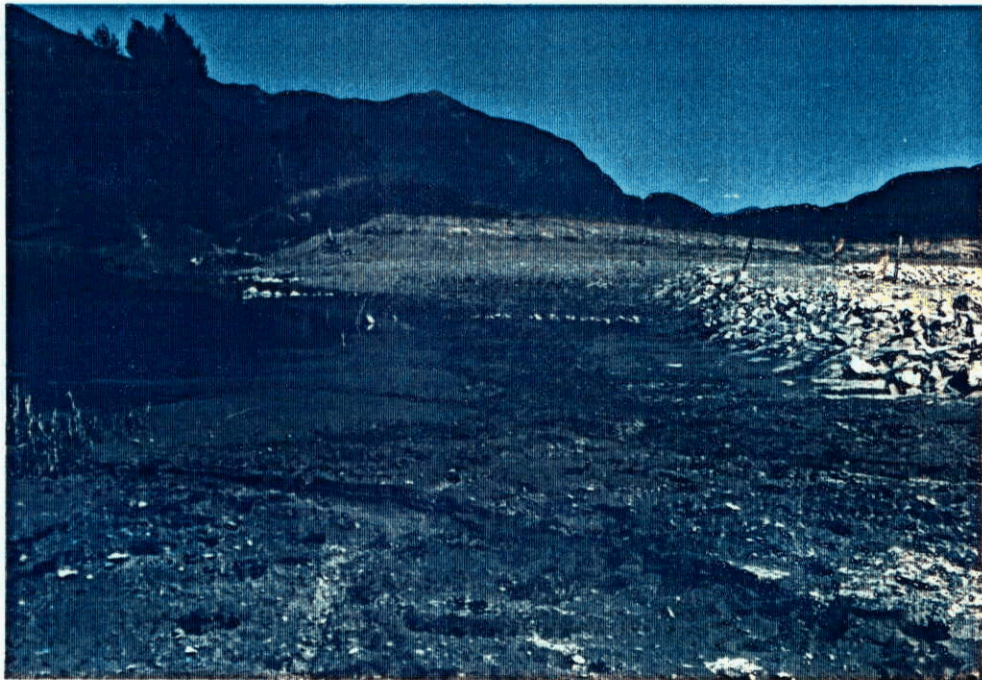
Plate 17 Looking north on the backfilled impoundment area after the receding of spring freshet waters, August, 16, 1985.
