**TILBURY SLOUGH
DYKE RECONSTRUCTION PROJECT**

*Construction and Post Construction
Environmental Impact Assessment*

R.N. NEUMEYER & V.G. BARTNIK

MARCH, 1981

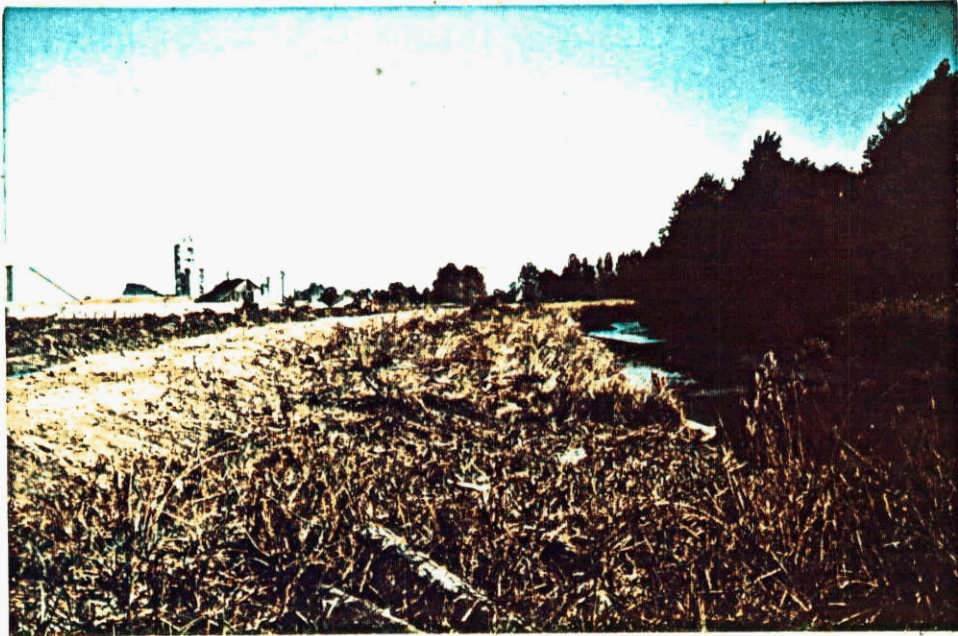
PRINT 1

Early stage of dyke reconstruction. Surface debris has been scraped from sloping face of existing dyke. This material is visible on top of the dyke where it will form part of new fill. Tilbury Slough is seen on the right (location D figure 5, October, 1979).

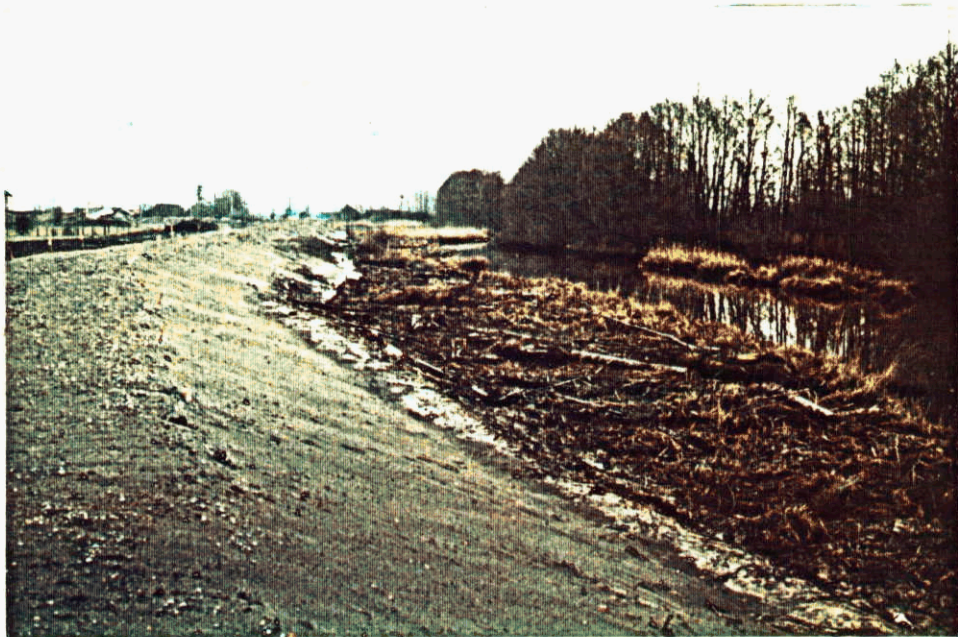
PRINT 2

Later stage of dyke reconstruction. Sand added to raise the dyke is visible. Note that this new fill has not encroached upon the slough (location D figure 5, January 1980).

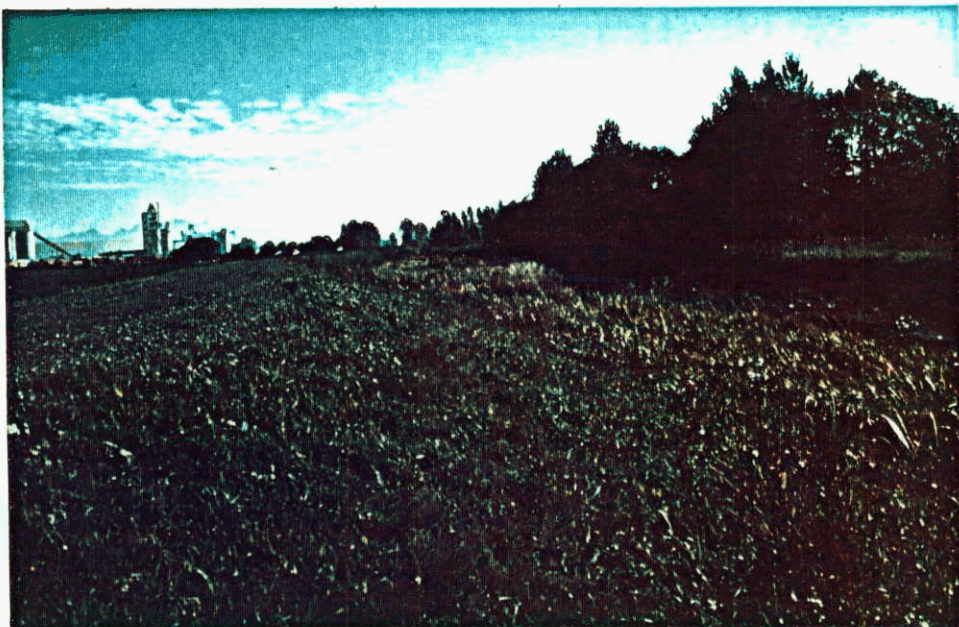
PRINT 3

Completed dyke reconstruction. Reseeding has successfully produced a vigorous plant community above high water (location D figure 5, October 1980).

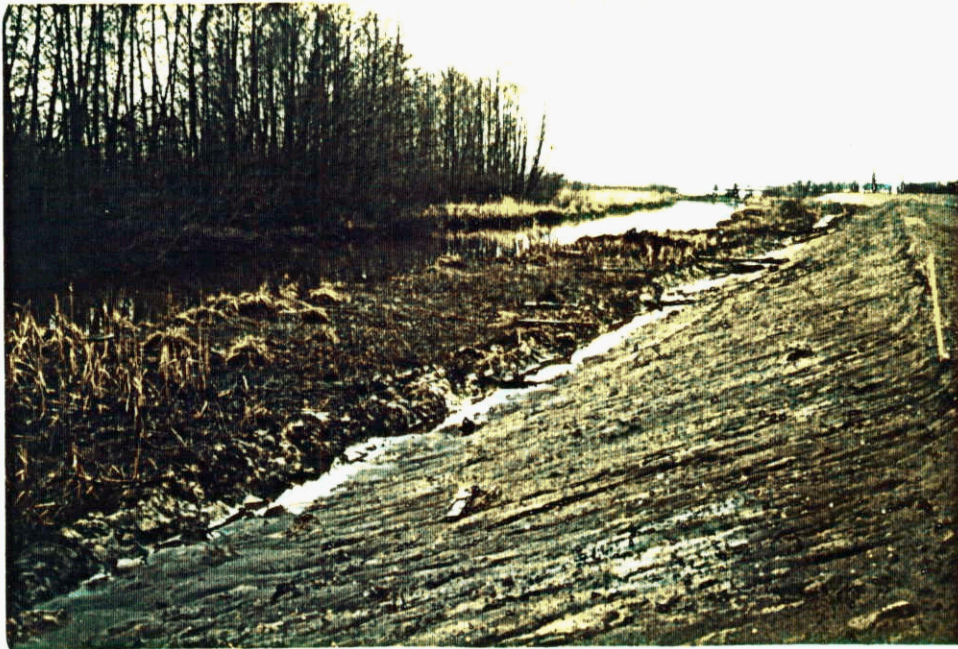
PRINT 4

Face of reconstructed dyke before reseeding, note slough-dyke boundary (location E figure 5, January 1980).

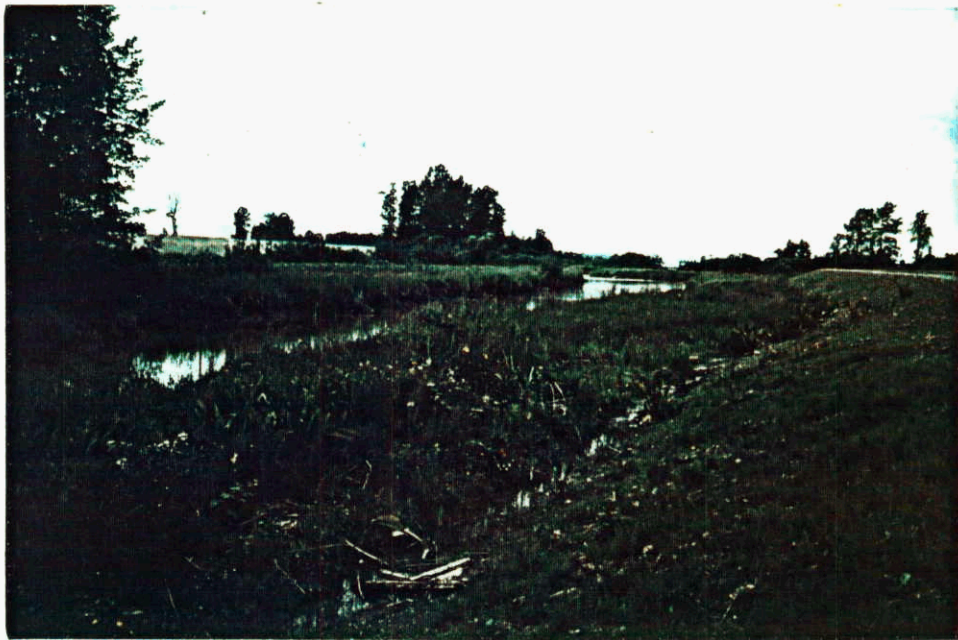
PRINT 5

Early stage of plant growth after reseeding. B.C.D.C. landfill is visible in the upper left of photo (location F figure 5, June 1980).

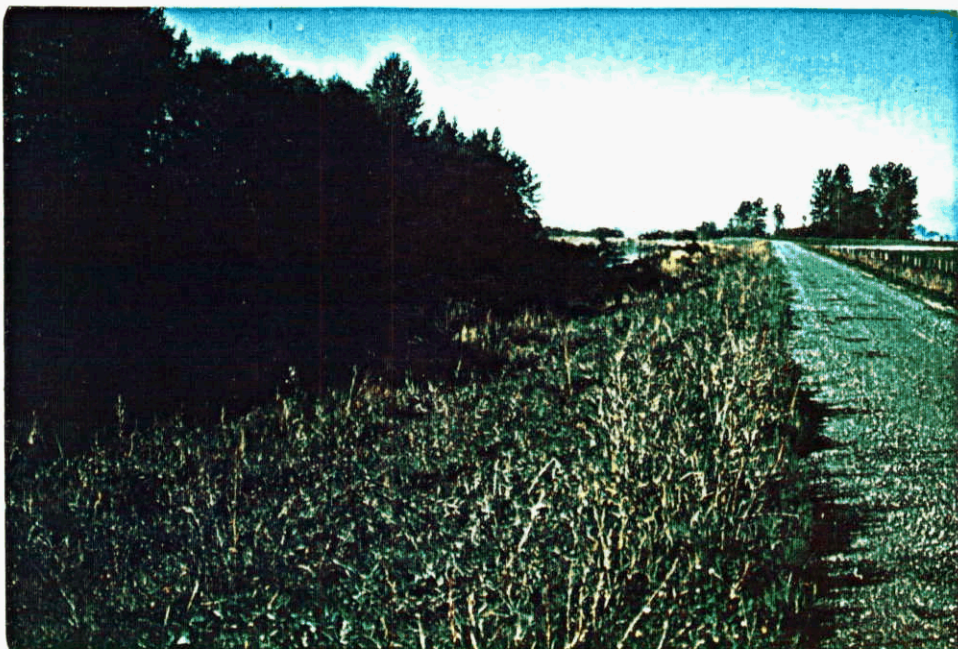
PRINT 6

Project has been completed and vigorous grass-legume community is now evident along the dyke face bordering the slough (location E figure 5, October 1980).

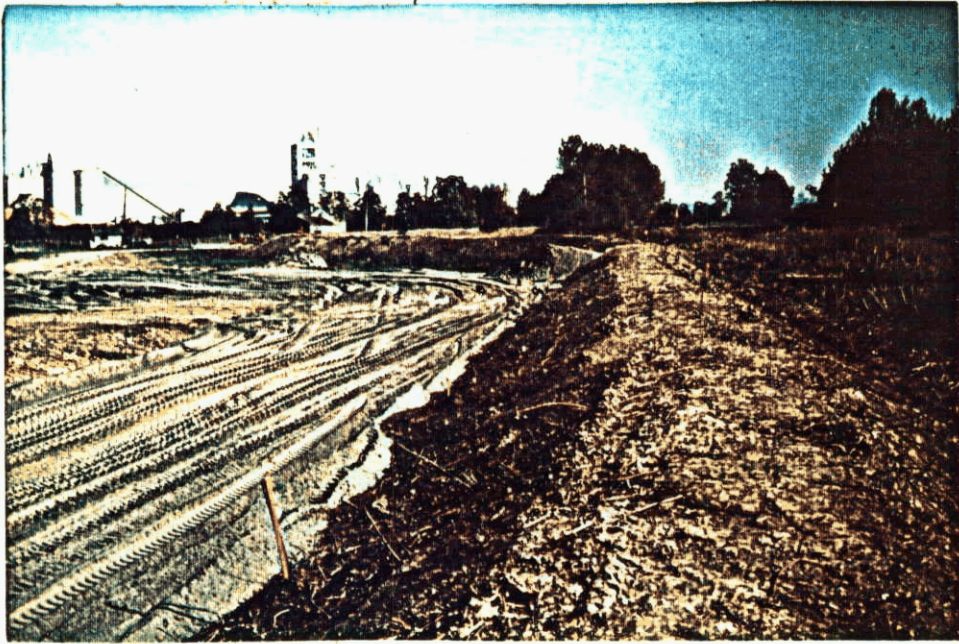
PRINT 7

Early stage of construction with the inland work easement visible as a tire tracked sand area to the left of the existing dyke (location B figure 5, October 1979).

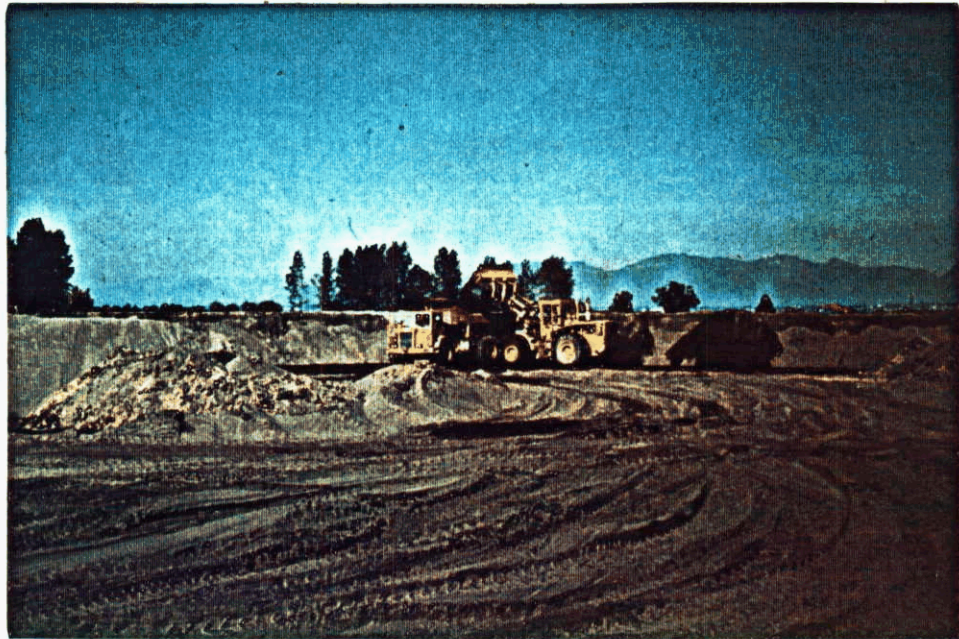
PRINT 8

Sand stockpile located on pasture area inland of dyke (location C figure 5, October 1979).

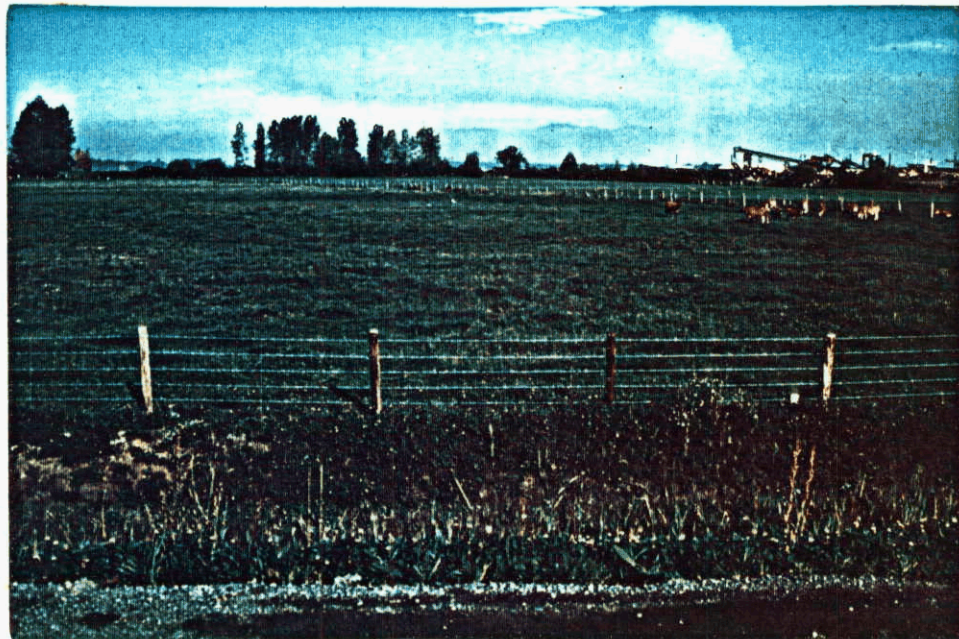
PRINT 9

In addition, an application has been made to preload the agricultural land north of the slough with dredged river sand. This property, which is shown in Print 9, comprises the western tip of Tilbury Island and is now protected from flooding by the Project alignment. Once preloaded, this property north of the slough will also likely support some type of industrial development.

The sand stock pile site shown in print 8 after completion of the Project. The old pasture area has been returned to production (location C figure 5, October 1980).

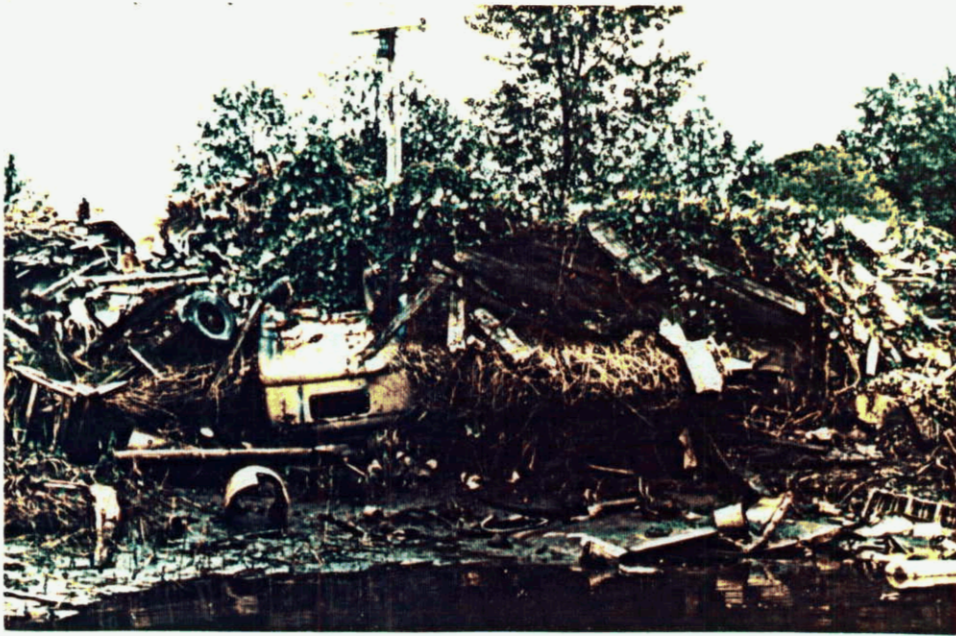
PRINT 10

1976 (summer) photograph of illegally dumped refuse in the headwater area of Tilbury Slough adjacent to the Tilbury pump station outlet (location K figure 5, 1976).

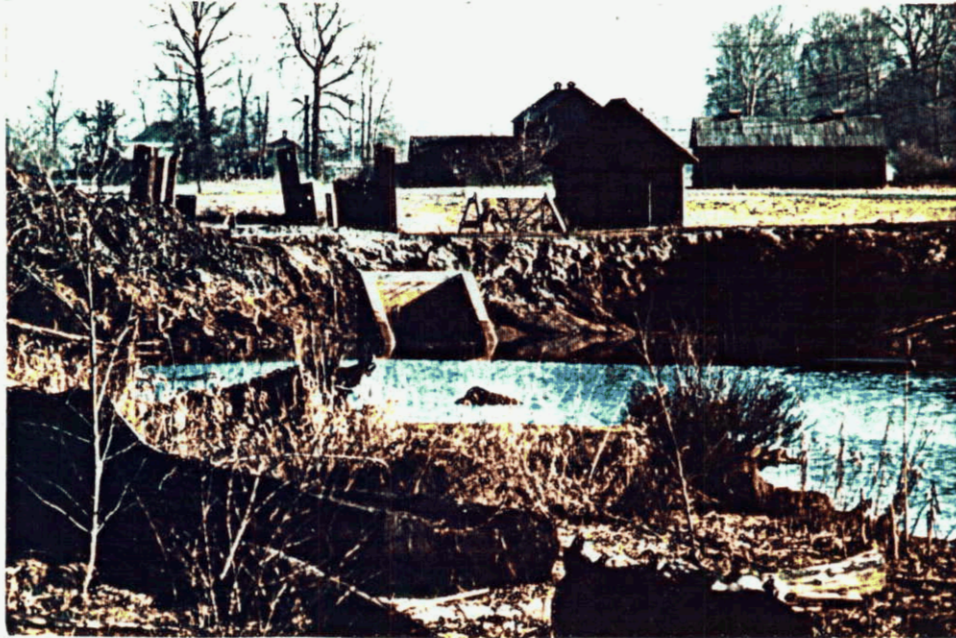
PRINT 11

Early stages of work on improvements to the Tilbury discharge structures. Note the debris shown in print 10 has been removed (location K figure 5, February 1980).

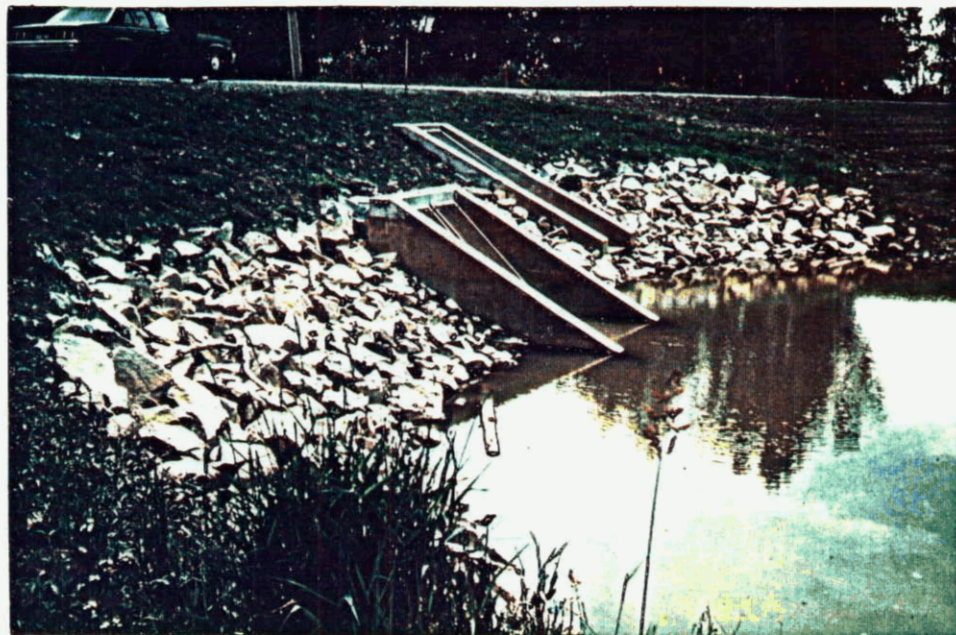
PRINT 12

The completed Tilbury discharge outlets. Riprap and reseeded grasses provide erosion protection (location J figure 5, June 1980).

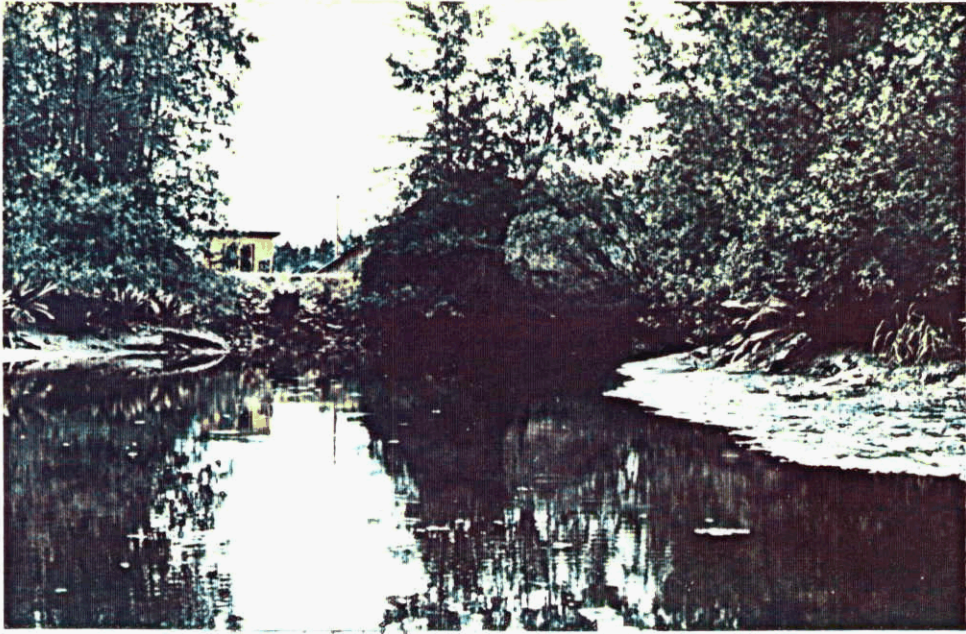
PRINT 13

As a result of the Project, the McDonald pump station and floodbox are now inactive and no longer release high organic content agricultural drainage to the upper reaches of Tilbury Slough, (see figure 2 and print 13). Instead this water has been re-routed to the new combined pump station and floodbox facility downstream of the slough near the foot of 62B Street (see prints 14 and 15). In the IEE report, prepared by the Interagency Task Force, water quality degradation in the slough was identified and linked to drainage from the McDonald discharge structures. With the redirecting of this discharge into the south arm of the Fraser River, a gradual improvement in the water quality of the slough should become evident. [If such improvement [benefits the slough's indigenous biological community, then it will constitute a positive impact of the Project on Tilbury Slough.

1976 (summer) photograph showing the upper reaches of Tilbury Slough with McDonald Rd. pump station and discharge pipe visible in the background (location L figure 5, 1976).

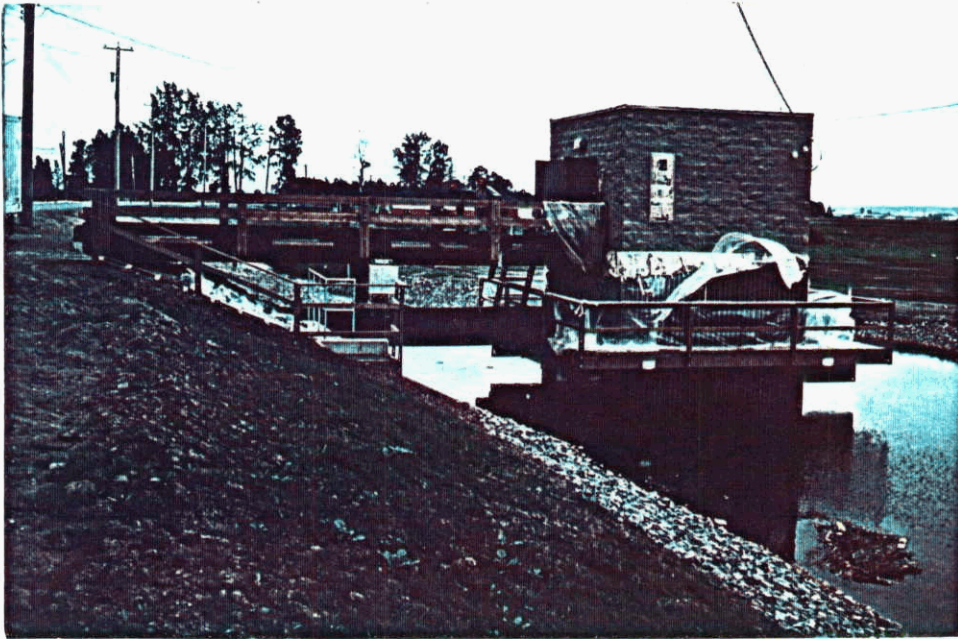
PRINT 14

New combined pump station and floodbox near the foot of 62B Street. (see figure 2, June 1980).

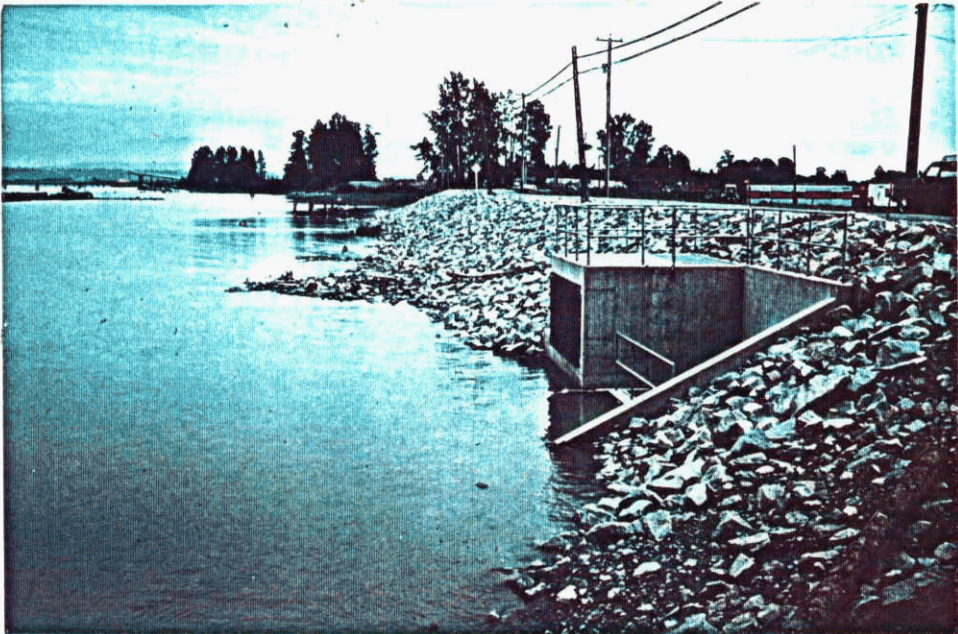
PRINT 15

Outlets for the 62B Street pump station and floodbox. These are located on the Fraser River foreshore, approximately 500 m downstream from the mouth of Tilbury Slough (see figure 2, June 1980).

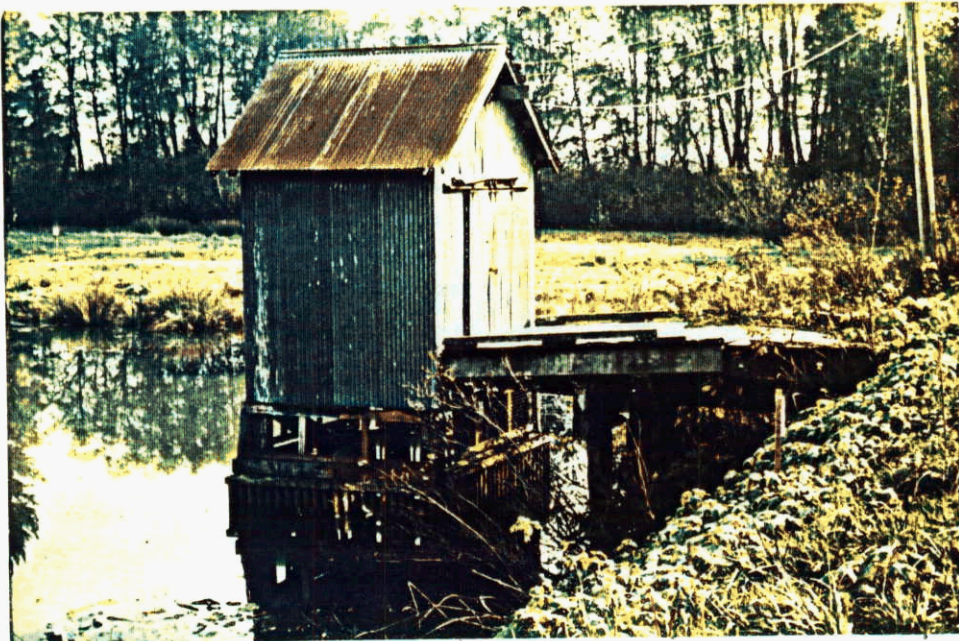
PRINT 16

Some inland drainage, however, does continue to enter the slough through the remaining Tilbury pump station and floodbox, located at the apex of the slough (see figures 2 and 6, prints 12 and 16). These structures release water from a portion of the slough that has been isolated from tidal influences by previous dyking and fill, becoming, in essence, a large freshwater pond (see print 17). Neither the pond's water chemistry nor the structure of its aquatic community has been investigated. Therefore, it is not known what effect this remaining discharge has on the slough's ecology. Consequently, any possible future salmonid enhancement activity at Tilbury Slough by the Department of Fisheries and Oceans should include a detailed examination of the role that this pond plays in the productivity and quality of the slough's aquatic habitat.

Tilbury pump station located at the head of
Tilbury Slough (location H figure 5, October
1979)

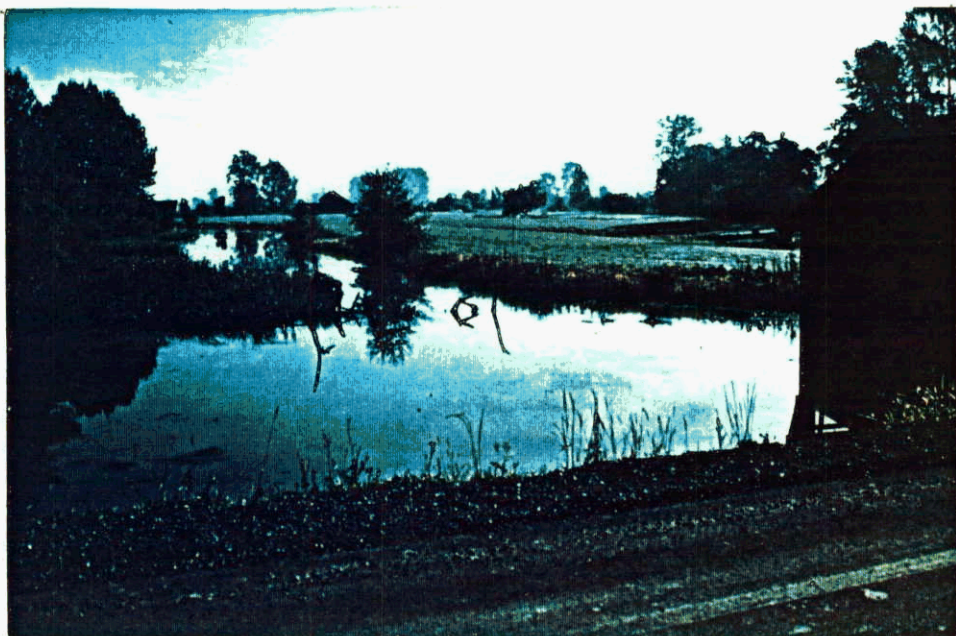
PRINT 17

Pond drained by the Tilbury discharge structures.
Pump station is visible on the right (location H
figure 5, October 1980).

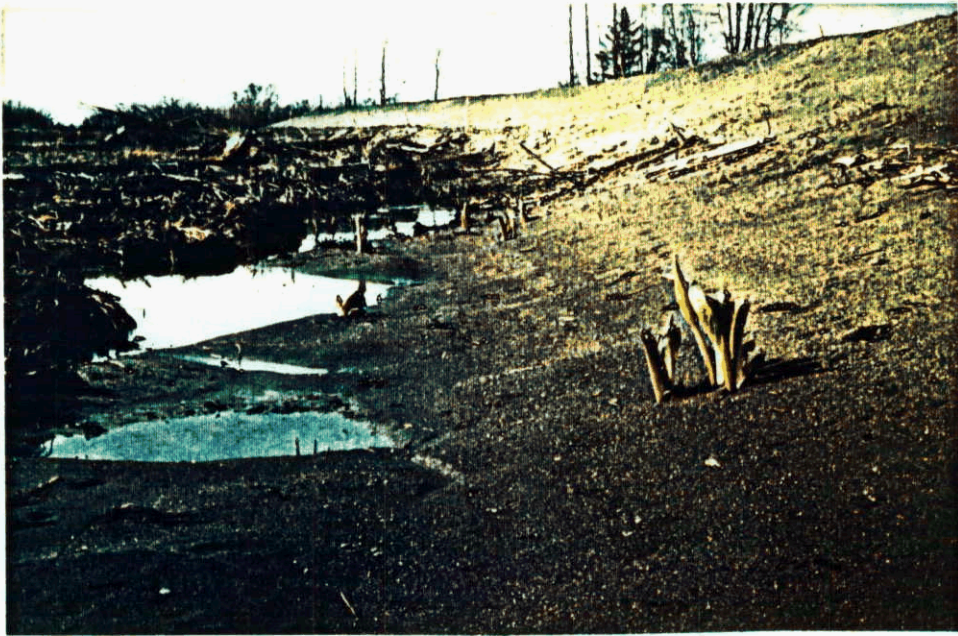
PRINT 18

Toe of dyke in relation to slough (location E figure 5, March 1980).

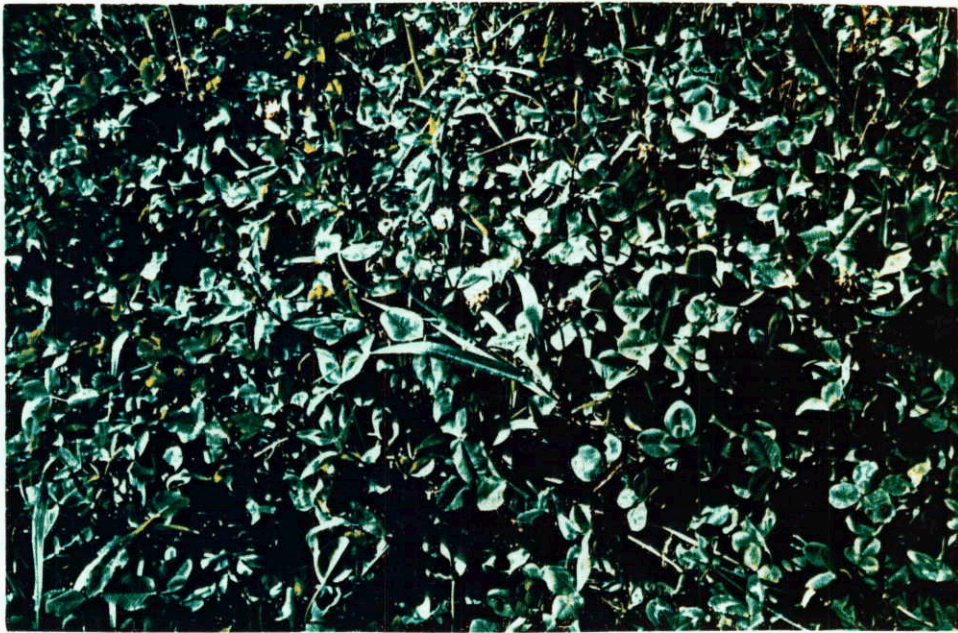
PRINT 19

first by the removal of illegally dumped refuse (see print 10), and second, by a successful revegetation program (see prints 3, 6 and 12). The latter has resulted in a vigorous legume-grass community (see prints 19 and 20) becoming established along the dyke embankment adjacent to the slough's northern perimeter. This area of new vegetation provides excellent ground cover and prevents erosion of fines into the slough.

Vigorous legume-grass community established along the dyke embankment adjacent to the slough (location M figure 5, October 1980).

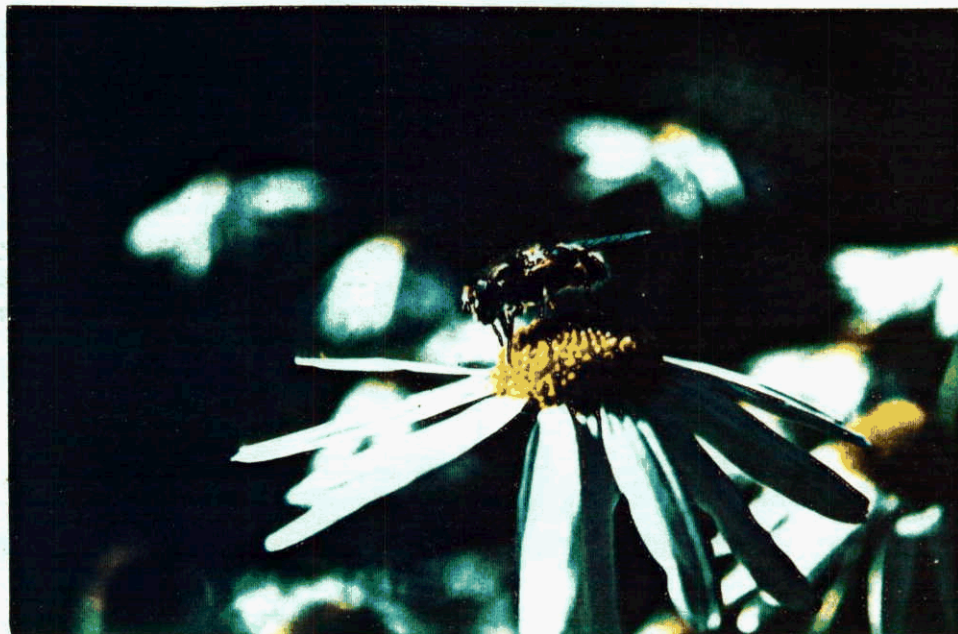
PRINT 20

Insect (a Dipteran) utilizing the revegetated area on the dyke embankment adjacent to the slough (October 1980). Analyses of stomach contents from salmon captured in Tilbury Slough have shown that Dipteran larvae, pupae and adults are an important food source.
