TSAWWASSEN INDIAN RESERVE FLOOD CONTROL WORKS

post-project environmental analysis

D.J. BERNARD and V.G. BARTNIK
MARCH, 1987

Inland Waters and Lands
Pacific and Yukon Region
Vancouver, B.C.

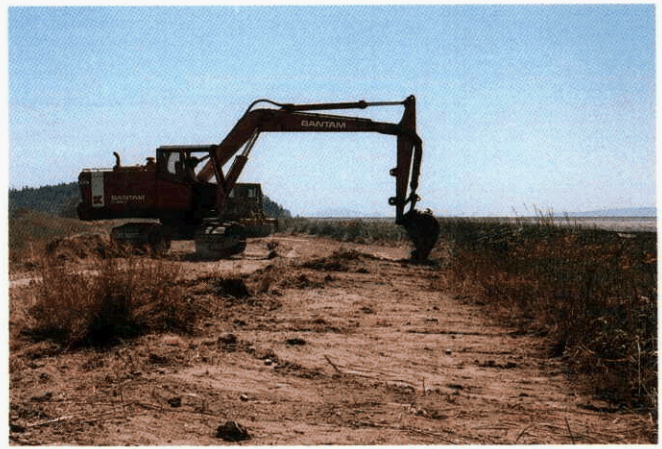
PLATE 1 8 July 1985

Backhoe used alongside the bulldozer for stripping activity to ensure better edging control along the staked toes of the breakwater.

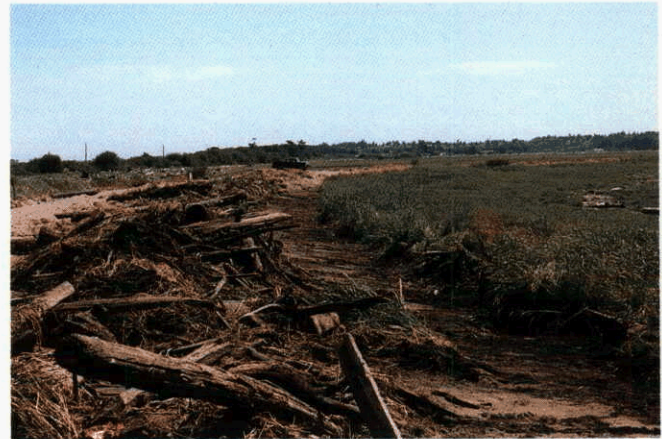
PLATE 2 8 July 1985

Debris and waste material were piled and kept within the stacked toes of the breakwater. Disposal was to an inland Indian Reserve site. No burning of debris was done on-site.

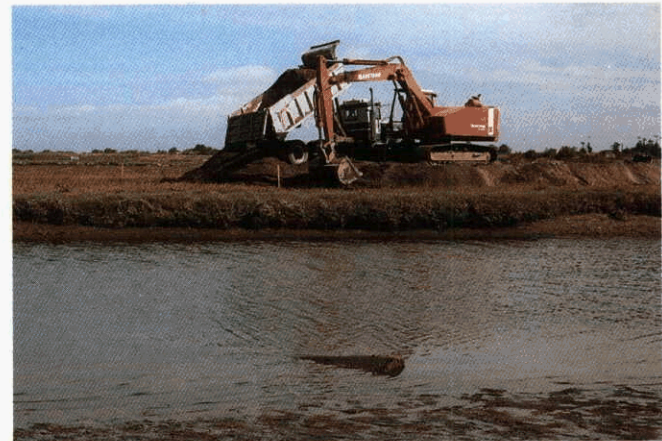
PLATE 3 22 July 1985

Near the mainchannel, where there was no prebuilt 1975 base, the backhoe worked from the constructed base pad and did not encroach on the marsh beyond the staked toes of the breakwater. There was no side casting or stockpiling of material as trucks would haul in fill and on return trip would haul out excavated material to the approved disposal site.

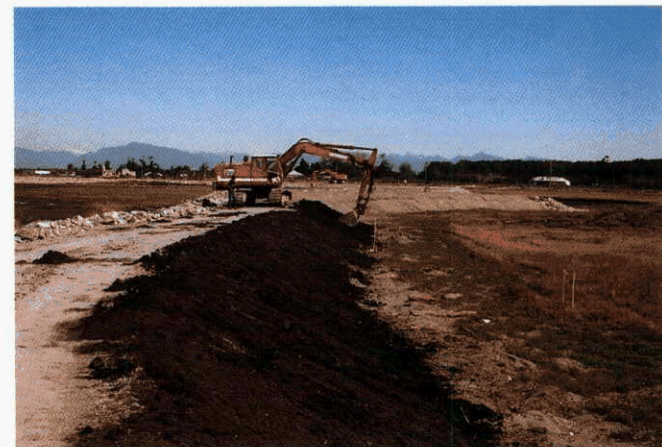
PLATE 4 27 September 1985

Placement of topsoil on the landslide slope of the breakwater. Topsoil was trucked in as needed (no stockpile on the marsh) and scooped from the truck with a backhoe and placed directly on the slope.

Note area adjacent to landslide toe of breakwater can be seen revegetating after remedial action removed material pushed beyond staked toe (see section III.A.2).

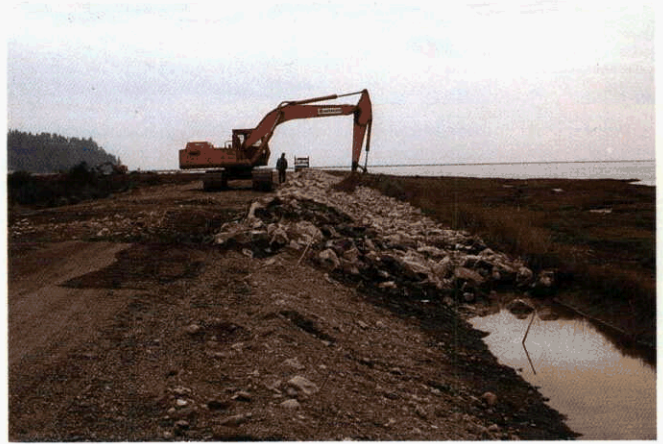
PLATE 5 20 September 1985

To prevent impacts and burial of the marsh along the seaside toe, all bank protection work was done with a backhoe and trucks working from the top of the breakwater. The toe trench was excavated during low tide to prevent sediment generation. Excavated material was either used as topsoil or fill, as suitable.

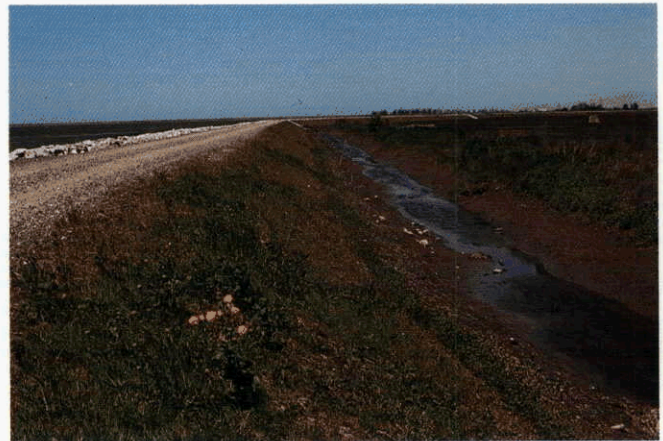
PLATE 6 2 June 1986

The landslide slopes of the breakwater were grass-seeded in early 1986 after some delay due to inclement weather (heavy rains and frost) in the autumn of 1985. Note the lack of vegetation in the collection ditch due to the daily tidal action through the culvert in the background.

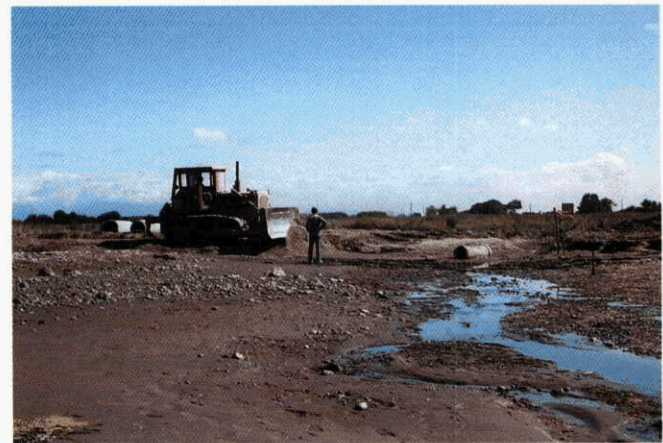
PLATE 7 12 July 1985

Temporary culverts were installed at two dendritic channels which had been reopened to the sea following the 1975 partial dyking. This ensured maintenance of the status quo of the marsh in this area prior to the installation of the large arch culverts.

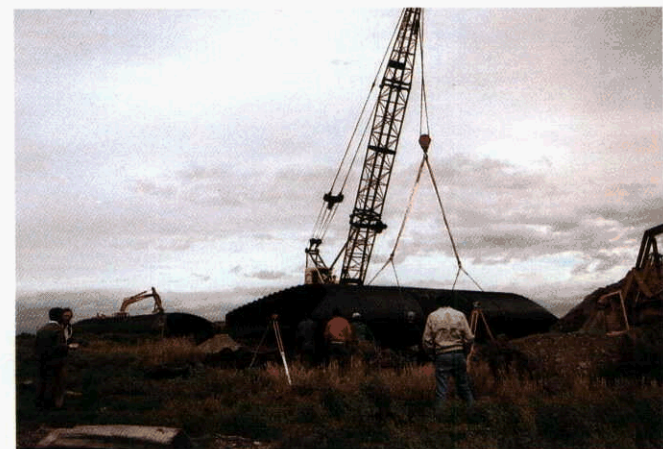
PLATE 8 12 September 1985

Installation of galvanized (asphalt-coated) arch plate type culverts. The breakwater was excavated to the designated surveyed depth ensuring proper drainage between dendritic channels, toe ditches and culverts.

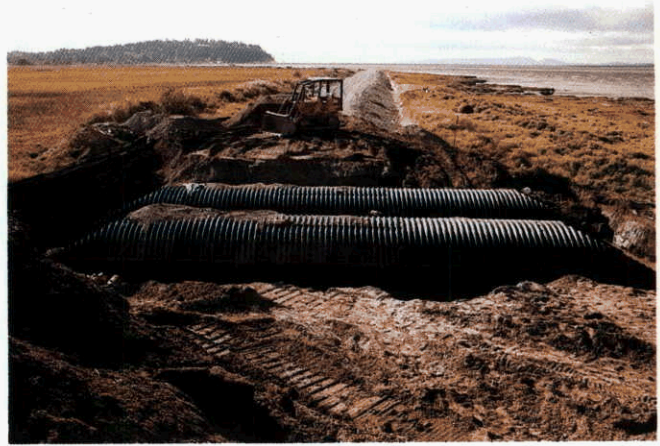
PLATE 9 12 September 1985

During the installation of culverts excavated material was stockpiled on the breakwater for later use in backfilling.

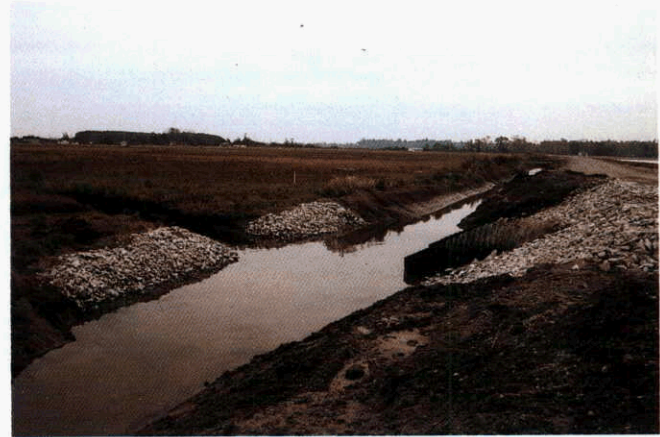
PLATE 10 20 September 1985

Installed single arch culvert depicting the system of dendritic channel (left), toe ditch (centre) and culvert (right).

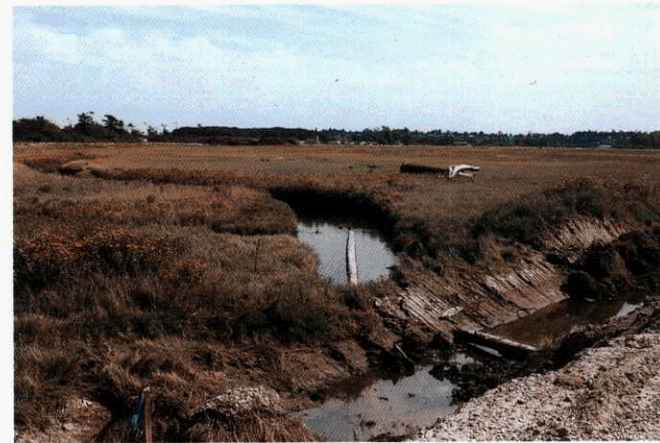
PLATE 11 29 August 1985

View of a typical dendritic channel that was blocked by the 1975 partial dyke construction. The soil plugs were left until the ditches and culverts were installed to prevent sediment generation. These plugs were then removed by dragline and direct tidal exchange was restored.

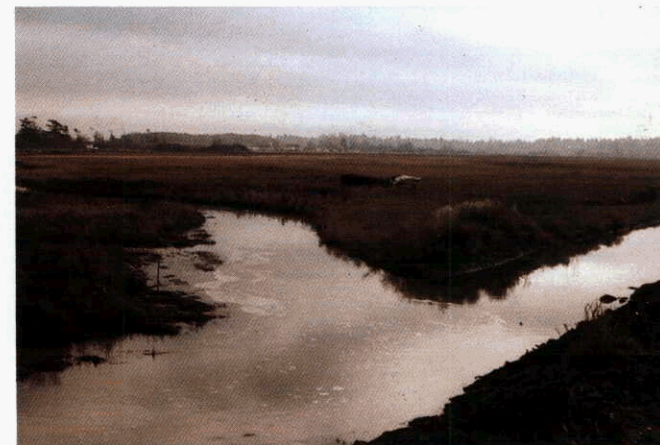
PLATE 12 6 December 1985

View of opened dendritic channel of Plate 11 once tidal exchange had been restored [photo taken during an observed tide of 5.6 ft (1.71 m) GCS at Point Atkinson].

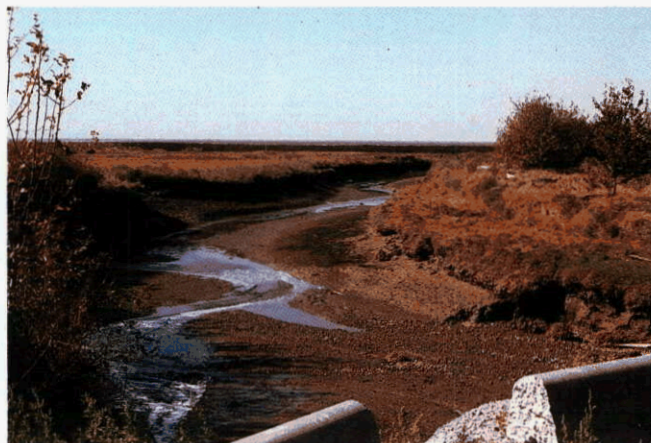
PLATE 13 27 September 1985

Outfall channel below the floodbox/pumpstation showing the silted-in condition that had built up over the years. Dredging of 700 ft. (213.4 m) of channel bottom was requested to provide an effective low-level drainage channel to the sea.

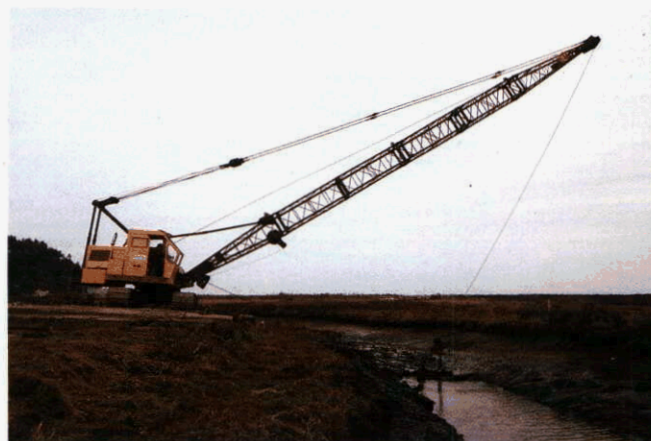
PLATE 14 9 October 1985

The outfall channel was dredged with a dragline operating from moveable pads on the channel bank, thus protecting marsh vegetation from damage. Dredged material (soft silt) was moved by the dragline, in a 4 day period, in progressive steps within the channel with final trucking for disposal at an approved disposal site on the Reserve. Release of silt into the main channel was minimized by operating at low-tide only.

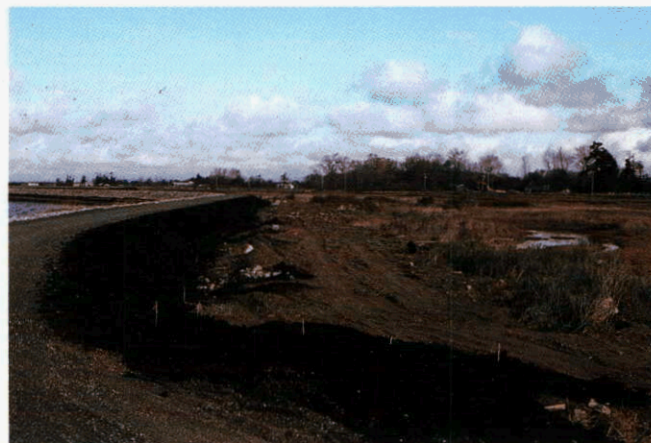
PLATE 15 6 December 1985

1. During construction of the southern section of the breakwater, waste material had been sidecast on top of a windrow remaining from the 1975 construction. Although this sidecast material was removed by the contractor to pre-1985 condition (Plate 15), DFO and F&WB also requested removal of the 1975 material to grade level. This additional work was carried out (see Plate 16) to the satisfaction of DFO and F&WB.

View of the sidecast area remaining from 1975.

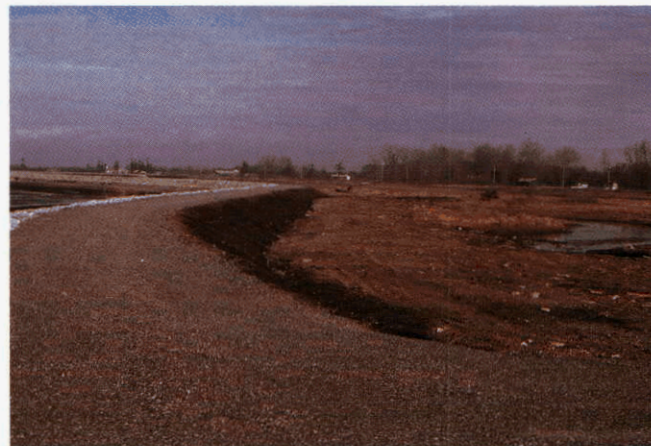
PLATE 16 28 February 1986

View of the same sidecast area as shown above (Plate 15) but after remedial work to remove the windrow remaining from 1975 sidecasting.

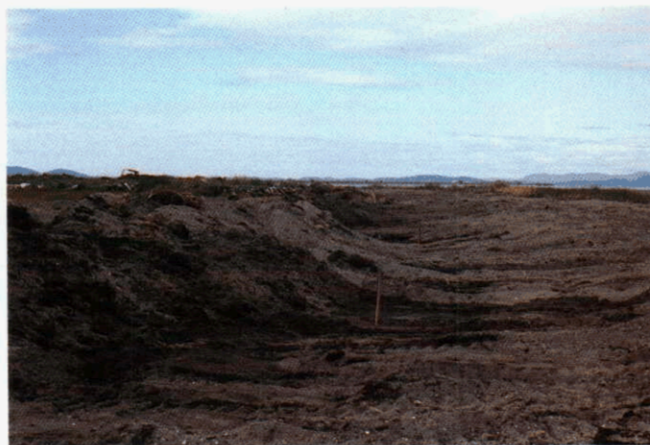
PLATE 17 10 July 1985

2. At another location, waste material was pushed beyond the staked landside toe of the breakwater and covered marsh vegetation (Plate 17). Remedial action was immediately taken. The waste material was removed with due care not to alter the underlying vegetation and disposed of at an approved site on the Reserve. This area, as illustrated in Plate 4, quickly revegetated without further intervention.

View of the stripped material pushed onto the marsh beyond the stacked landside toe of the breakwater.

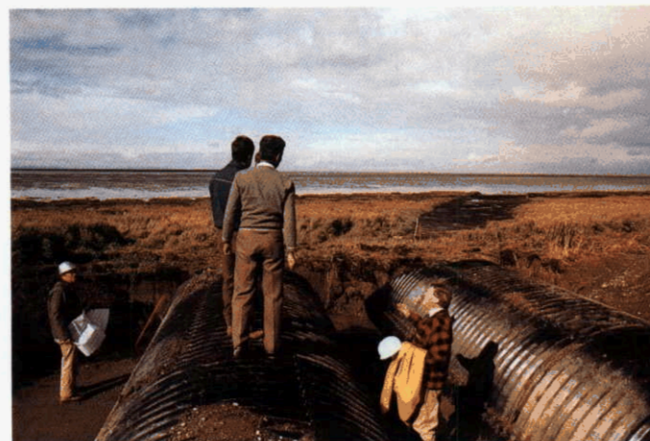
PLATE 18 13 September 1985

4. During installation of a double culvert on the northern section of the breakwater, DFO raised some concerns respecting the alignment of the culverts especially in relation to the seaside drainage channel (Plate 18). It was feared that the off-alignment would promote the erosion of the seaside channel, and possibly lead to the creation of a new drainage channel at the expense of marsh habitat. An on-site meeting to address this issue was immediately arranged among DFO, IW/L and consultant project engineers. A decision was made on-site, with no project delays, to leave the alignment as proposed but provide adequate rip-rap protection to the seaside channel banks adjacent to the culverts. All work was done as DFO requested. Follow-up inspection in December 1986 found no erosion had occurred.

On-site meeting between DFO, IW/L and consultant project engineers of Associated Engineering Limited to resolve DFO concern with the alignment of a double culvert. Natural seaside drainage channel in background.

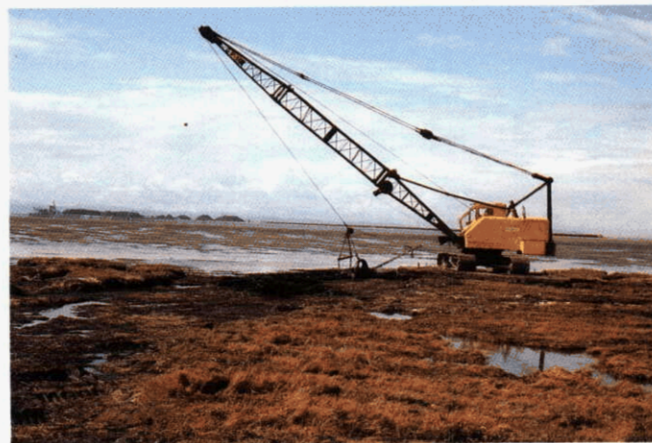
PLATE 19 13 September 1985

Dredging of a natural seaside channel at a double culvert location. The dragline used moveable pads and worked at low-tide.

5. The seaside tidal channels at the double culverts were heavily laden with soft sediments and were up to 0.5 m above the seaside invert of the culverts. In order to provide unrestricted tidal flow through the channels servicing the culverts, DFO granted permission to dredge the channels with a dragline. The work was performed as follows to minimize environmental impacts on the marsh and water quality:

- the dredging was done at low tide only and with a dragline sitting on moveable pads to prevent damage to marsh vegetation (see Plate 19);
- the work was started from the tidal flat area working towards the culvert. Excavated material was moved within the channel area until it could be loaded into trucks on the breakwater; and,
- the excavated material was disposed of at an approved site outside the tidal flat area.

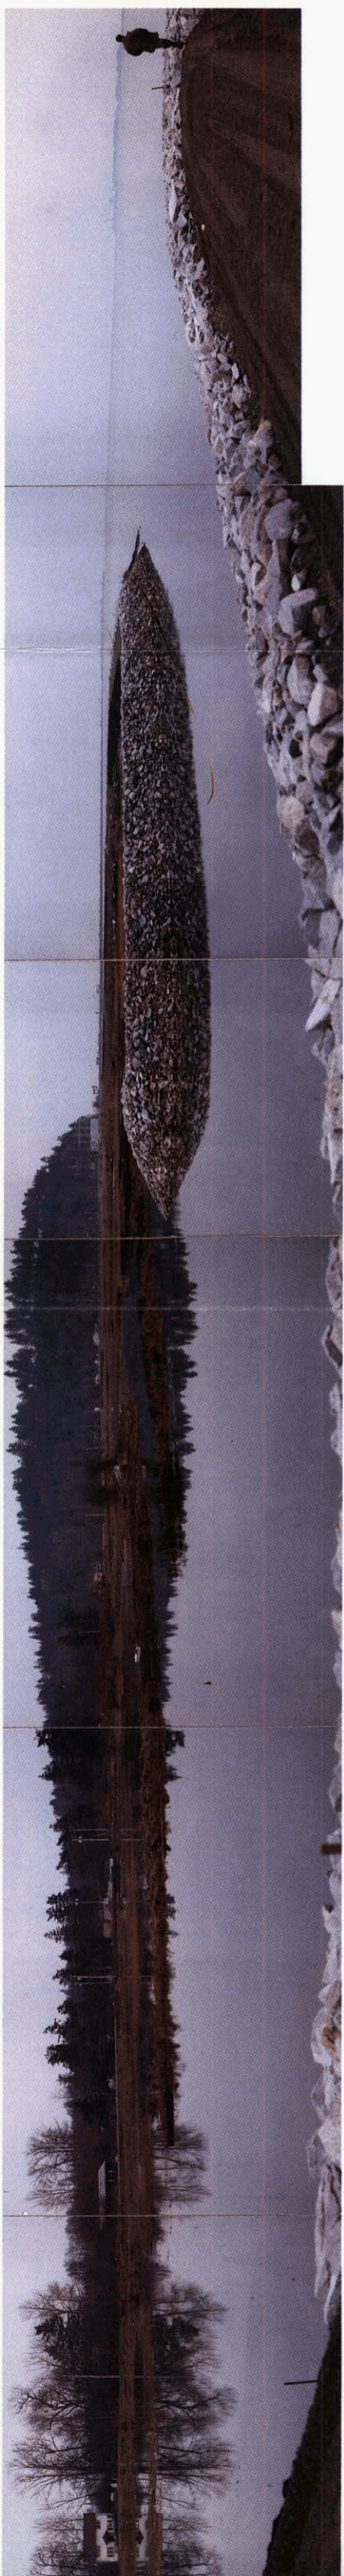
The areal extent of the inundation and movement of water into the marsh is illustrated in Plate 21. These panoramic pictures show a gentle transfer of water through the gap in the breakwater at the main channel [a maximum observed velocity of 2.8 ft./sec (0.8 m/sec) AEL 1986], overbank flow of the channels and a gradual spreading of seawater through the marsh vegetation. Velocities in the toe ditches, culverts and channels also appeared to be low [less than 3 ft./sec (0.9 m/sec) AEL 1986]. During the monitoring program only a slight head differential was observed across the culverts, confirming the adequacy of the sizing of the culverts.

View looking south at the gap in the breakwater and the inundation of the southern drainage area at high tide on December 14, 1985. Predicted high tide of 6.3 ft. (1.92m) G.S.C. at Point Atkinson.

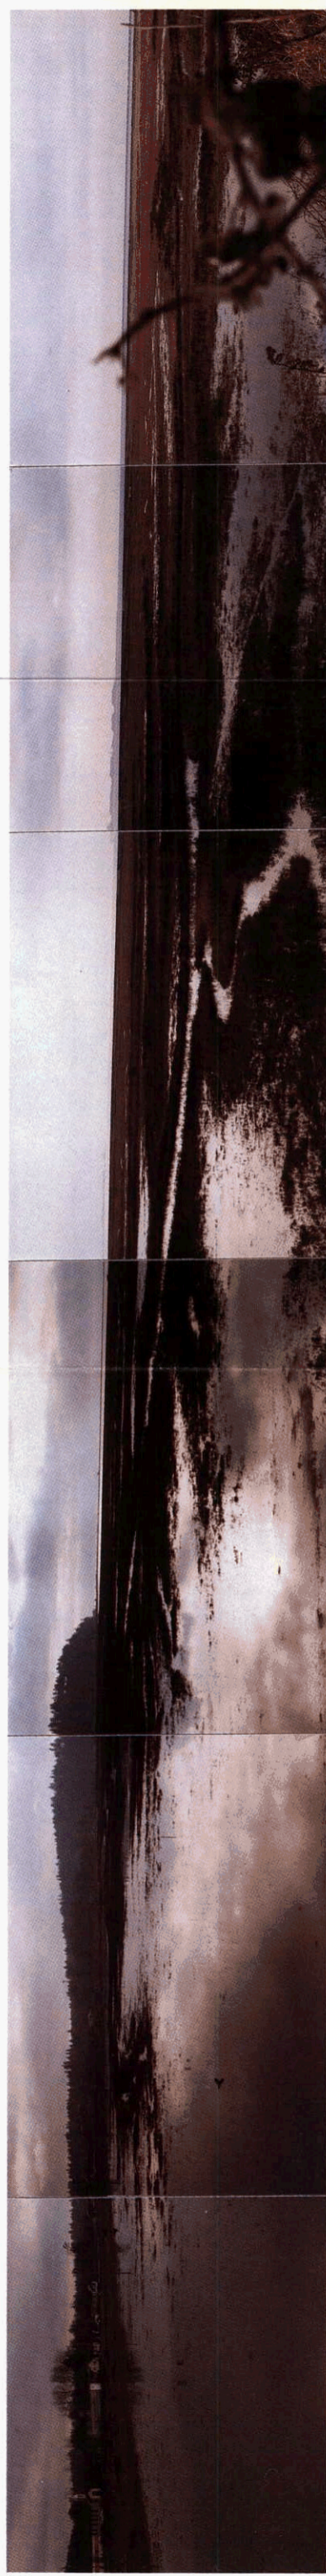
View looking south at the inundation of the central drainage area at high tide on December 6, 1985. Predicted high tide of 5.2 ft. (1.58m) G.S.C. at Point Atkinson.

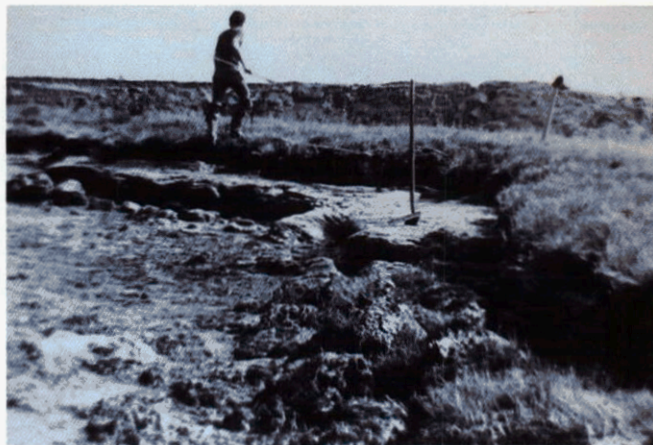
PLATE 22

1976 photograph of the active process of truncation and collapse of the leading edge of the Tsawwassen salt marsh near local promontories (photo courtesy of J.L. Luternauer, Geological Survey of Canada, Vancouver, B.C.)

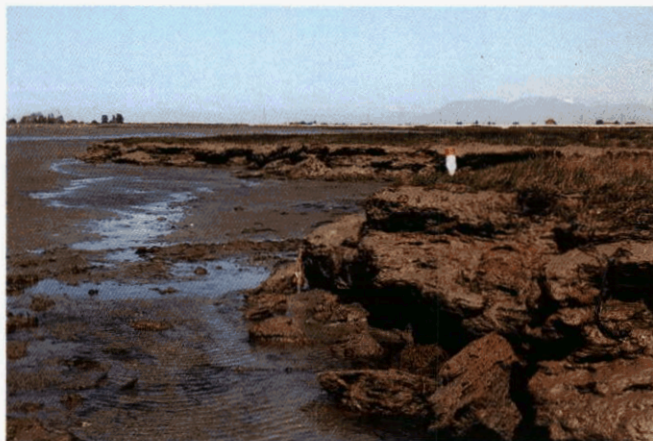
PLATE 23

1986 photograph illustrating the same 1976 erosional processes shown above. The survey pin demarcates the leading edge of the local promontory as of June 2, 1986.

During the baseline surveys a total of seven steel rods were also installed and surveyed in as reference pins to demarcate the leading edge of local promontories. The reference pins were located 23 to 75.5 m from the top of the breakwater. After approximately eight months, inspection of the reference pins indicated measurable erosion had already occurred at promontories in the four areas. The erosion measured at area one was 2 and 12.5 cm, at area two, 30.5 and 35.7 cm, at area three 10.7 cm and at area four 3.7 and 26.9 cm. A comparison of photographs taken of the same reference pin at area two shows how the leading edge of the promontory had eroded back by 35.7 cm (compare Plate 23 and Plate 24).

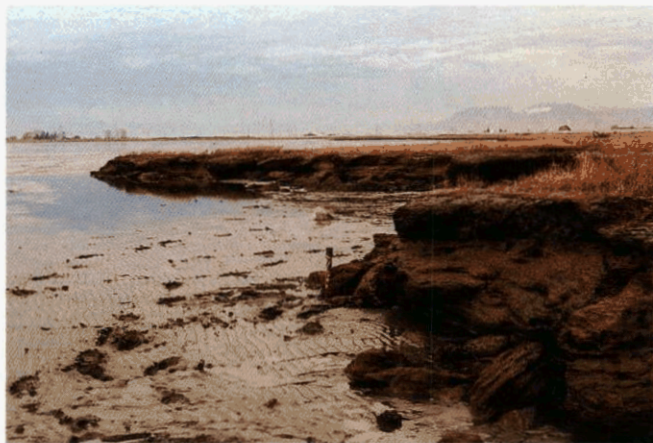
PLATE 24

Photograph of the same location and reference pin shown in Plate 24 above, but taken approximately 8 months later on February 5, 1987. The leading edge of the promontory had eroded back by 35.7 cm.

The initial observations indicate that the erosion of marsh promontories is progressing, probably due to the focusing of wave energy. If the heterogeneity of marsh material is preventing a stable marsh front from being established then it is likely this erosion will continue until arrested by the newly-constructed flood control breakwater. The breakwater will then serve to secure the areal extent of the marsh now protected by it.
