WASTE DISPOSAL AT COQUALEETZA

P. W. SOPER

Federal Activities Abatement Group  
Environmental Protection Service  
Environment Canada

September 1975

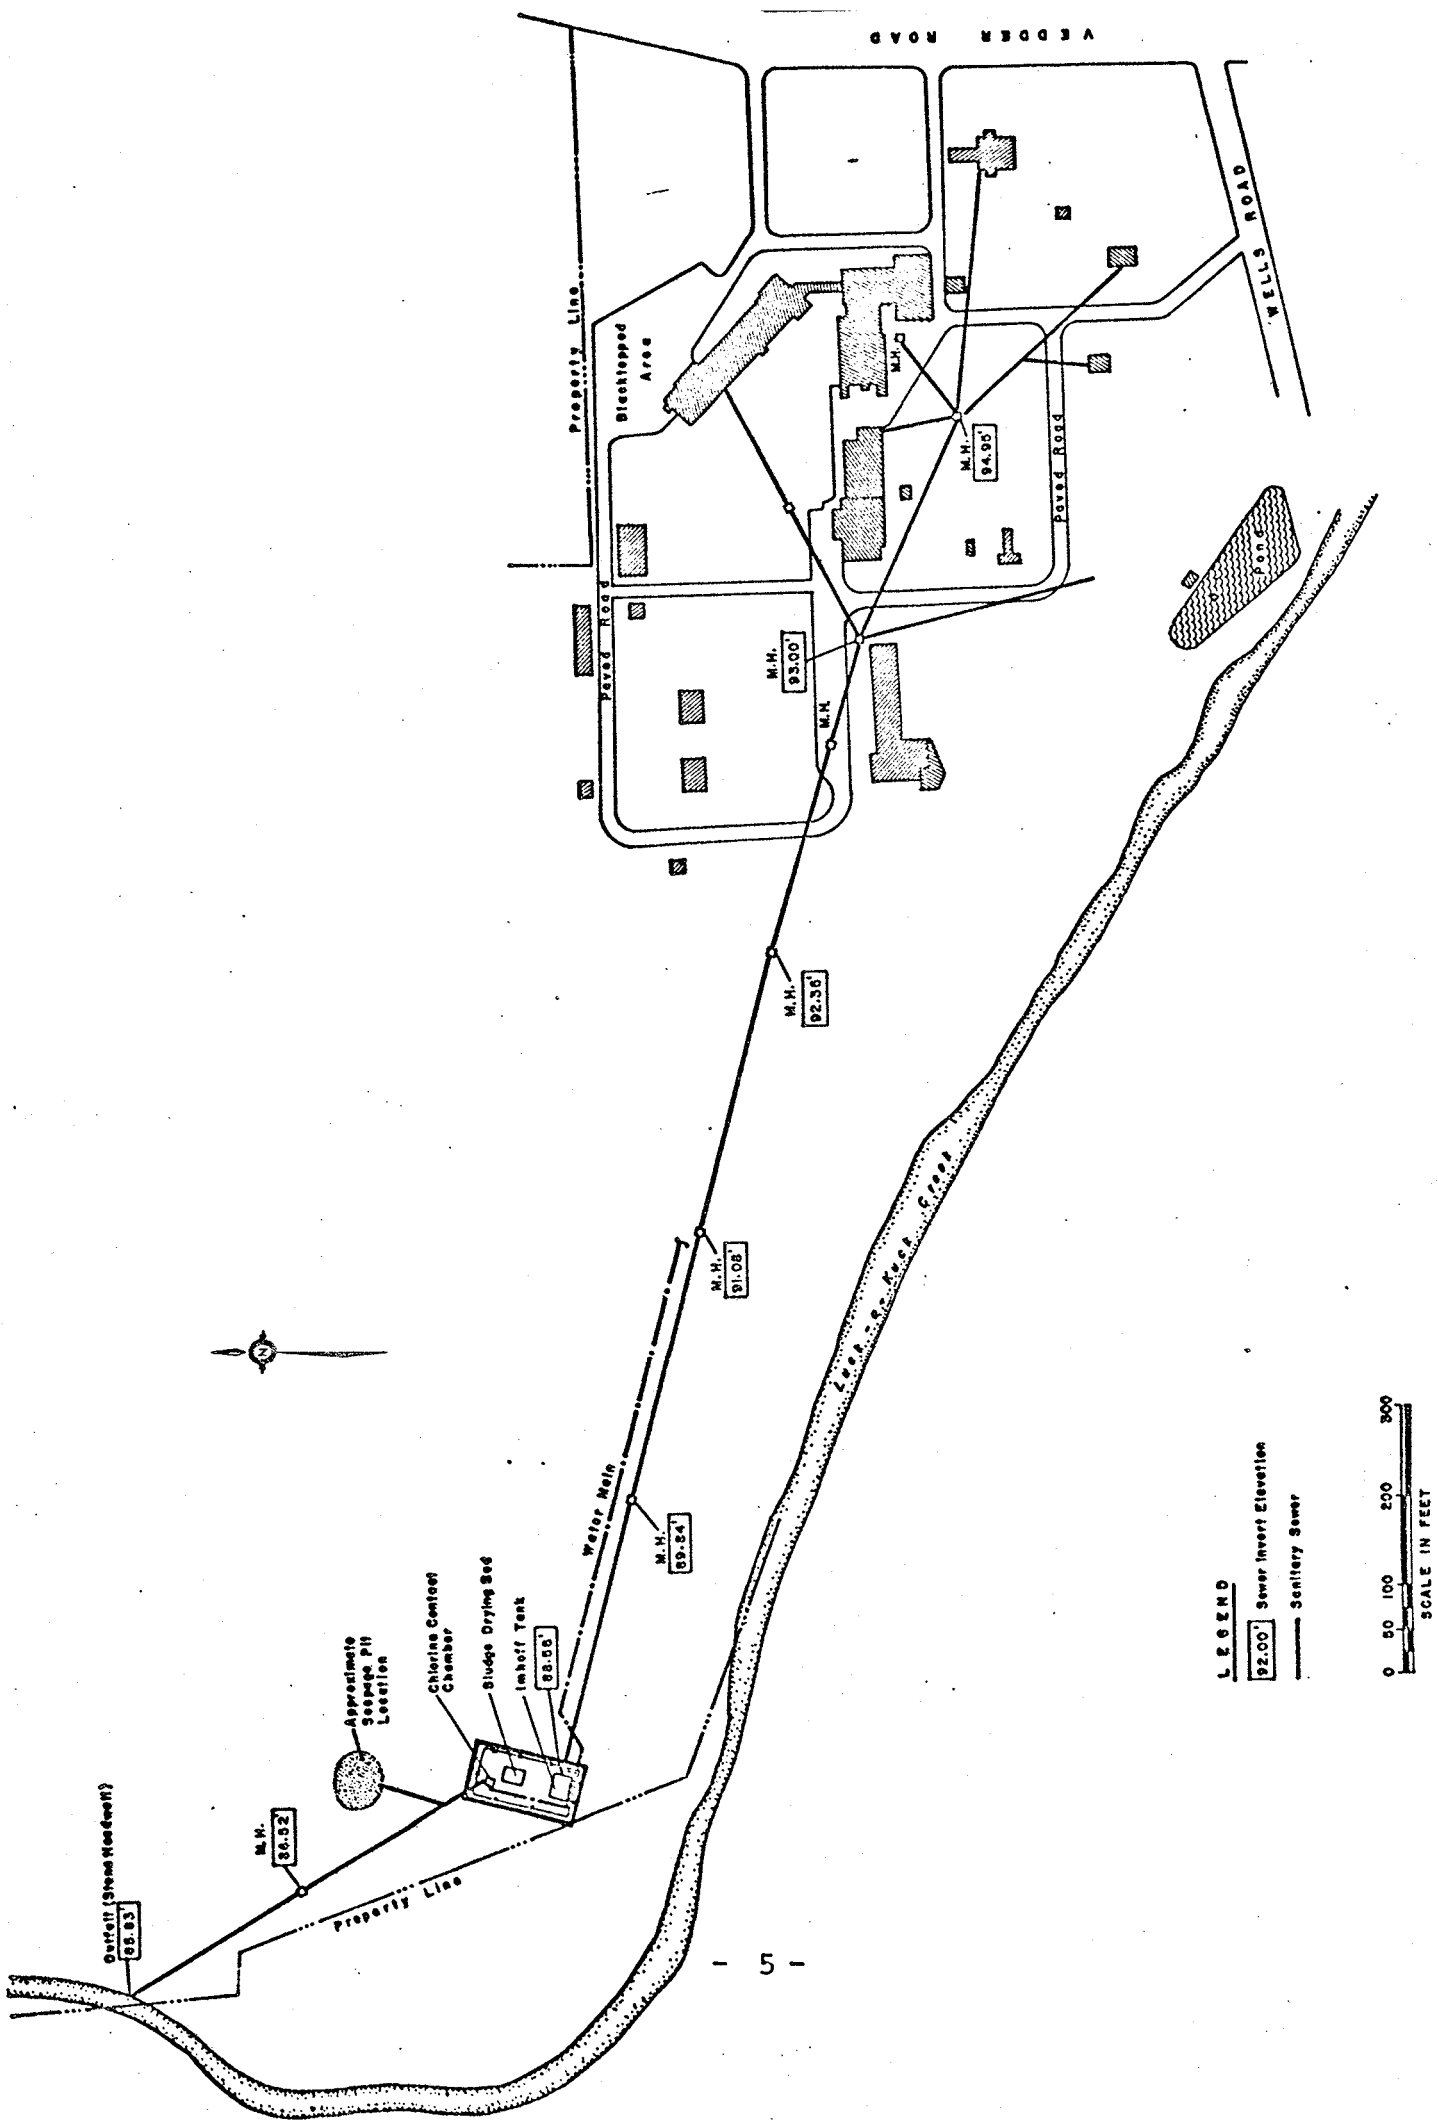
FIGURE 3 DOMESTIC SEWAGE COLLECTION, TREATMENT AND DISPOSAL SYSTEM.

The domestic sewerage works are shown in Figure 3, and the water and storm sewer layout in Figure 4.

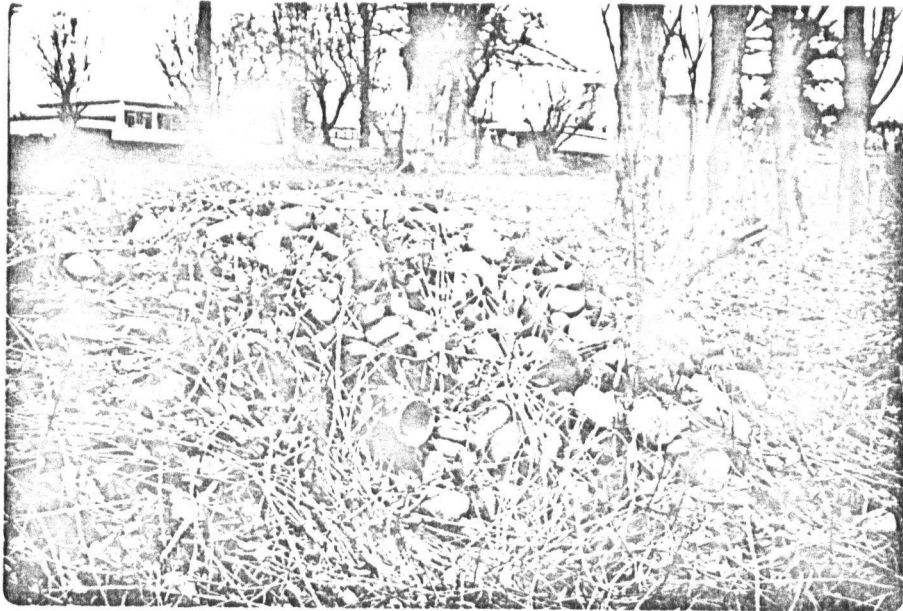
Plate 1: Storm Sewer Outlet

There is a separate collection system for storm runoff which discharges on the south side of the Coqualeetza property, adjacent to Luck-a-Kuck Creek (Plate 1 shows the storm water outlet). However, some of the roof drains discharge to drains connected to the sanitary sewer.

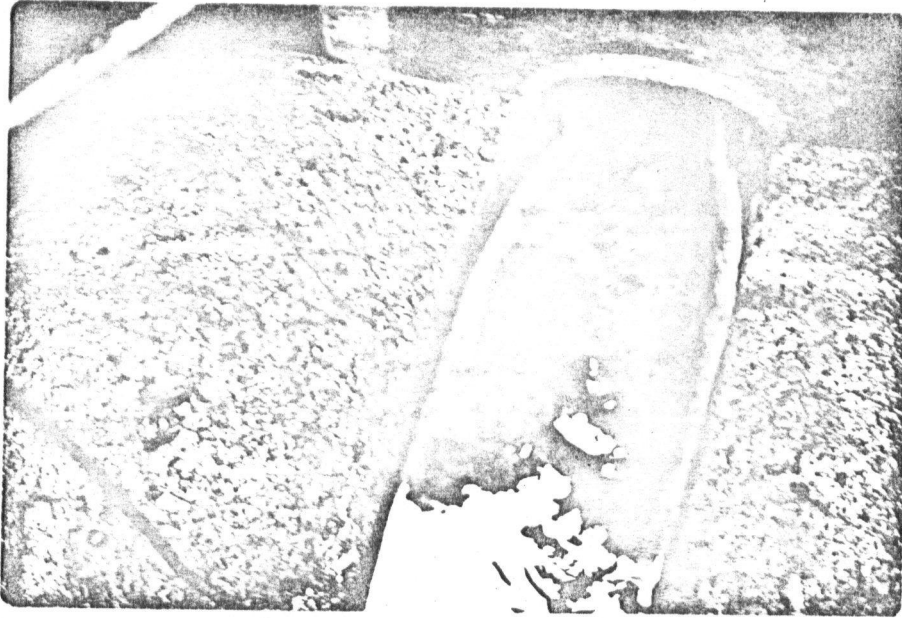
Plate 4: Flow in outfall manhole

Prior to 1971, the Imhoff tank discharged directly to Luck-a-Kuck Creek following chlorination. In 1971, as an interim measure, rock filled seepage pits were constructed with the discharge emanating from a submersible pump located in what was previously the chlorine contact chamber. However, either because of the elevation difference, seepage pit blinding or direct by-pass, the settled raw sewage now discharges to the creek outfall pipe (Plate 4 shows flow in outfall manhole). As no plans are available of the post-1971 discharge modifications, it is not possible to determine the exact path of the sewerage discharge. Dye tests and visual inspections have, nevertheless, identified the discharge from the treatment works to the creek. Plate 5 shows the creek outfall and Plate 6 the growth of sphaerotilus (sewage fungus) adjacent to the outfall pipe.

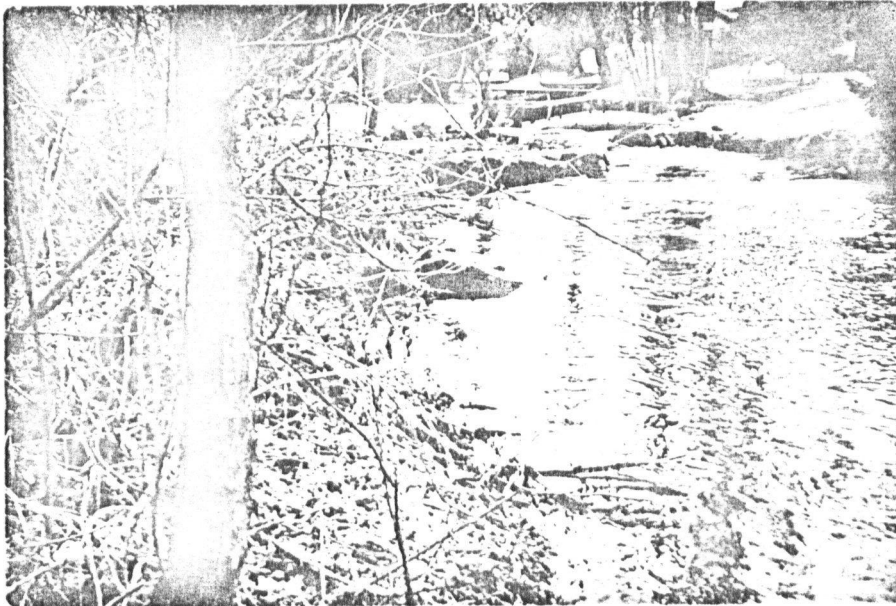
Plate 5: Location of outfall into Luck-a-Kuck Creek

Regardless of the generally poorly maintained treatment works with resultant associated malodours, the discharge of settled raw sewage to Luck-a-Kuck Creek is unacceptable in terms of both aesthetics, public health and fisheries. As well, the discharge does not comply with provincial Pollution Control Branch regulations or the Draft Guidelines for Wastewater Discharges from Federal Facilities.

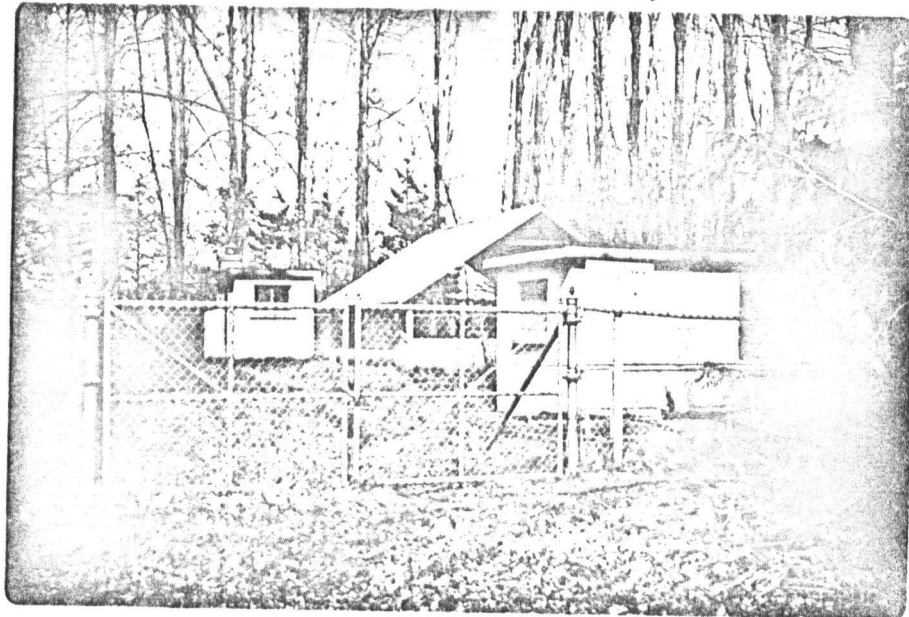
Plate 7:  
Treatment  
Works  
Compound

Within the treatment works compound (Plate 7) there is a bar rack, an Imhoff tank, covered sludge drying bed and chlorination facilities. The bar rack (Plate 8) has had every other bar removed, yielding approximately a 4" spacing and appears to be seldom, if ever, cleaned. The sludge drying bed is used periodically for sludge disposal from the Imhoff tank. The chlorination facilities were abandoned when the disposal scheme was modified in 1971. Malodours in the vicinity of the treatment compound were attributed mainly to solids build-up around the bar rack and the chlorine contact chamber.

- e) A sewer connection scheme should be designed with a view to connecting the raw sewage discharge prior to the Imhoff works at a manole associated with the new gravity sewer located within the bounds of the right-of-way crossing the west side of the Coqualeetza property. The treatment compound should be isolated by blanking the inlet and removing the outfall. The Imhoff works may be useful for operator training and as such should not be removed until its use for this purpose is investigated.

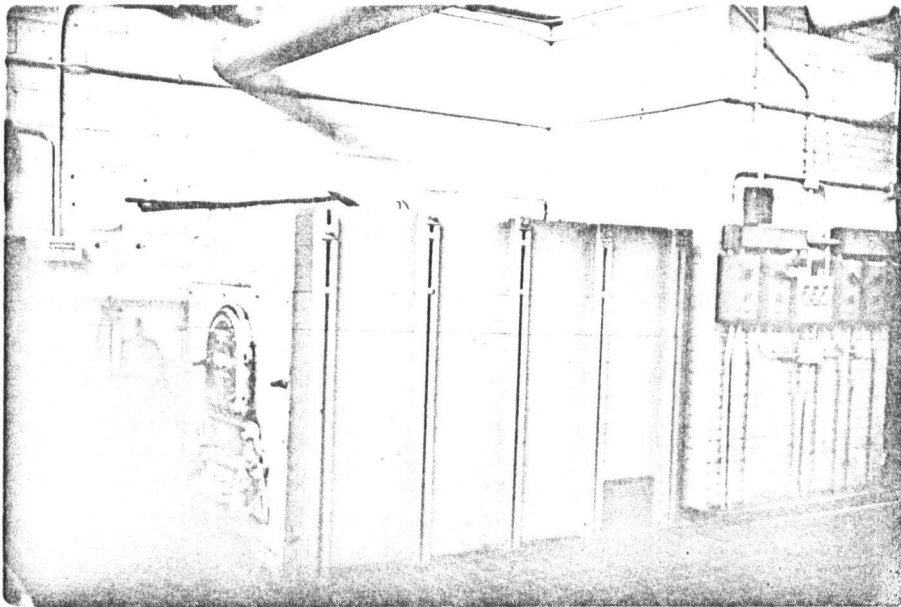
Plate 12: Incinerator

Other waste comprised almost entirely of waste paper, is burned in an incinerator (Plate 12) located in the boiler house. Approximately 16 to 20 garbage cans of refuse are burned per day, yielding about 1 garbage can of ash per week.

The incinerator, with no auxiliary fuel or air supply, operates about 4 hours per day; 2 hours in the a.m. and 2 hours in the p.m. The operator advised that fly ash and smoke can be seen emitting from the stack during incinerator operation.

The incinerator does not comply with Federal Facilities Interim Guidelines because of visible emissions produced and lack of air control.

- g) The incinerator should be either phased out or upgraded to comply with federal interim guidelines.

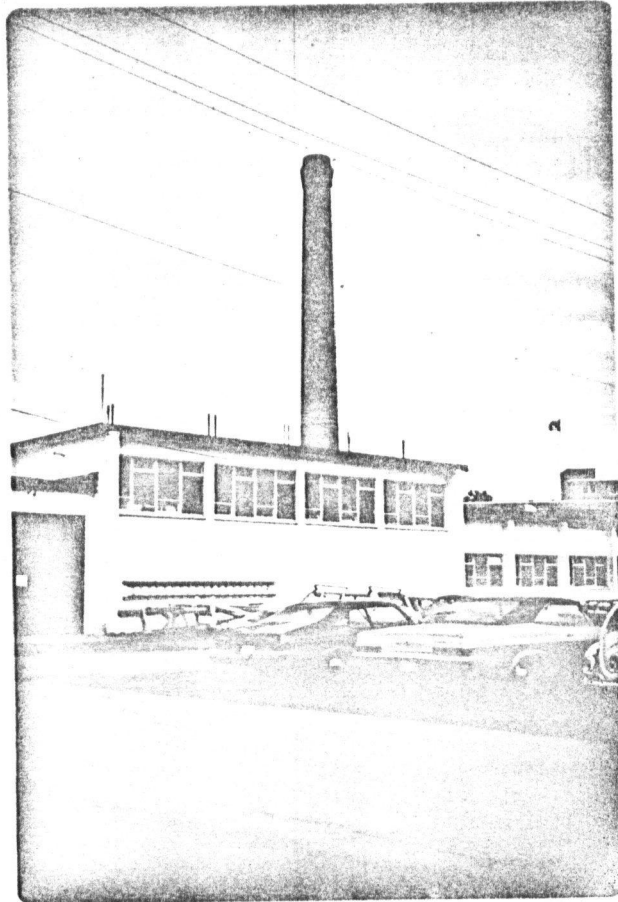
Plate 13: Boiler Plant Stack

Air emissions involved at Coqualeetza are associated with the incinerator discussed above and the central heating plant boilers, both of which share a common 50 to 60 foot stack (Plate 13).
