**HIGH QUALITY BASEMENT
ACCOMMODATION IN
OLDER HOUSES**

THE PROJECT IMPLEMENTATION DIVISION
POLICY DEVELOPMENT AND RESEARCH SECTOR
CANADA MORTGAGE AND HOUSING CORPORATION

THORCOR HOLDINGS LTD.
PROPERTY INVESTMENT AND DEVELOPMENT
OTTAWA, ONTARIO

1.1 Retrofit of 177 Frank Street

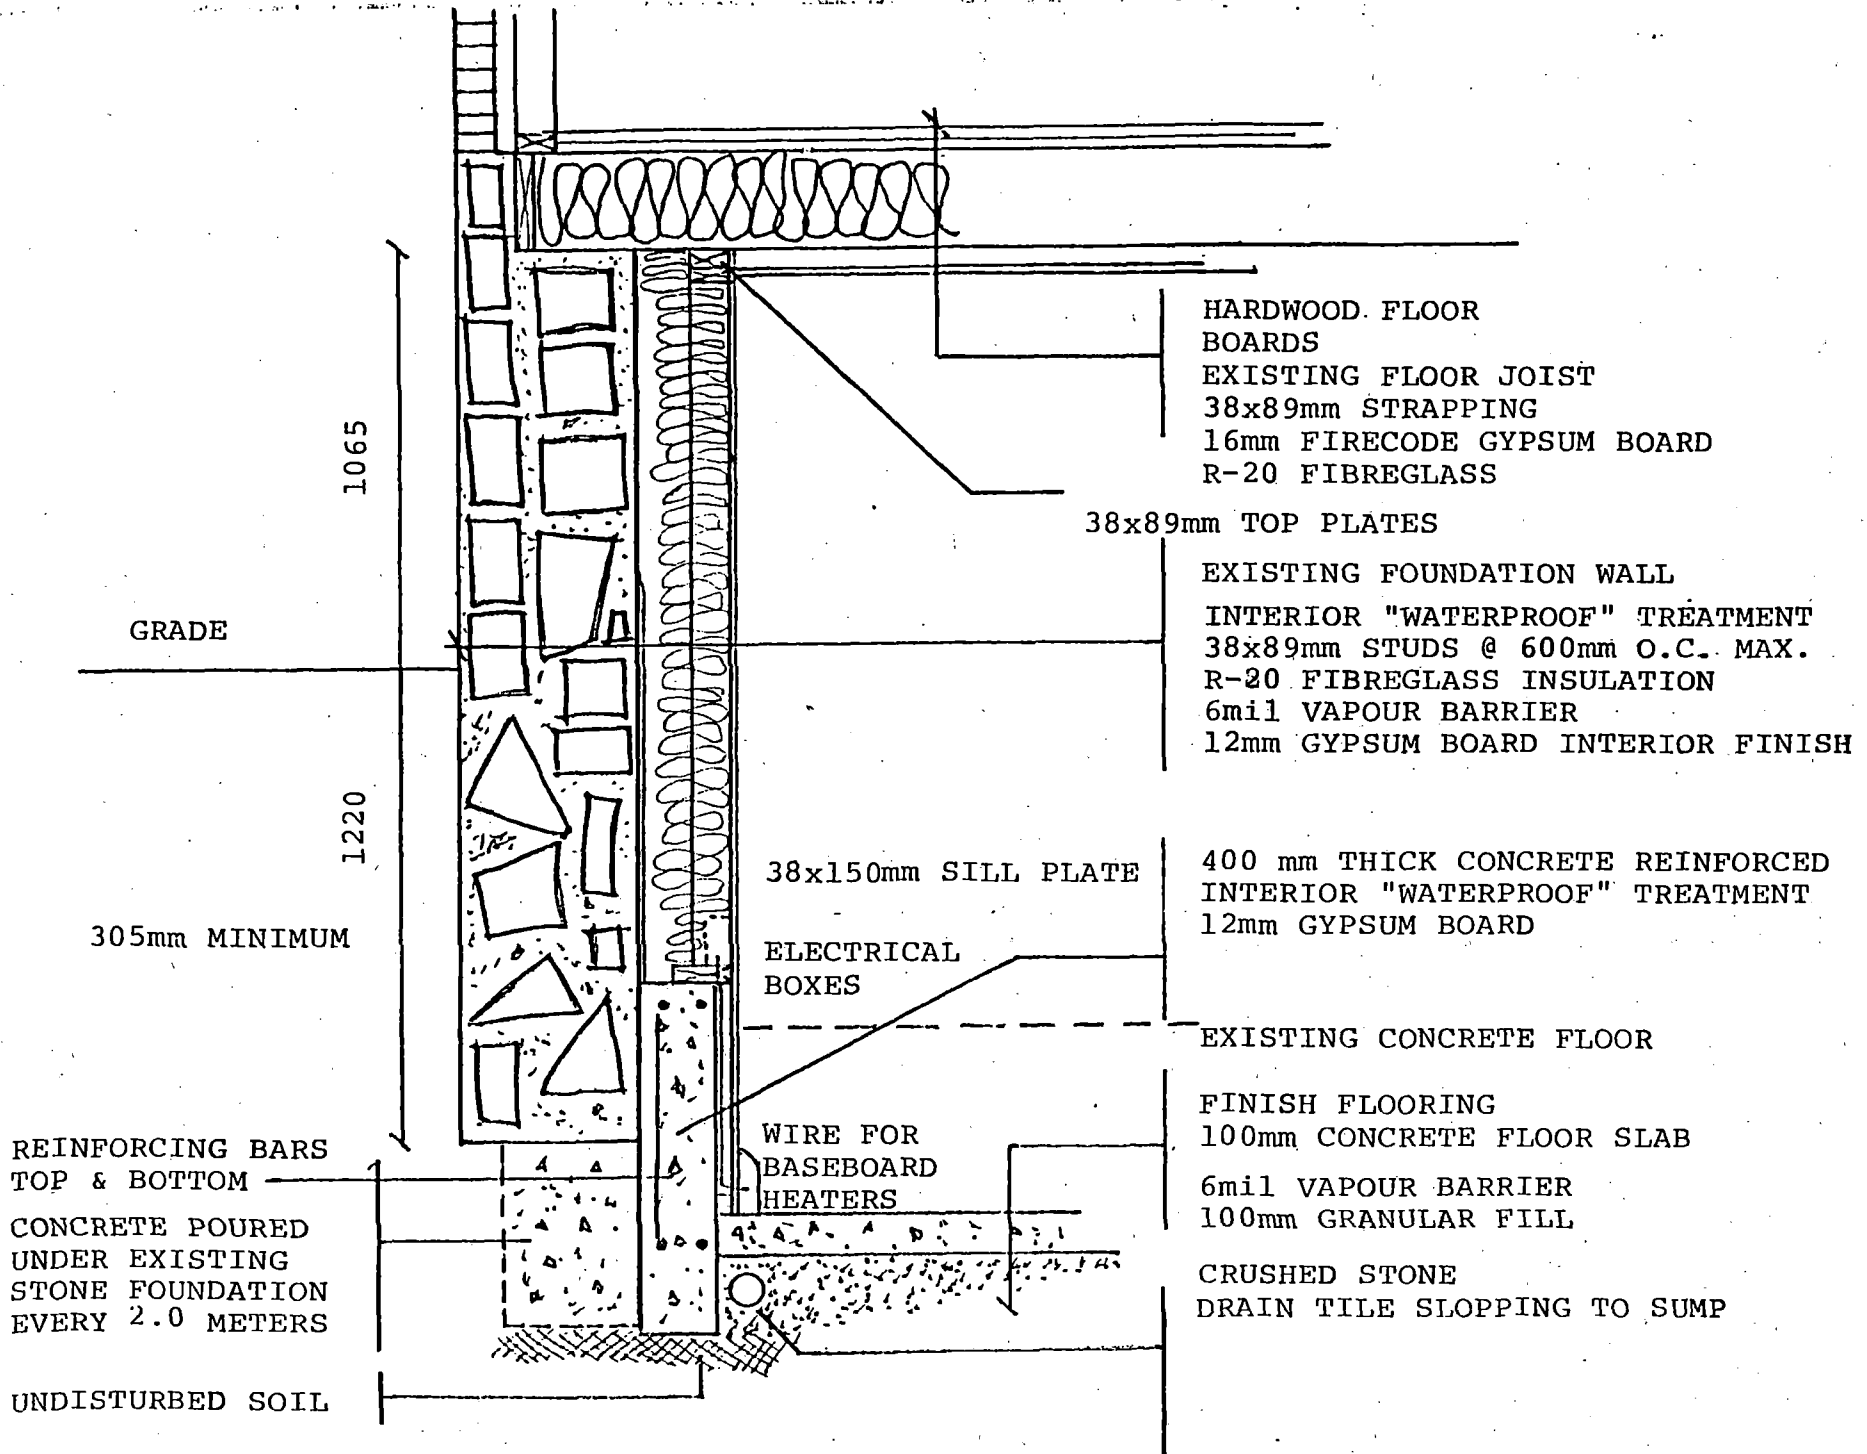
FIGURE 1

Exterior walls were framed with 38x89mm wood framing, with R.S.I. 3.5 batt installation, vapor barrier and 12mm painted drywall. (See Figure No. 1.)

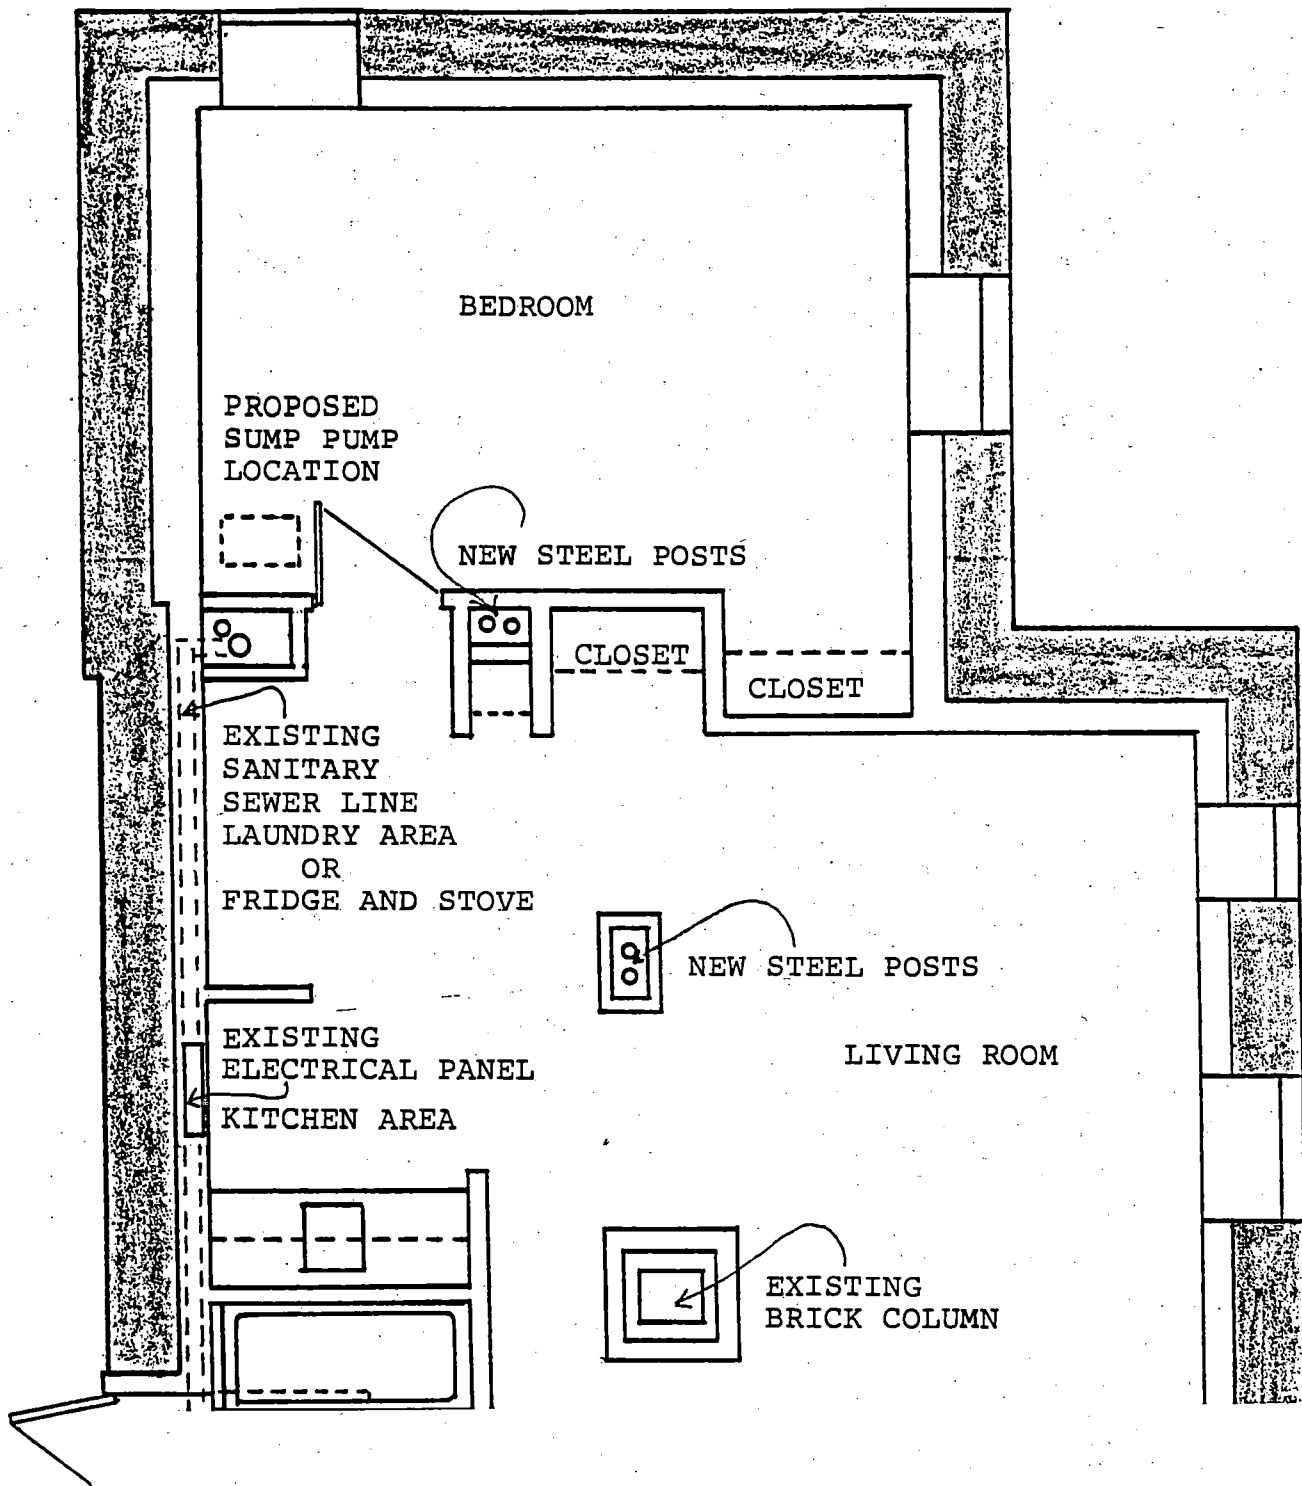
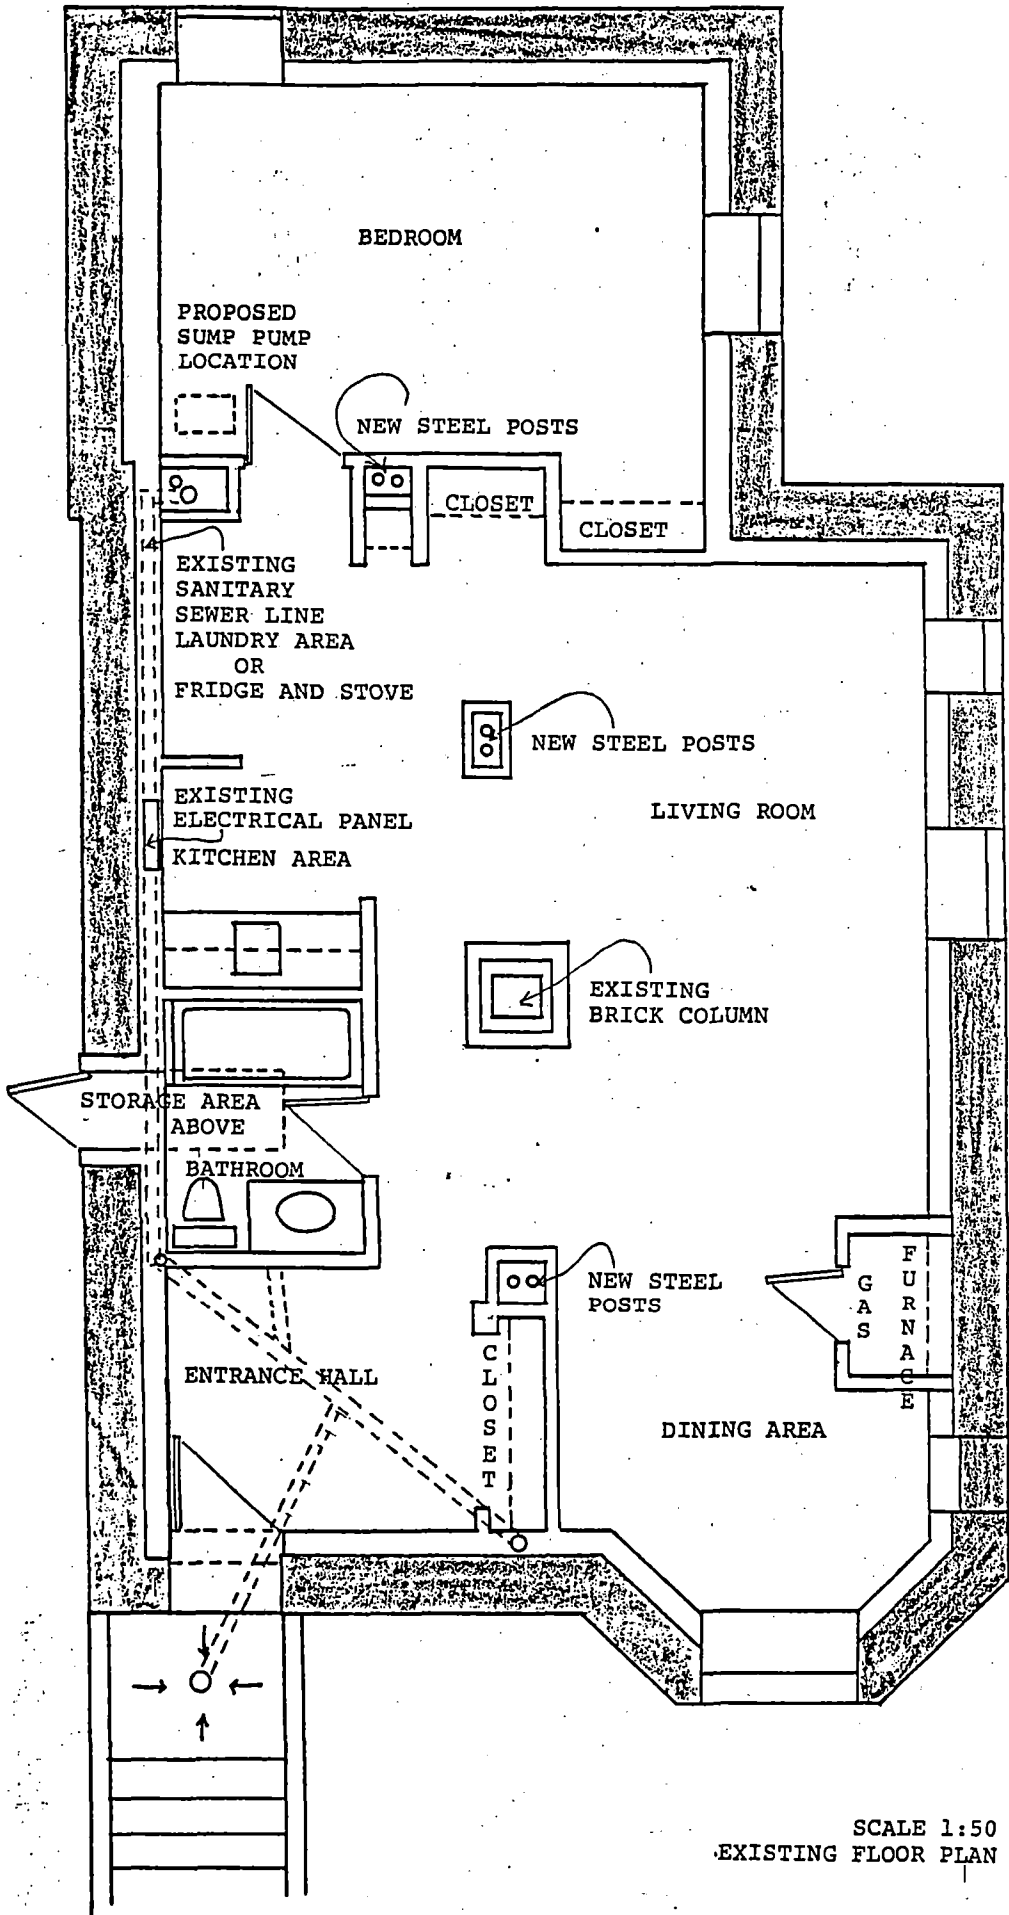
SCALE 1:50
EXISTING FLOOR PLAN

the perimeter, leaving about 100mm to 150mm of soil beyond and below the pier and then a reinforced concrete supporting collar around the supporting soil. Three brick columns were removed because of the obstruction they would have created. These brick columns were replaced with steel jack posts; two posts replaced each brick pier. The one existing brick column which remains, supports the main building support beam at mid span (See Figure No. 2).
