**RETROFIT AND  
REMEDIAL WORK ON  
EXISTING SLIDING  
DOORS AND  
WINDOWS**

By: Jozef Zorko, Desnoyers Mercure Inc.  
Dominic Chiovitti, Patenaude Chiovitti Inc.

9 June 1998

DMA: 96-81  
PC: RD-0102-A

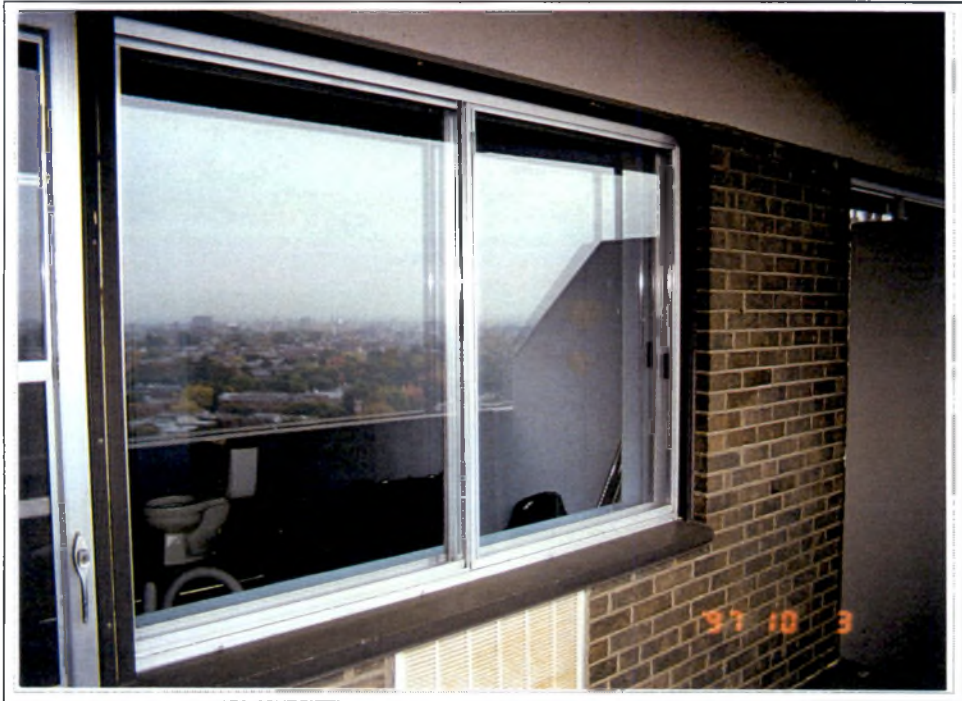
Photo # 1: Exterior view of aluminum sliding window at the L'Emminence apartment building. The unit is typical of the size and construction of the units studied.

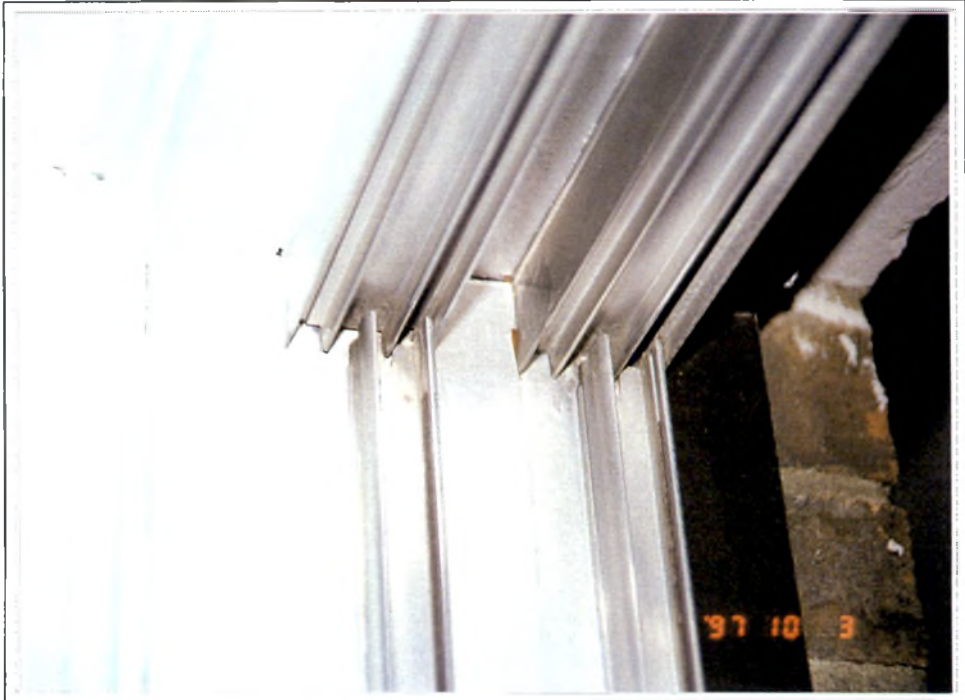
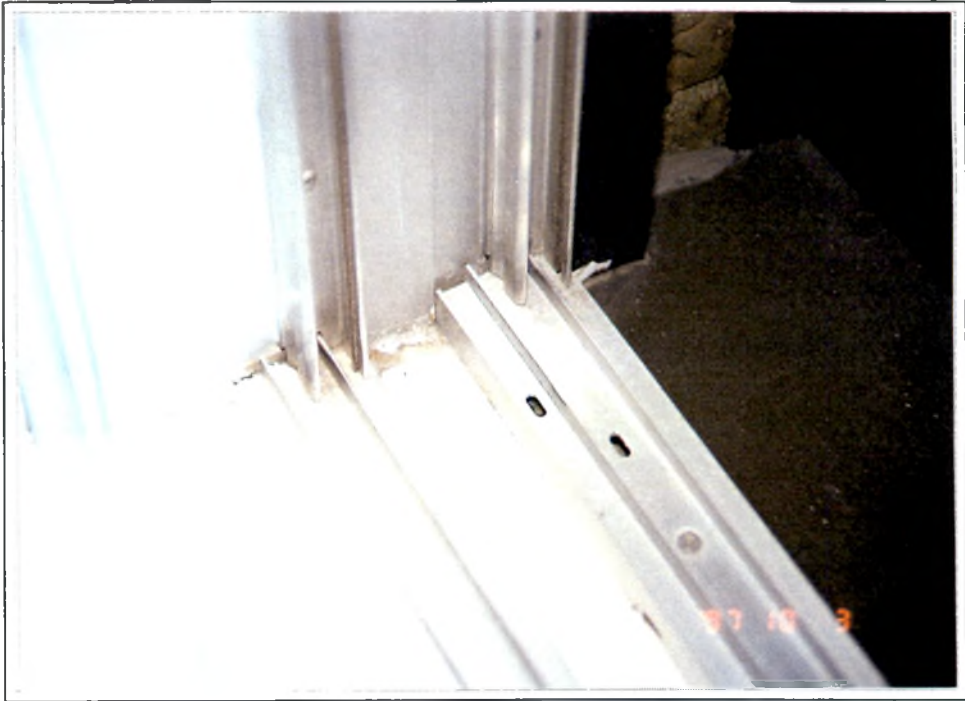
**Photos #3 & #4:** Views of head and sill condition showing the floating head track above and the weepholes at the sill track. Note the jamb weatherstripping which has dropped about 30mm permitting free air movement across the assembly.

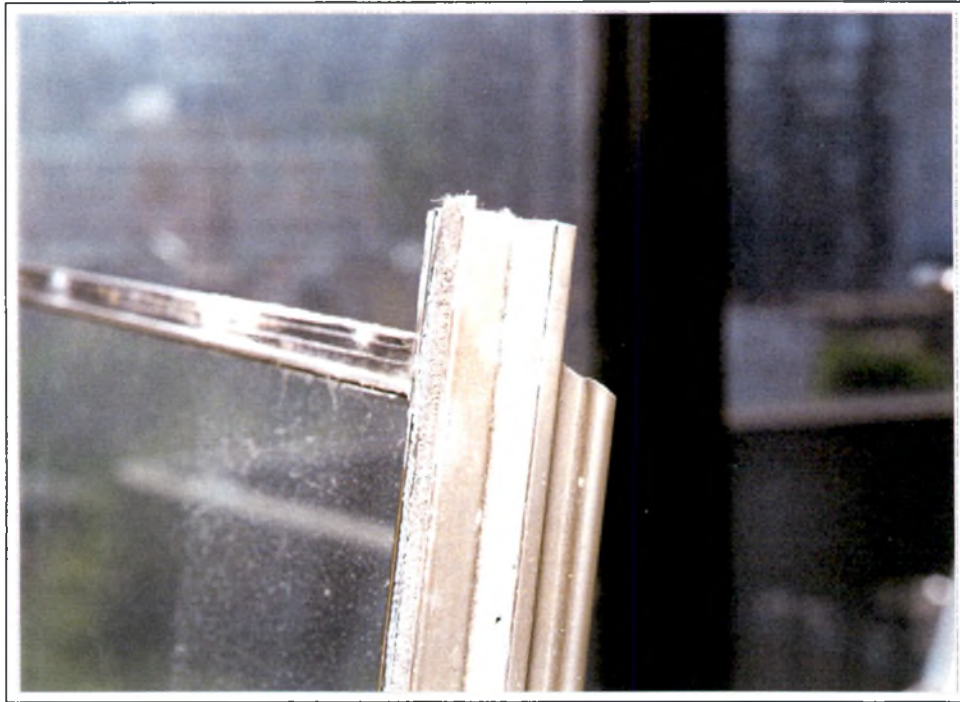
Photos #5: View of existing meeting rail weatherstripping at the La Cite Apartment test window.

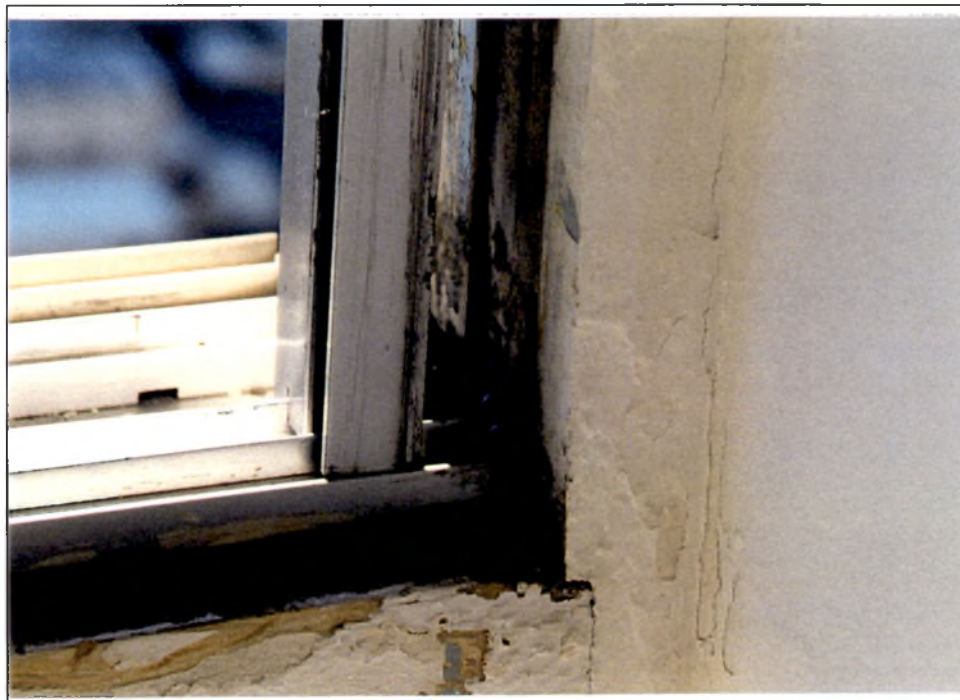
Photos #6: Existing sill/jamb condition at the St. Georges convalescent home. Note the severe deterioration of the wooden window frame due to prolonged water infiltration problems.

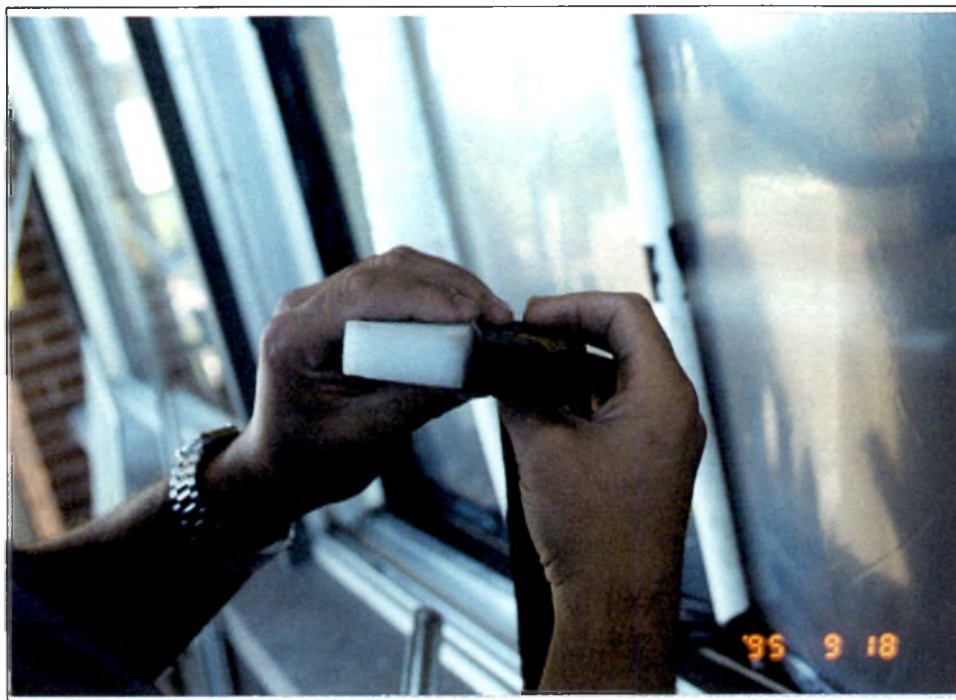
**Photos #7:** Comparison between a new pressure head sponge on the left, and the existing sponge from the MacDonald avenue apartments. The new foam provides for a much tighter seal at the window head and is wrapped to protect the foam from deterioration.

**Pressure head:** The existing foam at the pressure head (interior side) was removed and replaced by a new foam wrapped in a polyethylene film.

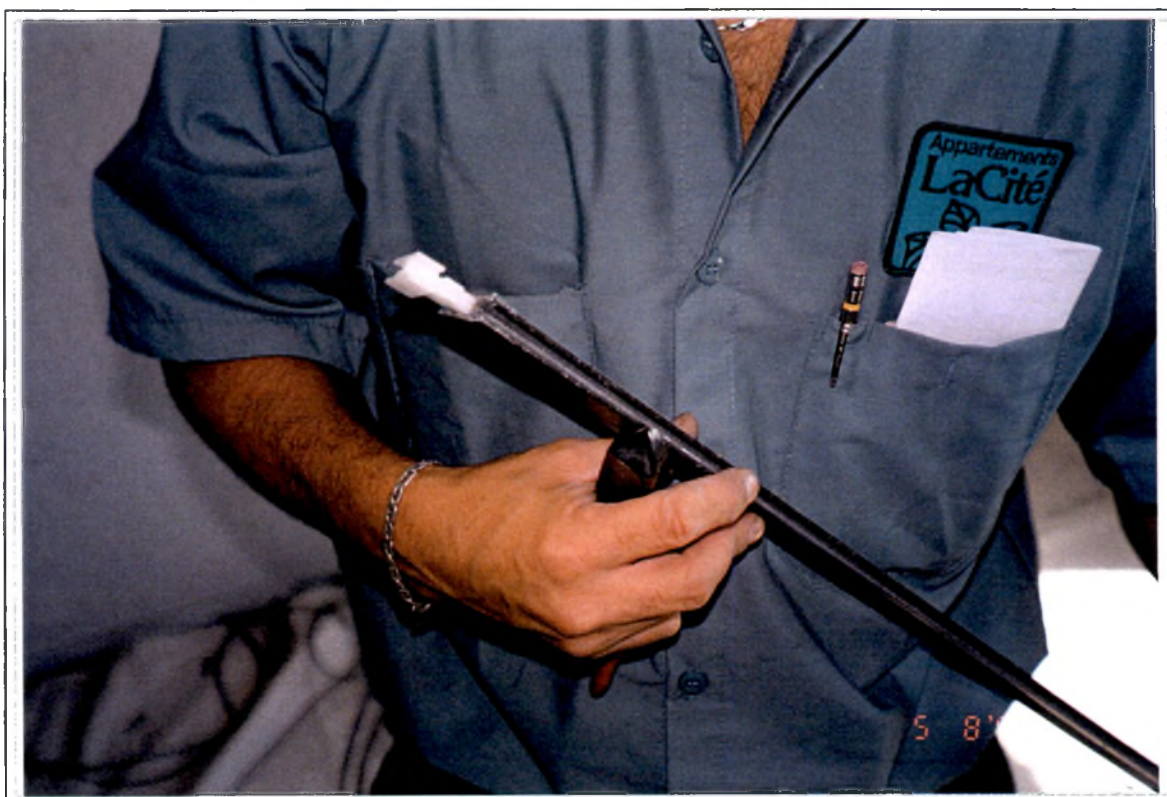
**Photos #8:** Maintenance worker from the La cite aptmnt complex holding a sash sill with newly installed weatherstripping. Note the plastic glider at the end of the sash sill.
