FIELD INVESTIGATION
OF
BRICK VENEER/STEEL STUD
WALL SYSTEMS

PREPARED FOR: MR. JACQUES ROUSSEAU
PROJECT MANAGER
PROJECT IMPLEMENTATION DIVISION
CANADA MORTGAGE AND HOUSING CORPORATION
682 MONTREAL ROAD
OTTAWA, ONTARIO
K1A 0P7

SUBMITTED BY: SUTER KELLER INC
1390 PRINCE OF WALES DRIVE
OTTAWA, ONTARIO
K2C 3N6

NOVEMBER 30, 1989

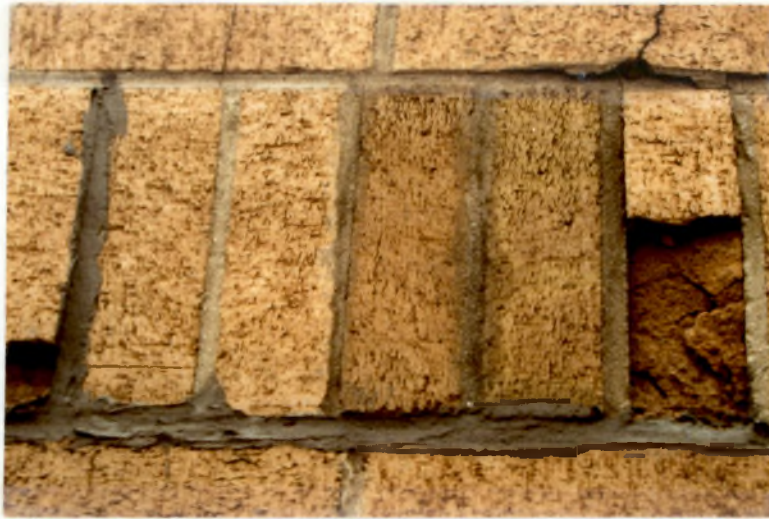
Fig. 3 Freeze/thaw damage at soldier course

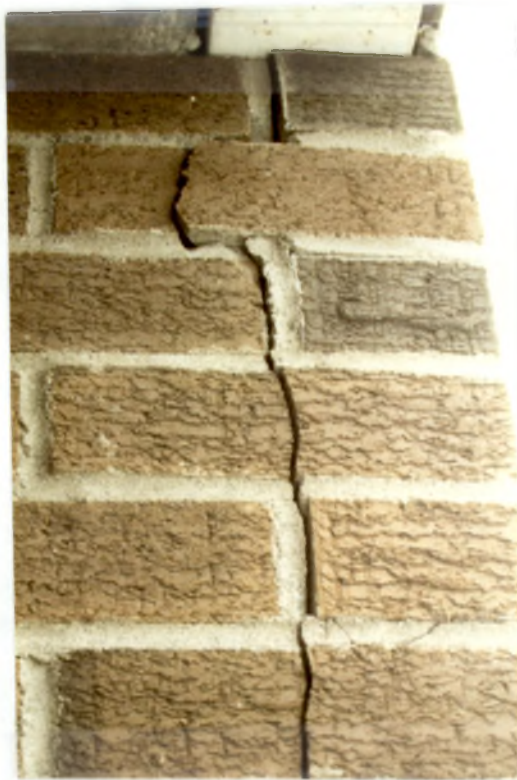
Fig. 4 Vertical cracking due to unintentional load transfer at balcony

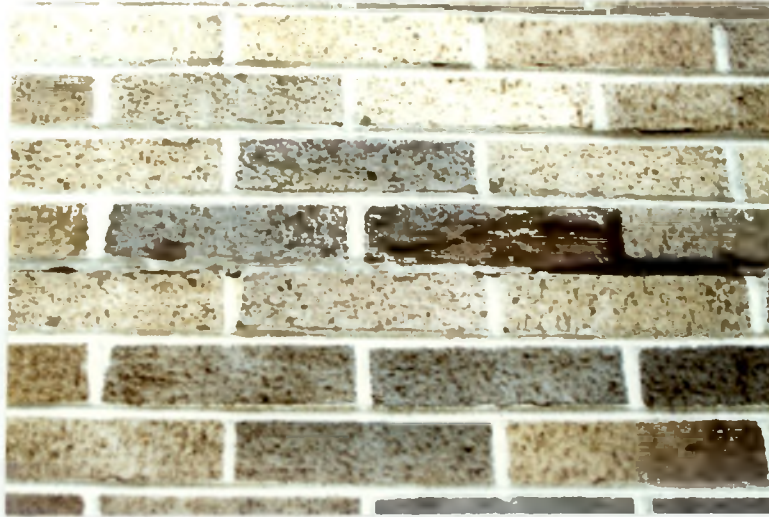
Fig. 5 Spalling of brick units at shelf angle location due to lack of a "soft" joint

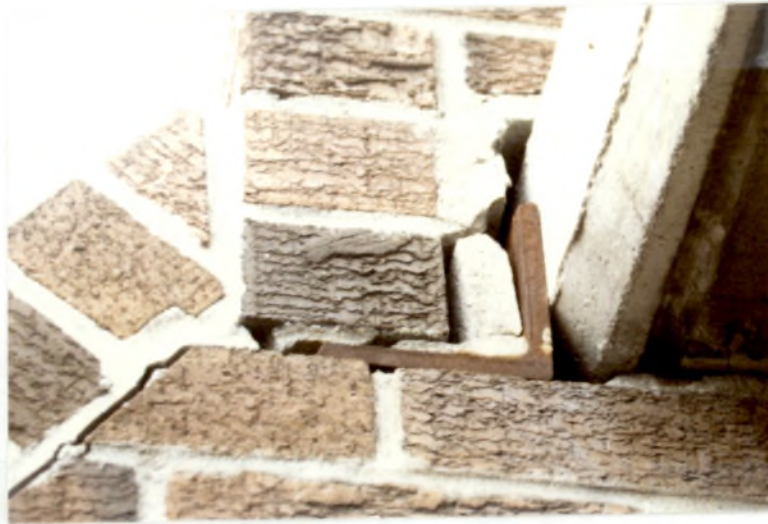
Fig. 6 Cracking of masonry due to poor detailing at balcony slab locations

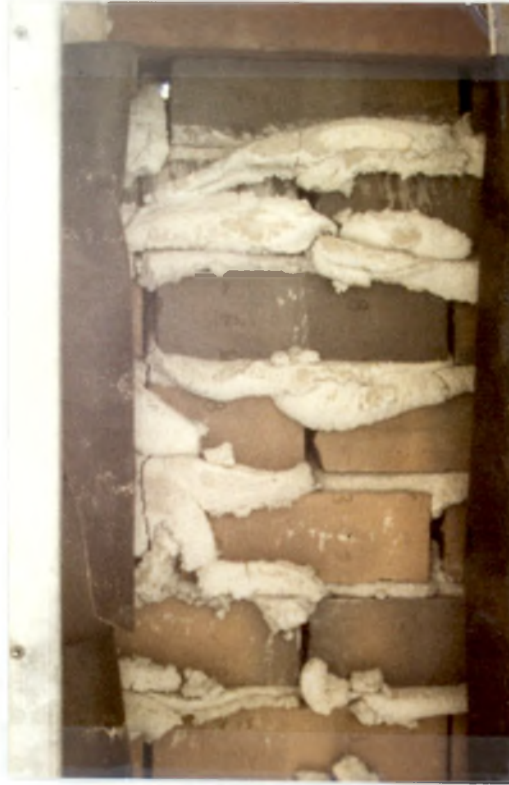
Fig. 7 Extensive mortar protrusions and poorly filled head joints.

construction. Poorly filled head joints, excessive mortar protrusions into the cavity and extensive mortar droppings on brick ties and at the flashing levels were frequently encountered. Examples are shown in Figs. 7 and 8.

- All efforts should be made to keep the cavity clear and to ensure that weepholes at the bottom of the wall can function properly.

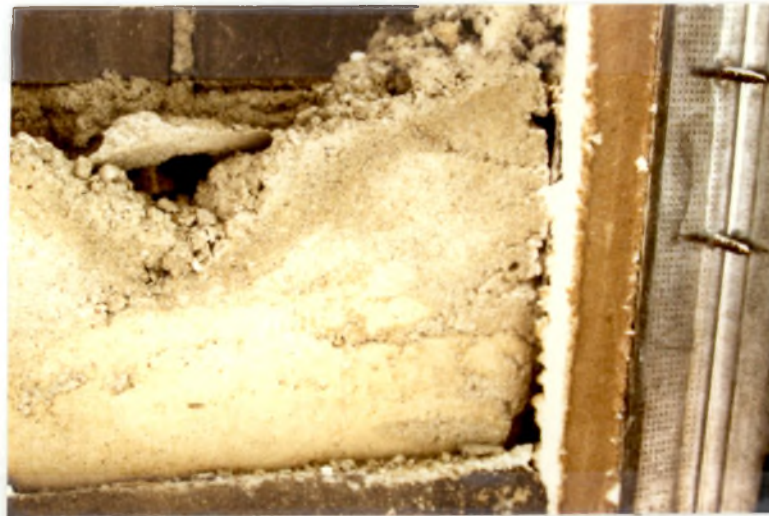
Fig. 8 Extensive mortar droppings at floor levels

The cavity space typically was found to be too small and partially filled with mortar fins and mortar droppings at the bottom of the wall. This condition not only restricts the circulation of air in the cavity but the bridging of the air space by mortar fins and droppings provides potentially large paths for moisture movement across the cavity to the backup wall. In order to minimize bridging by mortar fins and improve drainage and air circulation in the cavity a minimum air space of 50 mm is recommended.

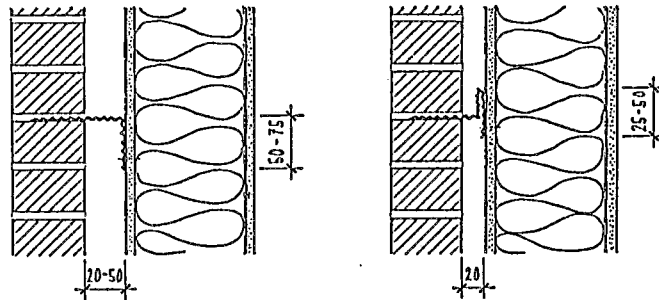
Fig. 9 Frequent strip tie installation

The condition of the brick ties varied from building to building. Strip ties generally showed corrosion at the brick/cavity interface or where in contact with mortar, i.e. if covered with mortar droppings as seen typically in Fig. 10. Adjustable ties were generally in satisfactory condition but corrosion was also evident in some instances especially at the brick/mortar interface.

- The practice of using ordinary strip ties to fasten the brick veneer should be discontinued. It is noted here that CSA Standard CAN3-A370-M84 (1) does not permit the use of standard corrugated strip ties to connect brick veneer in buildings exceeding 11 m (36 ft.) in height.

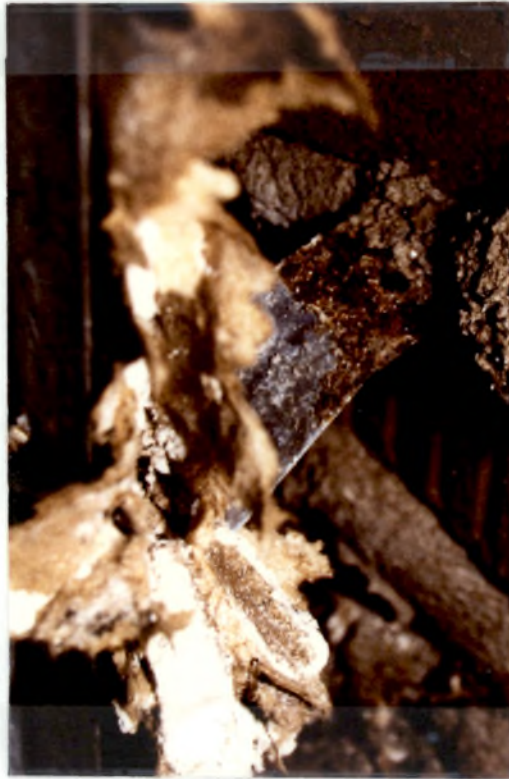
Fig. 10 Showing corroded strip tie after removal of mortar droppings

Our visual observations and metallurgical analysis have shown that brick ties are often corroded and where strip ties have been used their service life appears to be significantly shortened regardless of climatic region. The problem of early deterioration of brick ties appears to be related primarily to the presence of chlorides in the water and the minimal amount of corrosion protection currently specified on brick ties. The problem is obviously aggravated by the frequent presence of moisture in the mortar joints and the cavity.

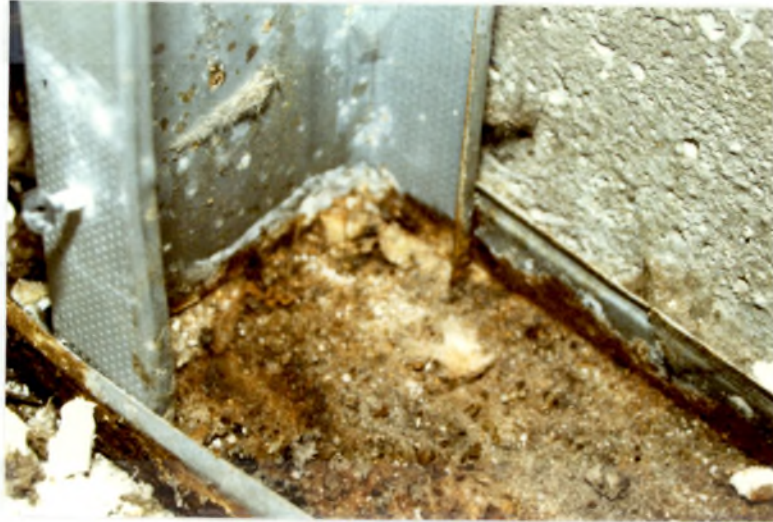
In general, steel studs were found to be in satisfactory condition. Only traces of corrosion were noticed in some cases except for one building in St. John's where the studs on some walls exhibited considerable corrosion. There were however cases where the bottom tracks exhibited extensive corrosion in the investigation areas. An example of bottom track deterioration is shown in Fig. 11.

Fig. 11 Bottom track corrosion as seen in St. John's, Toronto and Calgary

Where corrosion has been noticed, bottom tracks were the first ones to be affected.

- All efforts should be made to keep moisture out of the backup wall system. Evidence has shown that the key factor leading to deterioration is moisture, whatever its source.
