AIR TRANSPORTATION SAFETY INVESTIGATION REPORT A17C0146

LOSS OF CONTROL AND COLLISION WITH TERRAIN

Avions de Transport Régional ATR 42-320, C-GWEA

Fond-du-Lac, Saskatchewan

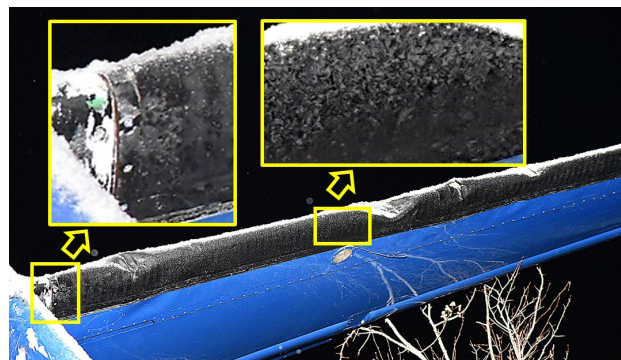
Although there was no observable precipitation or fog while the aircraft was on the ground, weather conditions were conducive to ice or frost formation. This, combined with the residual mixed ice on the aircraft, which acted as nucleation sites that allowed the formation of ice crystals, resulted in the formation of additional ice or frost on the aircraft's critical surfaces.

Figure S1. Ice contamination on leading edge of left horizontal stabilizer following the accident (Source: Royal Canadian Mounted Police, with TSB annotations)

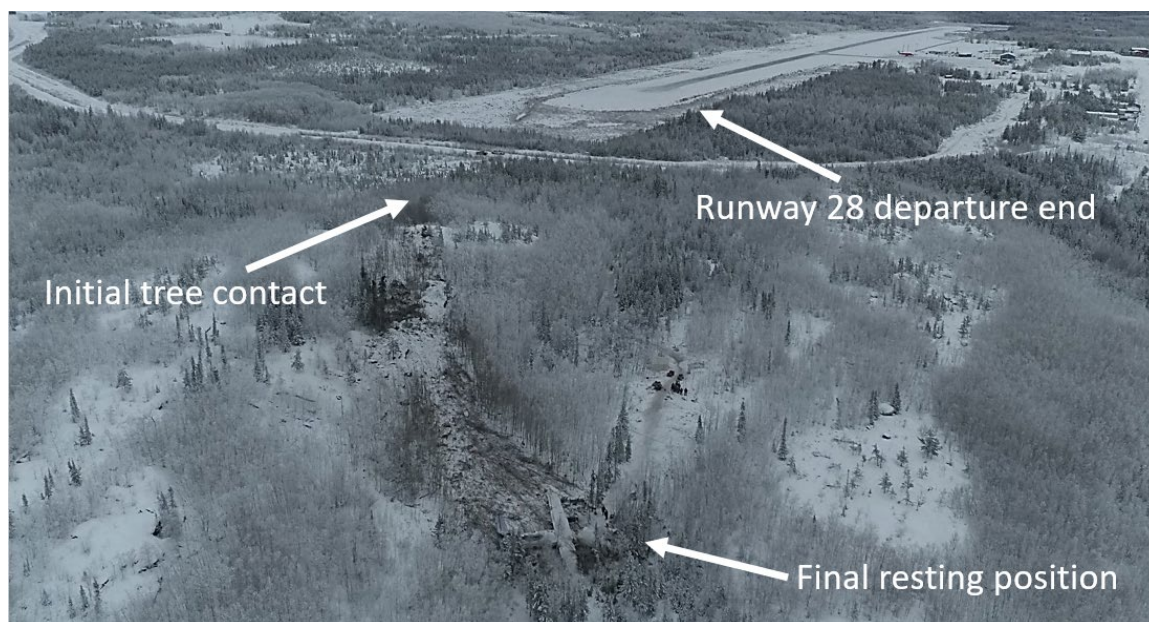
Figure S2. Aerial view of occurrence site (Source: Royal Canadian Mounted Police, with TSB annotations)

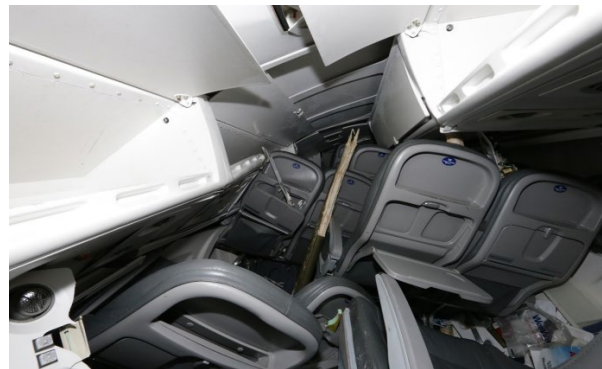
The reduced survivable space between the floor above the main landing gear and the collapsed upper fuselage caused crushing injuries, such as major head, body, and leg trauma, to passengers in the middle-forward left section of the aircraft. Of the 3 passengers in this area, 2 experienced, serious life-changing injuries, and 1 passenger subsequently died.

Figure S3. Image of the displaced cabin seats
(Source: TSB)

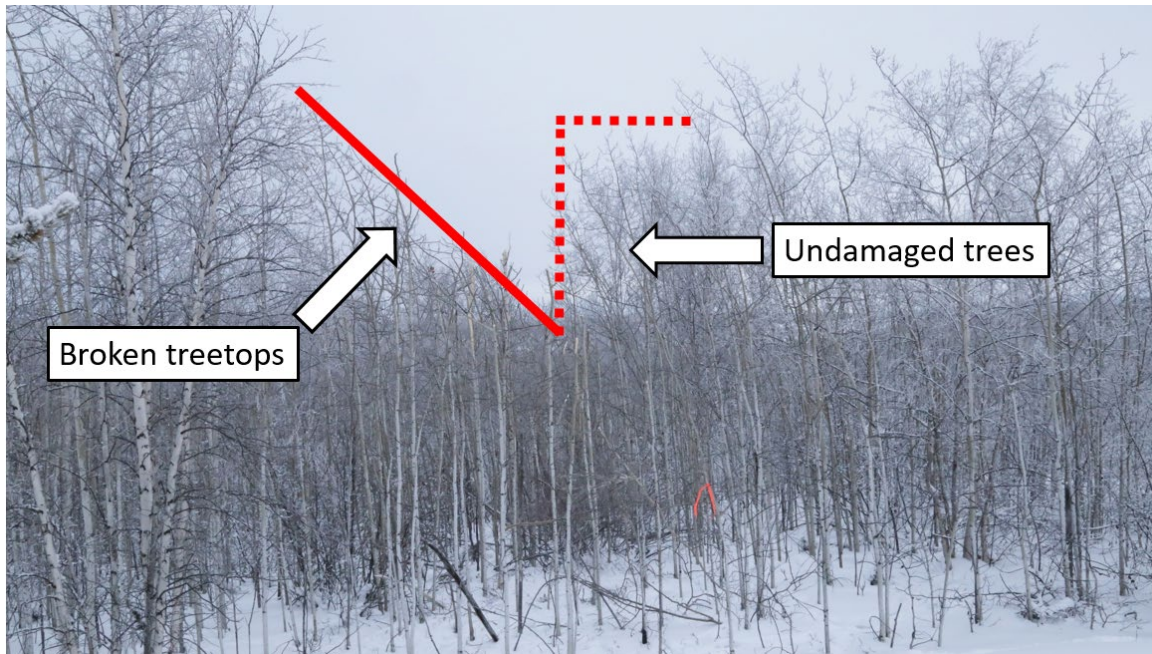
Figure 7. Photo of initial impact with trees (image facing towards the airport and showing the aircraft's bank angle at the time of impact) (Source: TSB)

The aircraft made initial ground contact about 20 m following these tree strikes, on a track of approximately 258°T, which matched the track through the trees.

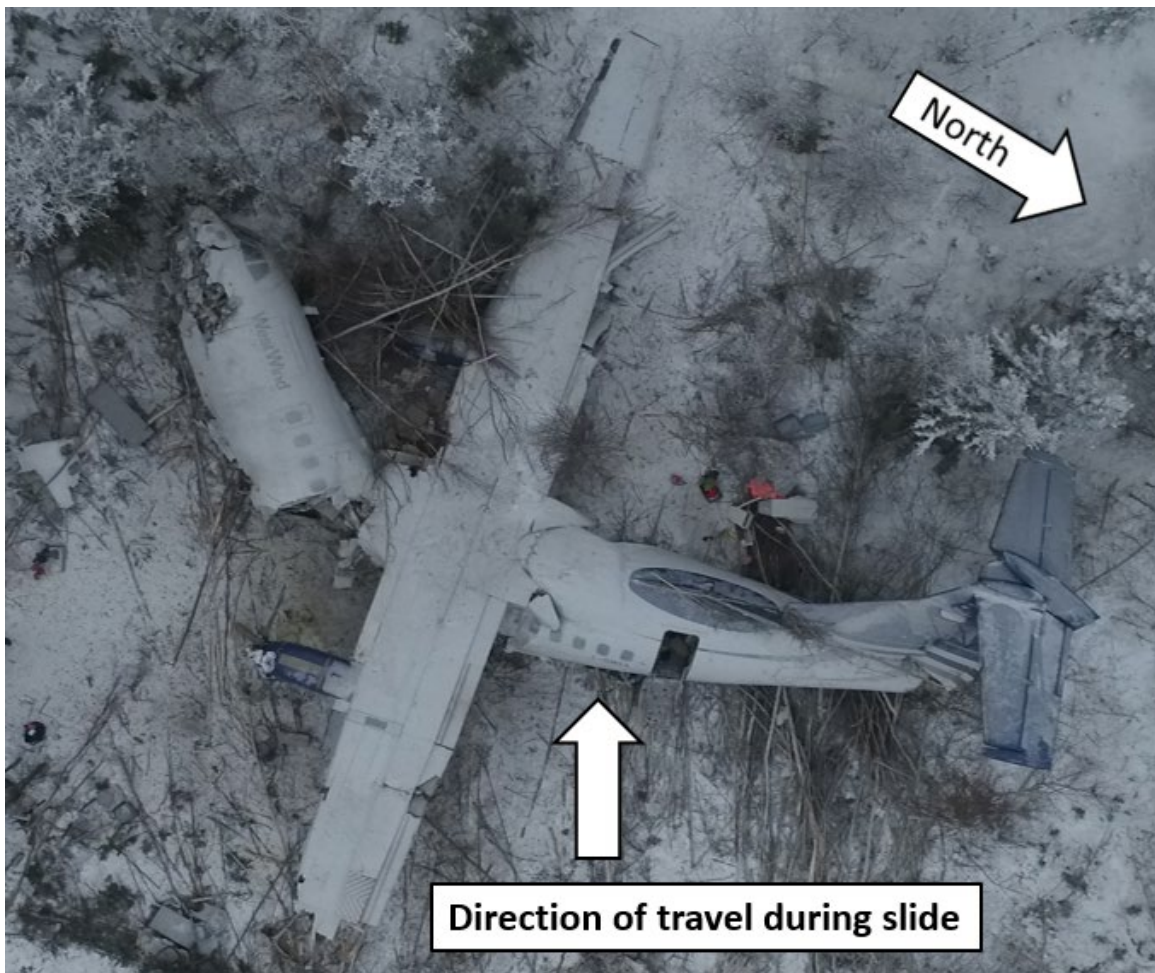
Figure 9. Photo of aircraft wreckage, as seen from above (Source: Royal Canadian Mounted Police, with TSB annotations)

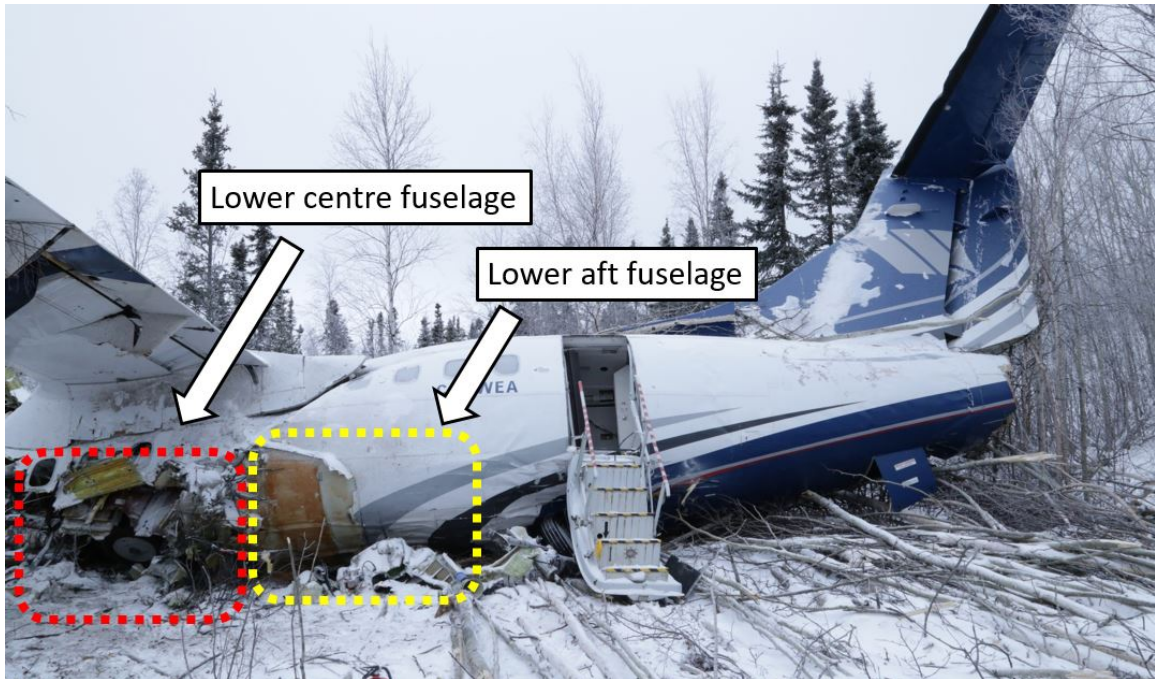
Figure 11. Left side view of the lower centre and aft fuselage sections of the aircraft at the crash site
(Source: TSB)

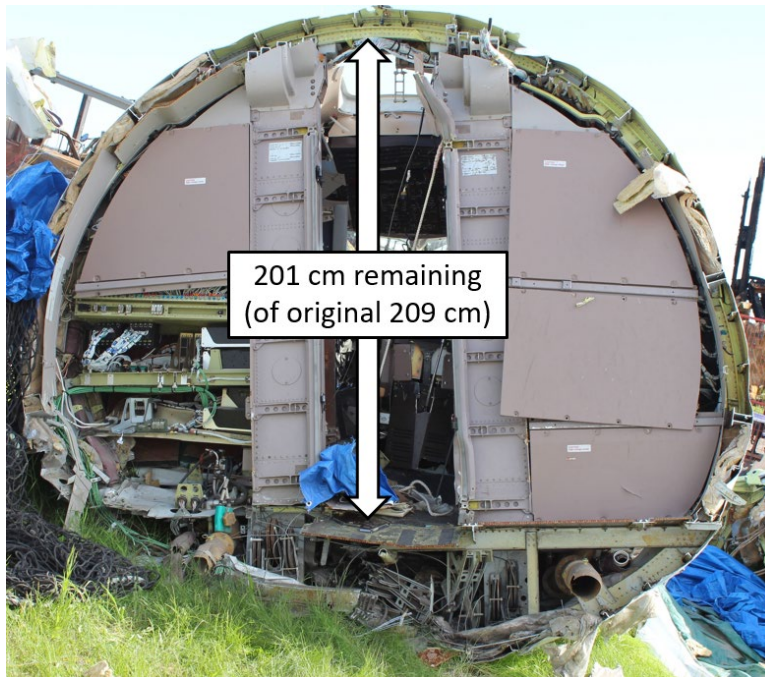
Later off-site examination of the forward fuselage section, just aft of the cockpit, showed that the left bottom area of the fuselage and the stanchions underneath the floor were crushed to some extent.

Figure 12. Cross-sectional view of the forward fuselage, just aft of the cockpit, looking forward, from later off-site examination (Source: TSB)
