Transportation
Safety Board
of Canada

AIR TRANSPORTATION SAFETY INVESTIGATION REPORT A20Q0015

CONTROLLED FLIGHT INTO TERRAIN

Service aérien gouvernemental of Quebec
Bell 206L-4 (helicopter), C-GSQA
Lac Saint-Jean, Quebec
22 January 2020

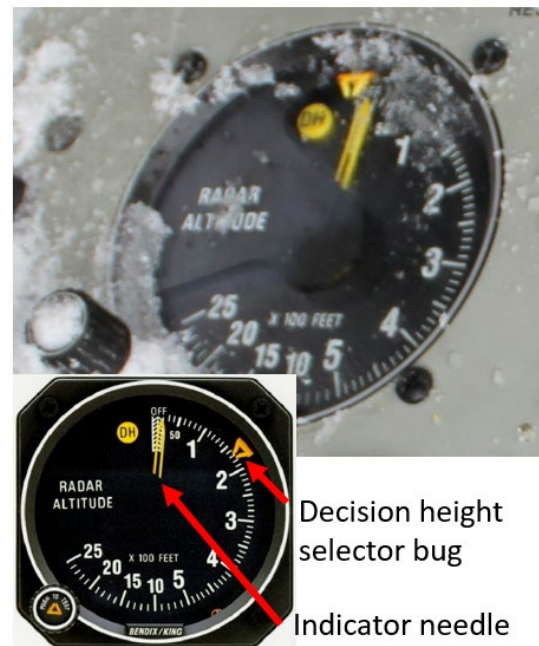
Figure 2. Radio altimeter on the occurrence aircraft (Sources: TSB [main image] and manufacturer's brochure [inset image])

A decision height selector bug allows the pilot to choose a minimum height (Figure 2). If the aircraft descends below the selected minimum height, a light illuminates and an alarm sounds to notify the pilot. The decision height selector bug on the radio altimeter found at the accident site was set to 0 feet.

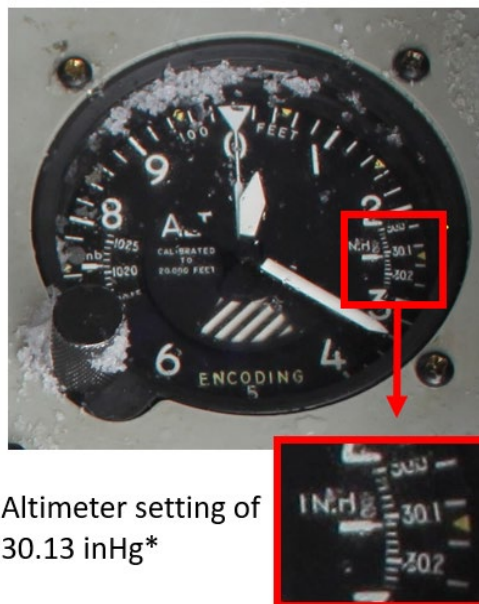
Figure 3. Conventional altimeter on the occurrence aircraft (Source: TSB)

Tests performed on the conventional altimeter at the TSB Engineering Laboratory in Ottawa, Ontario, showed that the margin of error for the altitude indication was 20 feet or less for simulated altitudes below 500 feet, which is within the allowable margin of error for the instrument according to *Canadian Aviation Regulations* (CARs) Standard 571.⁴

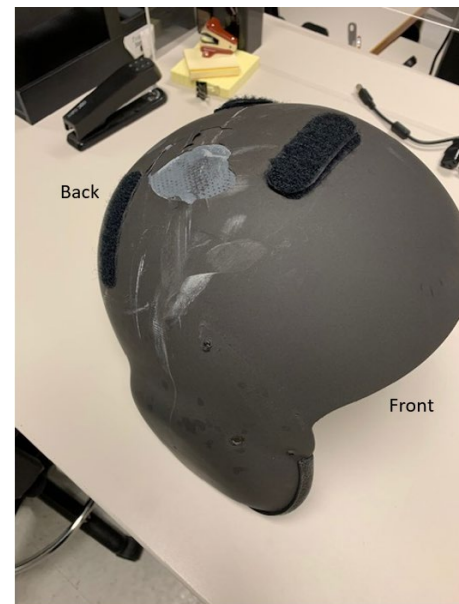
Figure 7. Impact marks on top of the pilot's helmet (Source: SAG, with TSB annotations)

Marks found on the top of the helmet shell indicate that a major shock occurred in that area (Figure 7). The TSB has previously highlighted the importance of wearing a helmet to prevent fatal injuries or to reduce the effects of non-fatal head injuries received in an accident.¹⁸ These effects may vary from confusion to complete loss of consciousness.

Wearing a flight helmet and fastening the 4-point shoulder harness helped to reduce the severity of the injuries to the pilot, who was able to egress from the aircraft and contact the dispatcher to get help quickly.

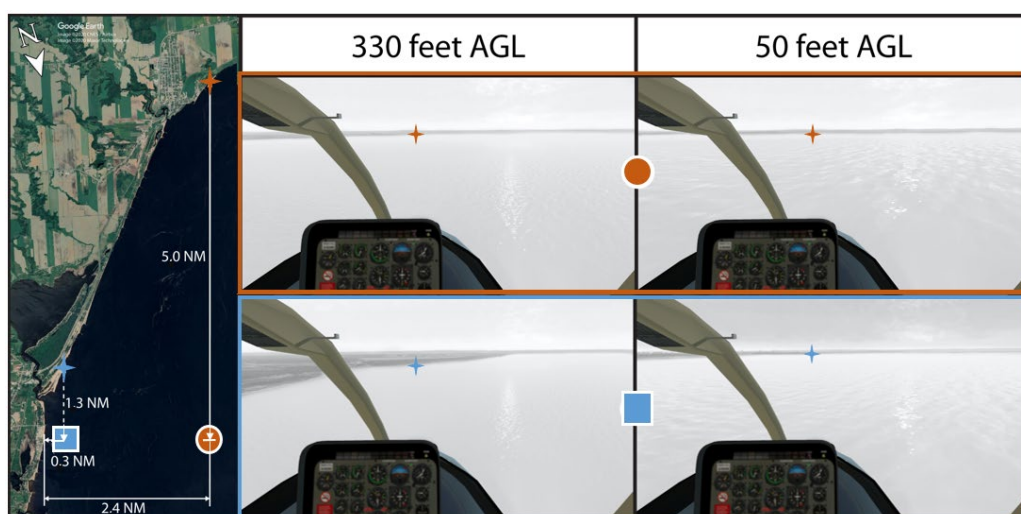
Figure 8. Simulated view of the shoreline from the cockpit at 330 feet above ground level and 50 feet above ground level when the aircraft is 2.4 nautical miles and 0.3 nautical miles from the shoreline (Source: TSB)

Figure 8 illustrates a simulated view of the shoreline from the cockpit at 2 different altitudes—330 feet AGL and 50 feet AGL—when there is no contrast at the surface. The top 2 images represent the view from the accident location (2.4 NM from the shoreline), and the bottom 2 images represent the view from a distance closer to the shoreline (0.3 NM), for comparison purposes.

When the aircraft is 2.4 NM from the shoreline, the shoreline has the same profile at both altitudes, which shows that, at these 2 altitudes, a lateral distance of 2.4 NM is too great to be able to notice a loss of altitude if the shoreline is the sole visual reference being used. However, when the aircraft is at a lateral distance of 0.3 NM, the amount of shoreline that can be seen decreases with a loss of altitude.

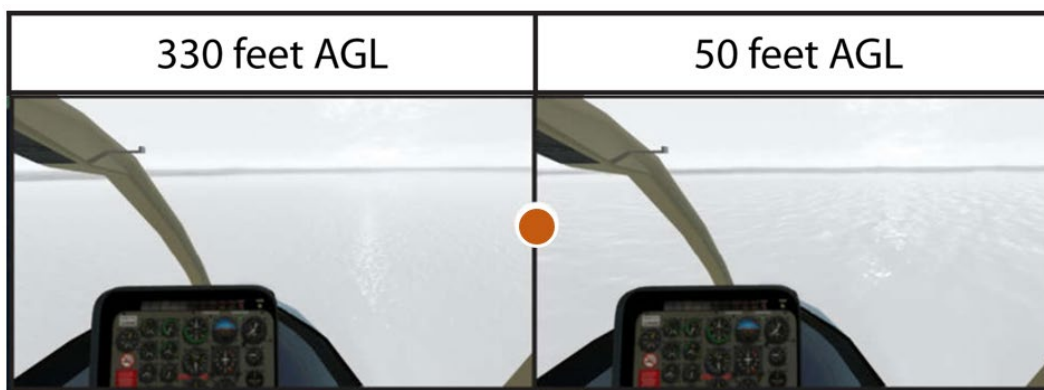
Figure 9. Simulated view of the shoreline from the cockpit at 330 feet above ground level and 50 feet above ground level when the aircraft is 2.4 nautical miles from the shoreline (Source: TSB)

According to the simulated view of the shoreline from the cockpit at 330 and 50 feet AGL (Figure 9), without any contrast at the frozen surface of the lake, and once the islands had been passed, the appearance of the shoreline would change very little because the lateral distance would be too great to notice a loss of altitude at these heights if the shoreline was the only visual reference used.
