AIR TRANSPORTATION SAFETY INVESTIGATION REPORT A21C0052

LOSS OF CONTROL AND COLLISION WITH TERRAIN

Helicopter Transport Services (Canada) Inc.
Bell 214ST (helicopter), C-GDYZ
Nipigon, Ontario, 14 NM NE
07 June 2021

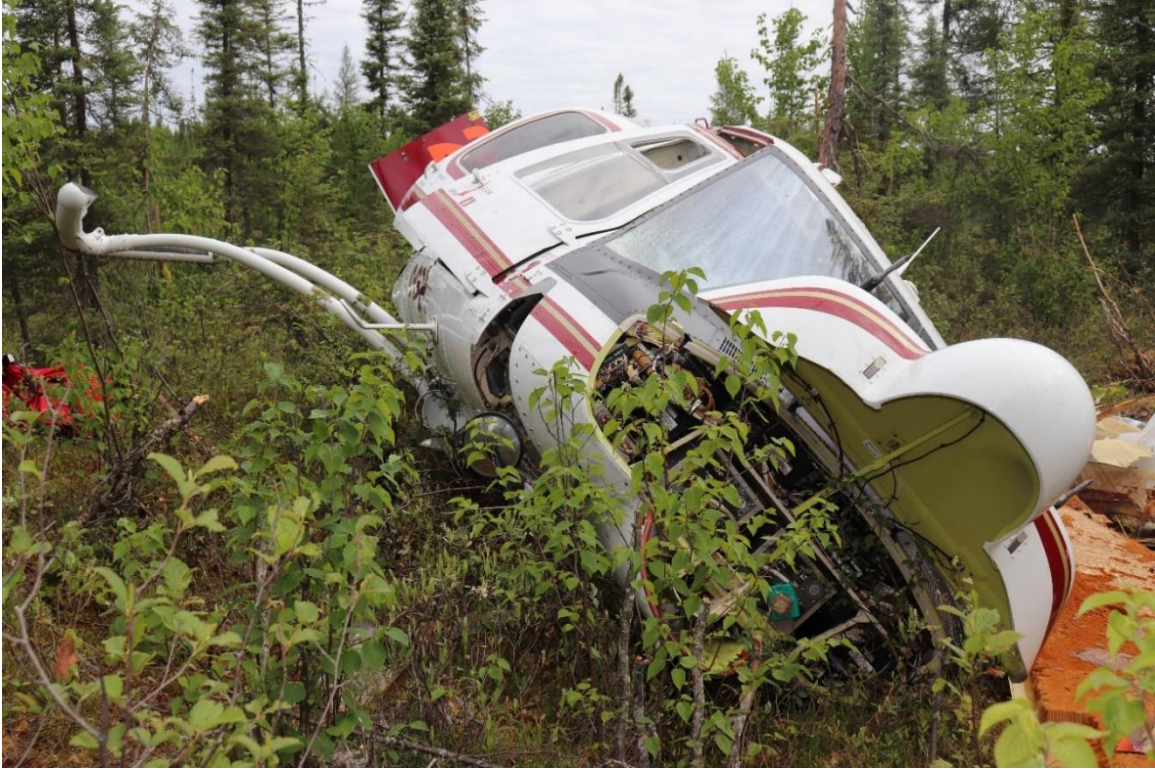
Figure 1. The occurrence aircraft during recovery preparations (Source: TSB)

The helicopter landed on its left skid gear and came to rest leaning to the left on soft, boggy terrain. The skid gear cross tubes had been pushed 2 feet to the right from their normal position in the saddle mounts. The trailing edge of 1 tail rotor blade was damaged; however, there was no indication that the tail rotor was rotating at impact.

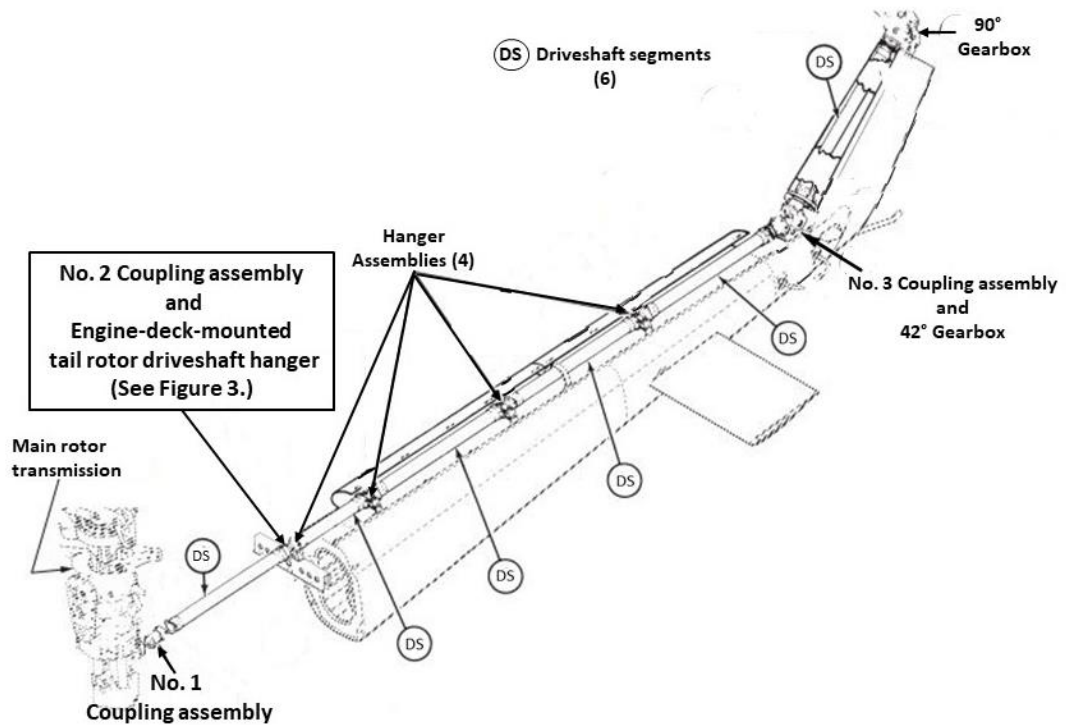
Figure 2. Tail rotor drivetrain (Source: Bell, with TSB annotations)

The tail rotor drivetrain consists of 6 driveshaft segments, 4 hanger assemblies, 3 coupling assemblies, 5 disc assemblies, and 2 gearboxes (42° and 90°) at the base and tip, respectively, of the vertical stabilizer (Figure 2). The coupling assemblies and disc assemblies provide axial and angular flexibility.

Each of the 2 gearboxes is self-lubricated by an internal oil pump and is monitored by a chip detector, temperature switch, and low oil-pressure switch. A separation of the tail rotor drivetrain in front of the 42° gearbox will cause an immediate loss of oil pressure in both gearboxes. As a result, the 42° BOX OIL PRESS and 90° BOX OIL PRESS annunciators on the main warning and caution panel will illuminate.

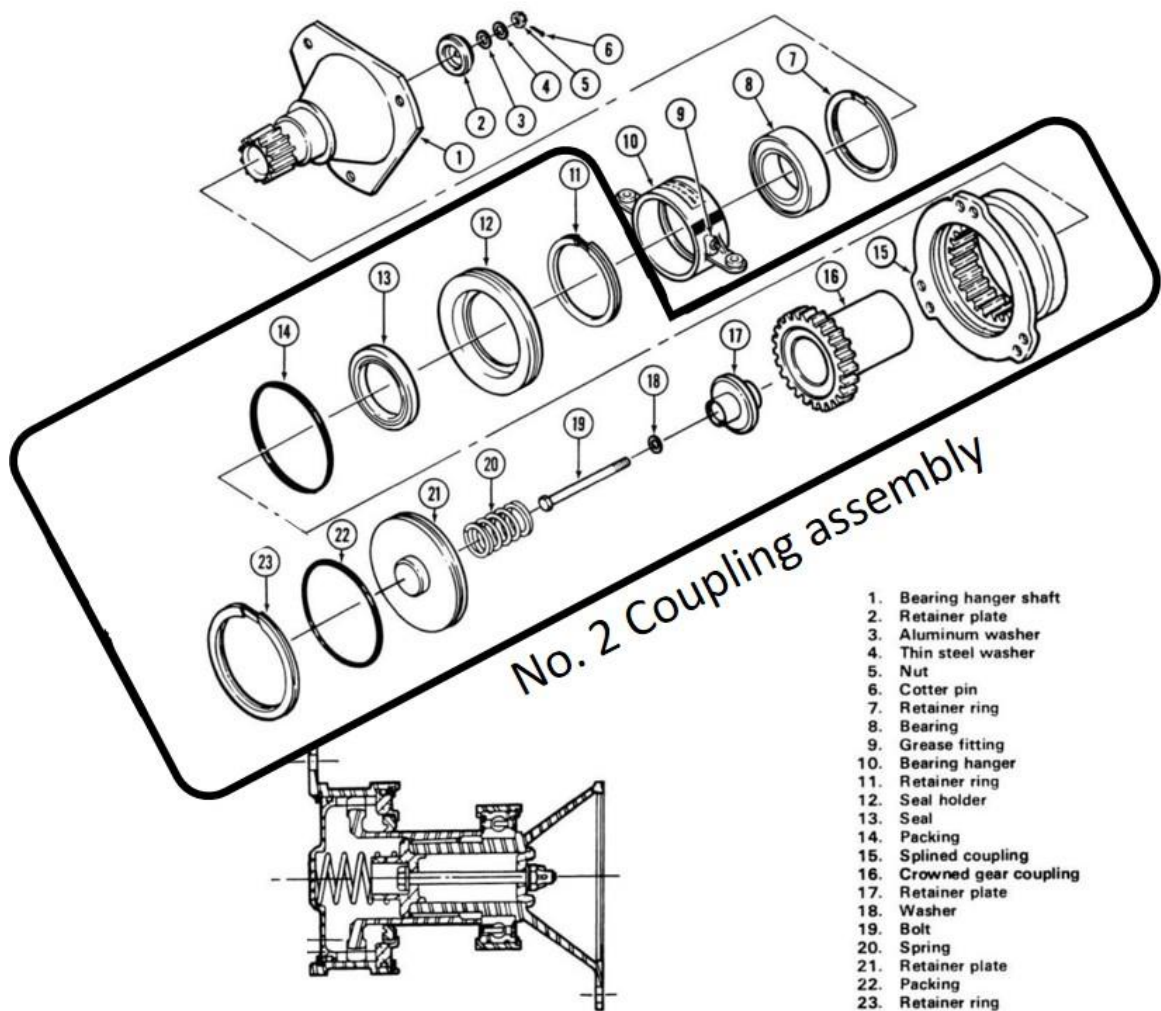
Figure 3. Exploded view of the engine-deck-mounted tail rotor driveshaft hanger (Source: Bell, with TSB annotations)

Figure 3 shows in detail the engine-deck-mounted tail rotor driveshaft hanger and the No. 2 coupling assembly.² The forward flange of the splined coupling (item 15) is bolted to the aft end of the first driveshaft segment. The splined coupling houses, and meshes with, the crowned gear coupling (item 16), which has an output shaft that extends through the seal holder (item 12). The seal holder is retained in the splined coupling via a retainer ring (item 11).

The splined coupling (Figure 3, item 15) on the aft end of the first driveshaft segment was found disconnected from the crowned gear coupling (Figure 3, item 16) of the engine-deck-mounted tail rotor driveshaft hanger. The first driveshaft segment exhibited rotational scoring as a result of flailing and consequent contact with components in the fuselage compartment.

A retainer ring (Figure 3, item 11), which should normally secure the seal holder (Figure 3, item 12) and crowned gear coupling within the splined coupling, was found lying loose in the fuselage compartment. The seal holder had exited the splined coupling and was loose on the shaft between the crowned gear coupling and the bearing hanger (Figure 3, item 10).

The retainer ring (Figure 3, item 11) is a spiral of approximately 690° made of flat spring steel that seats into a groove machined into the inner diameter of the splined coupling. The retainer ring secures the seal holder, and thus the crowned gear coupling, within the splined coupling.

The dimensions of the retainer ring groove were examined using a coordinate measuring machine, a digital comparator, and optical scanning at a manufacturer’s facility. According to specifications, the retainer ring groove in the splined coupling should be between 0.068 inch and 0.073 inch wide. The retainer ring was 0.062 inch thick. This would result in a free space from 0.006 inch to 0.011 inch between the retainer ring and the edge of the groove.

This suggests that a foreign object, or debris, thicker than 0.011 inch trapped between the spiral layers of the retainer ring could prevent the retainer ring from seating. However, an examination of the retainer ring could not determine whether a foreign object or debris had been trapped between the retainer ring layers.

The occurrence retainer ring was deformed to the extent that the spiral would no longer lie flat. This was likely due to rotational forces and impact with the flailing splined coupling after becoming dislodged. The retainer ring did not appear to be worn, and its outside diameter compared favourably with the exemplar retainer ring.

For an undetermined reason, the retainer ring was dislodged from the splined coupling. Subsequent movement of the main rotor transmission resulted in axial movement of the driveshaft. The seal holder, and ultimately the crowned gear coupling, exited the splined coupling, at which point the tail rotor drivetrain separated. This resulted in the loss of tail rotor thrust, and consequently, yaw control was lost.

The investigation noted that, without the use of a visual inspection aid such as a mirror, or verification with a measuring device, inspection of the installed retainer ring (Figure 3, item 11) is hampered by the proximity of the bearing hanger (Figure 3, item 10).

The HTSC Bell 214ST daily inspection was amended to require the opening of an additional access panel to facilitate the inspection of the engine-deck-mounted tail rotor driveshaft hanger and the No. 2 coupling assembly.

As seen in this occurrence, the consequences of an incompletely seated retainer ring entering service can lead to a failure of the tail rotor drivetrain and consequent loss of tail rotor thrust. Therefore, since some components, such as a seated retainer ring, may be difficult to view, the use of visual inspection aids and measuring tools may be warranted during installation and subsequent DCC inspection.
