RAIL TRANSPORTATION SAFETY INVESTIGATION REPORT R21M0002

MAIN-TRACK TRAIN DERAILMENT

Canadian National Railway Company
Freight train M30631-25
Mile 8.04, Pelletier Subdivision
Albertine Station, New Brunswick
26 January 2021

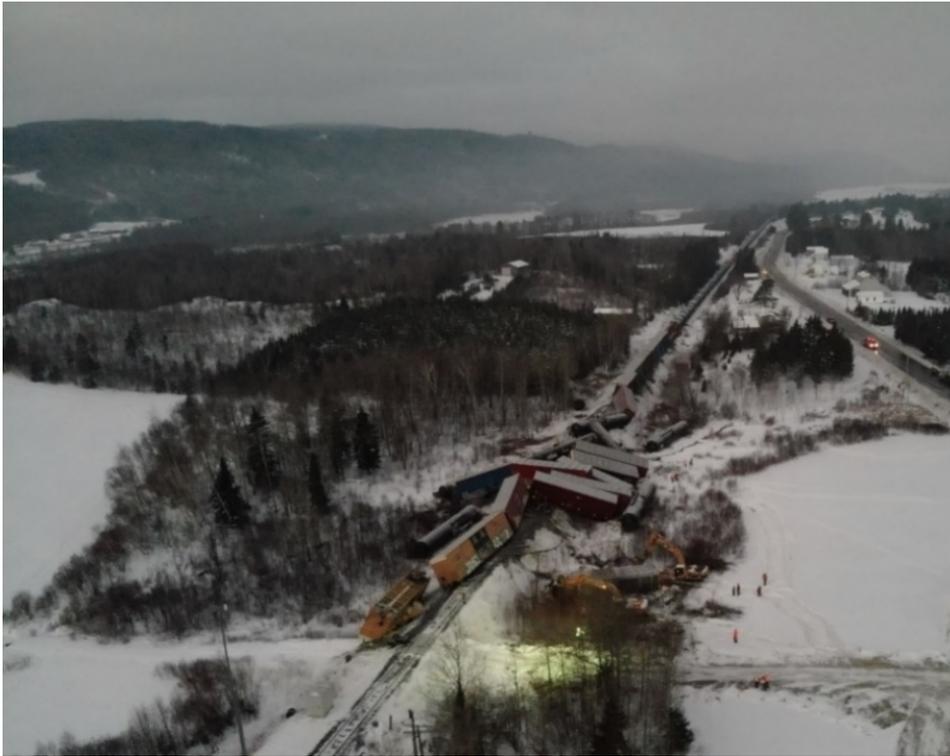
Twenty-two cars (cars 40 to 61 in the train consist) had derailed in an accordion fashion (Figure 2), destroying the track under the cars. The 40th car, CN 405766,³ was the first car to derail.

Figure 2. Aerial photo of the derailed cars, looking west (Source: New Brunswick Emergency Measures Organization)

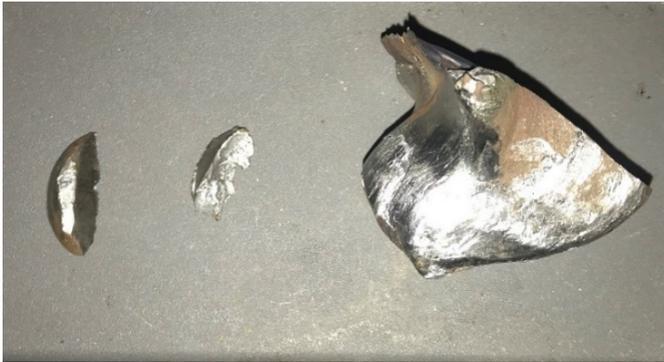
The 39th car, IC 21013,⁴ was still on the track. Its axles, trucks and brake beams had sustained minimal damage. The cross key⁵ retaining the coupler in the draft assembly⁶ at the leading end (A-end) of this car had sheared, leaving 3 small fragments (Figure 3) in the yoke.

Figure 3. Three small fragments of the A-end cross key from car IC 21013 (Source: Canadian National Railway Company)

The TSB laboratory examined the fragments from the failed A-end cross key recovered from car IC 21013. Given the small size of the fragments, the examination focused on the largest fragment, which was found lodged within the yoke.

The failed cross key was originally designed around 2006 and manufactured approximately 4 years before the occurrence. A metallurgical examination of the fragment determined that both its microstructure and chemical composition met the material specifications indicated in the manufacturer's engineering drawings.¹² There were no indications of metallurgical anomalies.

The examined fragment had a significant amount of plastic deformation. Due to the small size of the fragment and the extent of the damage it had sustained, the mode of failure of the cross key could not be ascertained.

The mode of failure of the A-end cross key of car IC 21013 could not be ascertained due to the small size of the fragments and the extent of the damage it had sustained. The laboratory examination of the B-end cross key of car IC 21013 and of 9 additional cracked cross keys of similar style and vintage that were bad ordered by CN determined that the cracks identified at the inside radii on all the cross keys were due to fatigue. In addition, following the derailment, inspections by CN revealed 408 cars with defective cross keys out of 604 cars inspected.

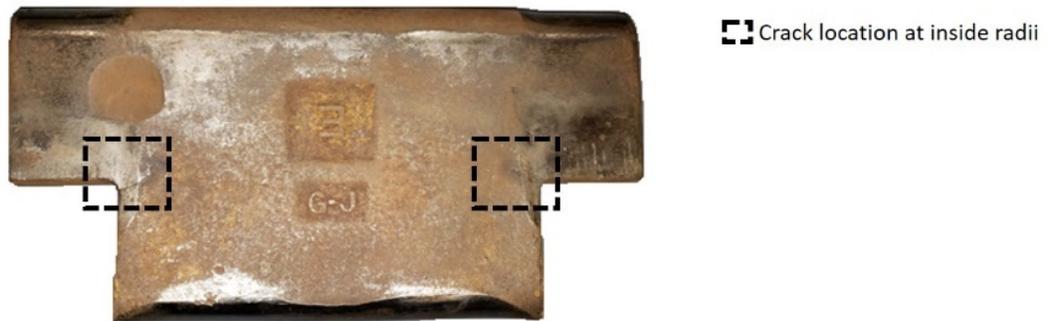
Each of the 10 cross keys was measured and found to meet the drawing specifications. Through visual inspection, it was noted that all 10 cross keys had at least one crack located at one of the inside radii (Figure 5). Eight cross keys had cracks at both inside radii. In all cases, the cracks were through the thickness of the cross key and originated at the inside radii of the keys (Figure 6).

Figure 5. Photo of one of the examined cross keys showing the location of cracks at the inside radii (Source: TSB)

The laboratory examination determined that cracks originating at one or both of the radii were a result of fatigue. Given the sharp angle of the inside radii, there would be higher residual stress in these areas. Furthermore, all examined cross keys had a significant amount of plastic deformation.

The component manufacturer revised the cross key geometry by increasing the radius in the area in which cracking had occurred in order to lower stresses and improve performance. The updated cross keys are currently undergoing service trials.

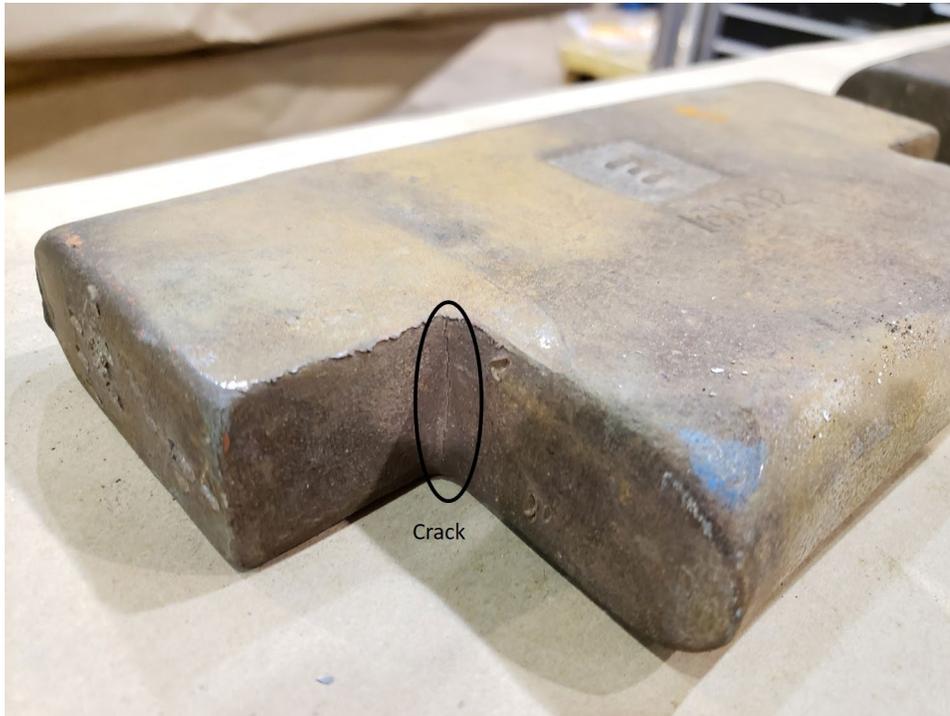
Figure 6. Photo of a crack at the inside radius (Source: TSB)

In order to further examine the cracks, 3 of the cross keys were sectioned adjacent to the crack tip and opened. Metallurgical testing of these cross keys indicated that the microstructure met the material composition specified on the relevant engineering drawing. Fractography performed on the same 3 cross keys showed beach marks on the fracture surfaces, consistent with fatigue crack propagation.

The plastic deformation observed in the cross keys suggests that their yield strength was insufficient to withstand the loading stresses applied during service. Loading beyond yield in compression¹⁴ allows for a localized residual tensile stress in the area of the radii when the compressive load is removed. This stress allows for progressive crack propagation each time a cross key is loaded and unloaded. Given the material met the specifications and the part experienced plastic deformation, it is likely that there are design limitations with either the specified material or the geometry of the part, including an incorrect radius causing localized stress risers.

The failed cross key had developed fatigue cracks at the inside radii, which likely occurred over its 4 years of service before the derailment.
