RAIL TRANSPORTATION SAFETY INVESTIGATION REPORT R21V0118

MAIN-TRACK TRAIN DERAILMENT

Canadian National Railway Company
Freight train A47251-02
Mile 547.7, Chetwynd Subdivision
Hodda Station, British Columbia
03 June 2021

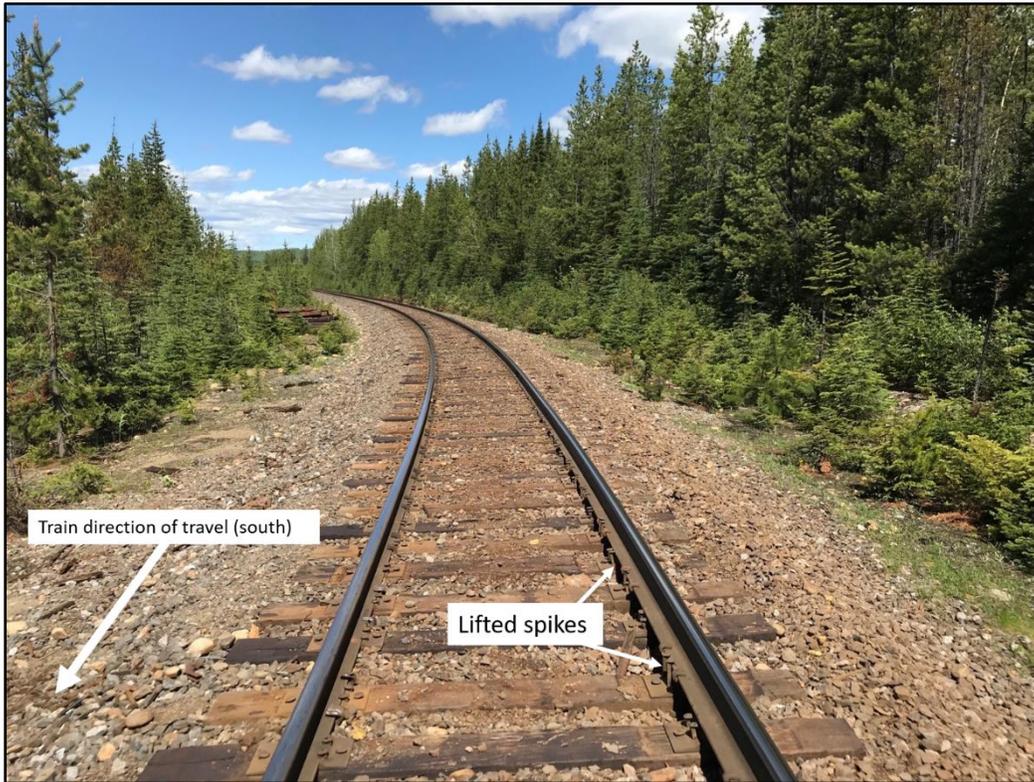
The gauge-side spikes of the high rail of the 8° curve had lifted away from, and out of, the tie plates (Figure 2). The high rail had rolled outward away from the train, thereby increasing the gauge and causing the cars to derail.

Figure 2. Chetwynd Subdivision looking north at Mile 548, showing the lifted spikes on the high rail at the 8° curve (Source: Canadian National Railway Company, with TSB annotations)

Travelling southward, the 8° curve begins at about Mile 548 and extends for 1278 feet. The curve has 3.51 inches of superelevation³ (SE), 1.49 inches less than balanced SE (the SE at which centrifugal forces are fully compensated), which for an 8° curve at 30 mph is 5 inches. CN engineering track standards limit SE to 5 inches and allow for curves to be up to 2 inches less than balanced SE; the TSR allow for up to 3 inches less than balanced SE. However, when curves with high numbers of defective ties are under-elevated, train forces can result in gauge-side spikes lifting as the high rail rolls or lifts out of the plates.

The track in the vicinity of the derailment also underwent inspection by a heavy track geometry test car. The most recent inspection before the occurrence was conducted on 25 May 2021. The inspection recorded 30 feet of 5.68° of near-urgent outward rail cant on the low rail at Mile 547.7 in the 8° curve. Near-urgent defects must be inspected within 72 hours and repaired within 30 days.⁴ The near-urgent condition was inspected the following day on 26 May 2021. During this inspection, no track geometry defects were identified; however, it is likely that signs of gauge widening (such as sliding tie plates, bent spikes or plate cutting) were present, but not observed. There were no repairs made or

On 28 April 2021, some new ties had been installed in the 8° curve to break up and reinforce clusters of defective ties, and the track had also been gauged on 05 May 2021. These actions, however, were insufficient to prevent the high rail from canting outward and rolling under the train.

Nine days prior to this occurrence, a near urgent defect was identified, but the subsequent track inspection did not reveal track geometry defects, even though signs of gauge widening were likely present. When conducting track inspections in curves, it is important to pay particular attention to both rails for signs of instability, so that repairs or operating restrictions can be put in place.
