A Survey of Problem Homes of the Environmentally Hypersensitive

Prepared for: Research Division
Canada Mortgage and Housing Corporation
700 Montreal Road
Ottawa, Ontario
K1A 0P7
CMHC Project Manager: Virginia Salares

Prepared by: Drerup Armstrong Ltd
P.O. Box 130
Carp, Ontario
K0A 1L0
Drerup Armstrong Project Manager: Oliver Drerup

May 1996

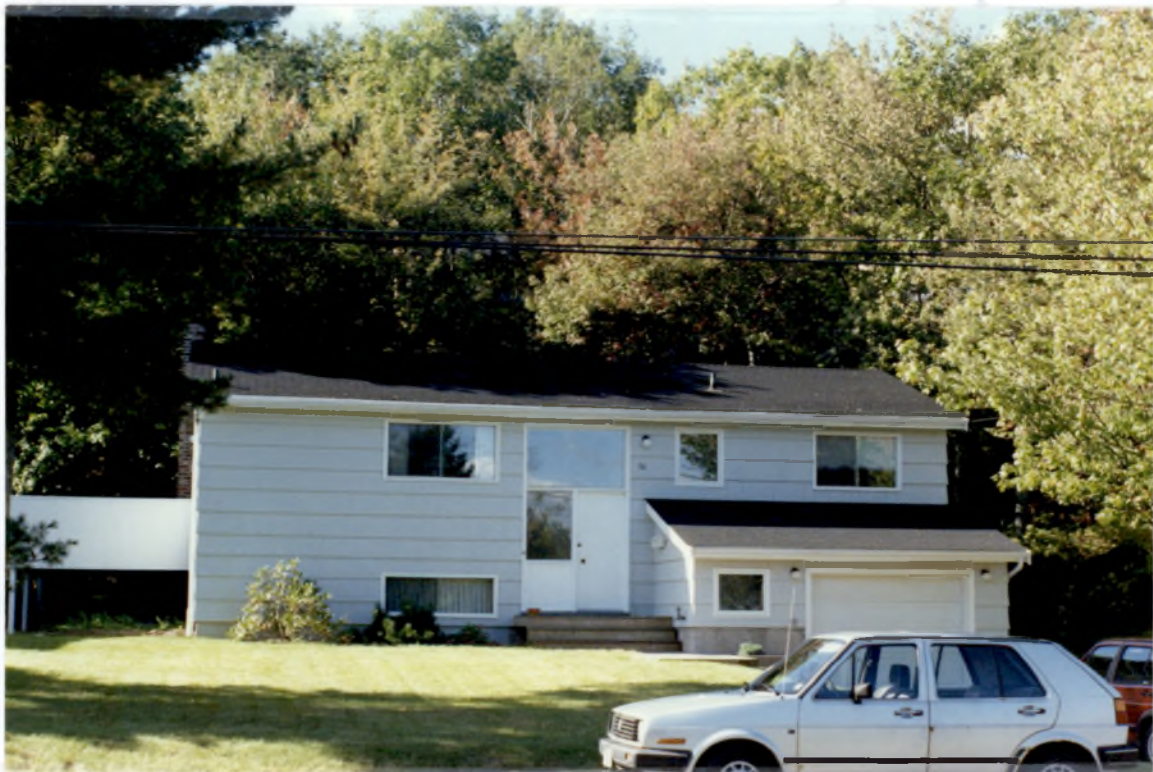
PHOTOGRAPH:

- cedar wood shingles on exterior walls, asphalt shingle roof
- north side of the house in shade most of the day, cool air circulation on this side, moisture, green algae visible on wall
- door to attached garage not sufficiently weather stripped to isolate garage from rest of house. Concrete garage floor with floor drain. Walls concrete half way up, then drywall.
- oil tank stored in garage, no signs of leakage. Strong moisture, damp, dusty smell in garage.
- old brass drain pipe on west wall from upper house. Shows signs of leakage and mold—should be investigated.

Secondary Issue: Mild to moderate excess humidity problem resulting in microbial growth. Localized areas of high humidity: room over garage, long showers, closed drapes, musty smells (closets), coastal climate, etc. Air filter may remove some microbials but probably not synthetic odours.

Dehumidify basement.

Ensure ventilation system is working adequately, may require moving air intake. Replace flex duct with smooth duct work (because of resistance to air flow and potential odours from plastic ducts—especially supply). Ventilation system could be improved by installing a unit with heat recovery and ducting to deliver fresh air where it is needed (living room and bedrooms) and removing stale air at points where it is created (kitchen, bathroom, basement, closets).

Suggested Remediation: Switch all household cleaning and maintenance products to low-tox products formulated for sensitive people. Walls, ceilings and floors may need cleaning with a low-tox cleaner to remove residual odours absorbed by surfaces. Air-seal garage and workshop from living space—if can't properly air seal, remove all odourous products. Use a high efficiency dehumidifier to reduce indoor humidities.

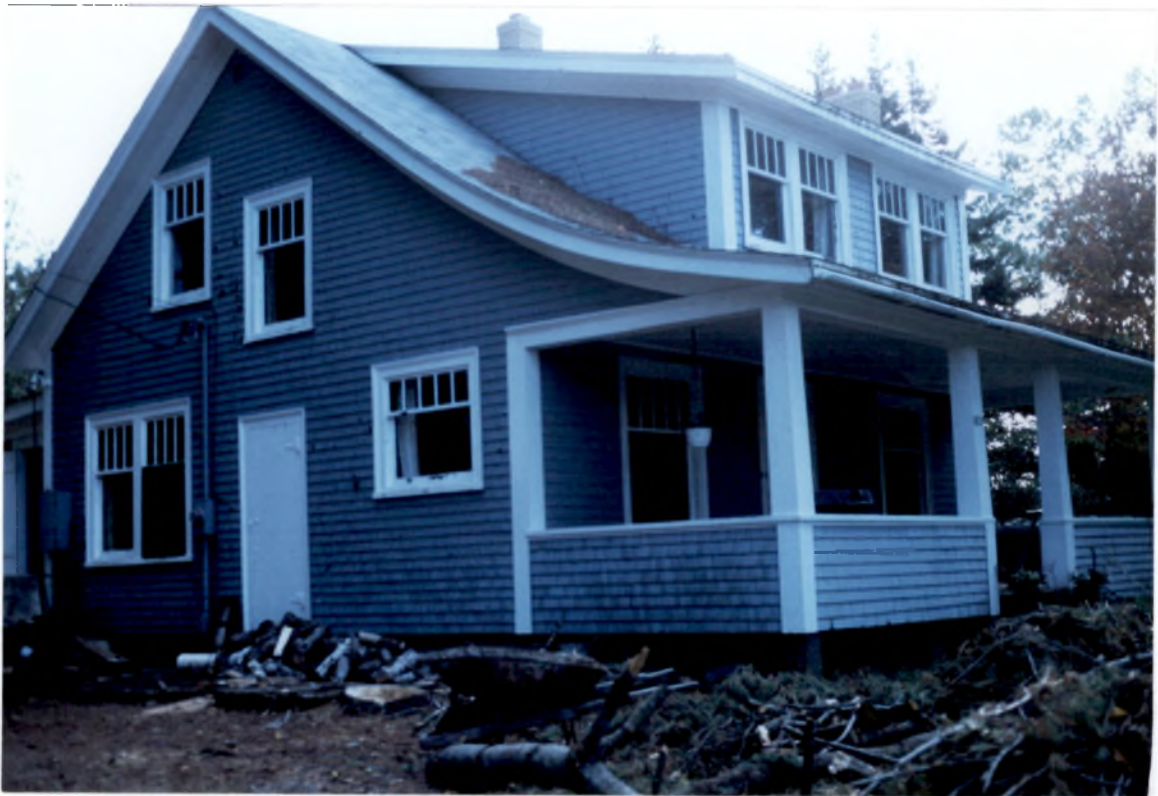
PHOTOGRAPH:

- walls/floor not insulated, no vapour barrier, concrete floor in good condition
 - fuzzy white mold growth on floor
 - fibrous dust
 - may have asbestos

From its history of flooding, this house appears to have a moisture problem. Visual and odour observations indicate presence of molds. The control of moisture in the basement, therefore, is a top priority. Water should be led away from the foundation by draining to a lower point, upgrading the sump pump (automatic with a cover) and installing eavestrough. Once drainage is improved, clean basement walls and floors to remove molds. The whole house and furnishings may also require cleaning.

Use a dehumidifier in the basement to assist in controlling moisture levels.

Seal sources of moisture and provide adequate ventilation to house.

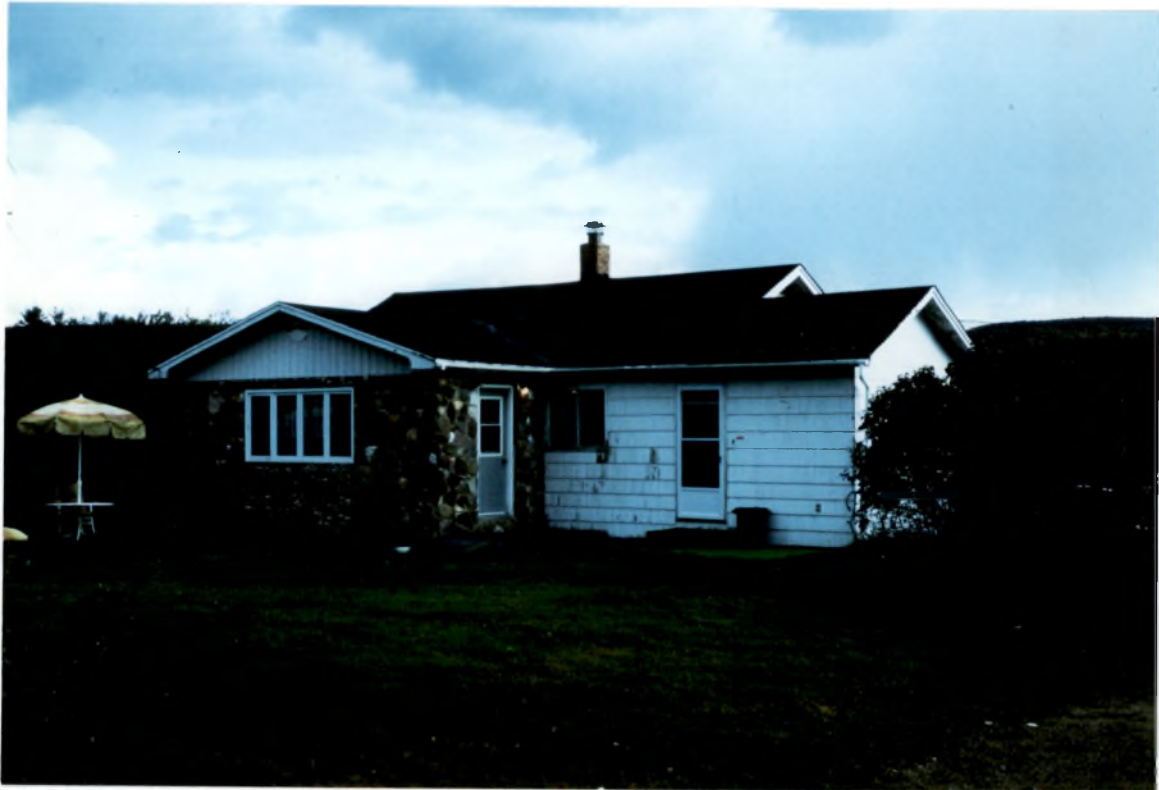
PHOTOGRAPH:

- HRV is exhausting air from ground floor living space and supplying fresh air in the basement.
- EXTERIOR:**
- down spout not connected at kitchen
 - stone, exterior sheathing. Cement and rock facing on west side with some cracking.

- unattached garage
 - wood siding in good condition
 - low slope roof with asphalt shingles in fair condition
 - peeling blistering paint
 - mold on north and south walls

- Service the HRV and check flows in and out of machine. Re-route HRV supply air duct from basement to back bedroom. The return air duct should be located in the living room in order to deliver fresh air to the area of greatest need.
- Clean exterior fuel tank area around fill area.
- Seal floor, walls and sealing.
- Use liquid laundry products in laundry.
- Clean dehumidifier regularly.
- Install central vacuum system, vented to outside.
- When roof is replaced, use metal or wood, do not recommend asphalt shingles.
- Plantings on the border on the property with the highway would have a positive effect in reducing traffic noise.

Repair roof leak. Connect downspout at kitchen.

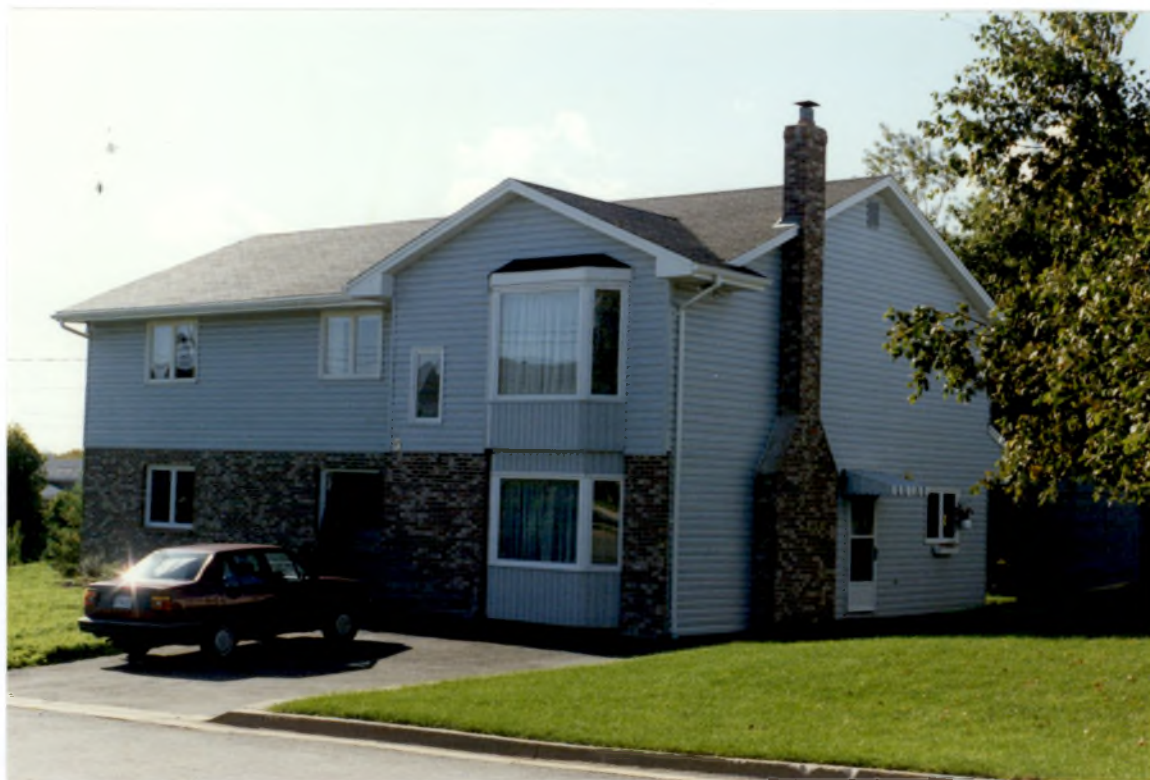
PHOTOGRAPH:

- slab on grade foundation
 - Slight mold on soffit
 - dryer vents near air intakes (potential for introducing contaminants). Air exhausts under deck next to dryer vents.

- Extra drain trap in bathroom should be filled with water or sealed or a back check valve installed.
- Better seal side-mounted furnace exhaust to prevent exhaust fumes from getting in around cracks.
- Fix leak in furnace hot water piping.

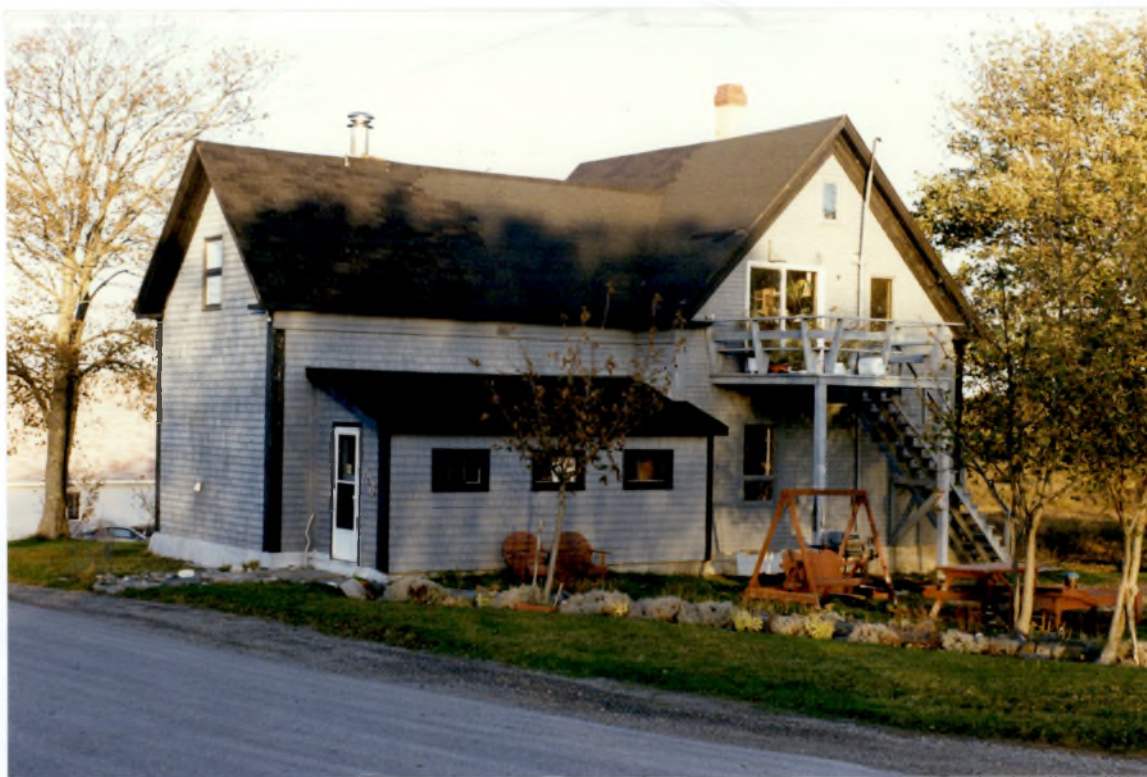
PHOTOGRAPH:

- siding: wood shingles in good condition, slight peeling paint in some sections; if old original shingles, lead is a potential problem
 - roof: asphalt shingles in fair condition—lichen & moss growth on north side

- metal chimney has cap, masonry chimney has no cap
 - foundation in good condition for type
 - basement windows covered over with plywood
 - no air intakes or exhausts

- basement is a major source of moisture and mold

- Inspect north roof, moss will accelerate decay of shingles

If feasible, the occupants should move to another home or replace the structure—with fire damage and age and condition of structure it will be very expensive to markedly improve the indoor environment in the existing building.

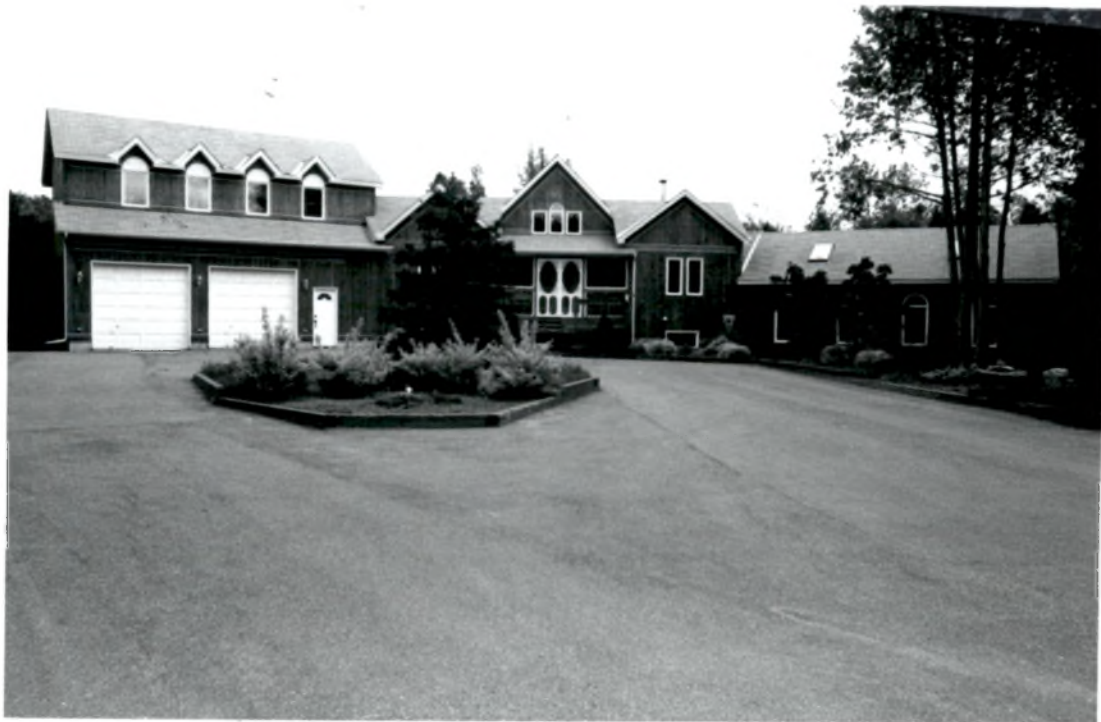
PHOTOGRAPH:

- heated by electric resistance radiant panels
 - foam underpad and carpet
- MASTER SUITE** - cathedral ceiling with significant moisture damage at eaves

Problem: Moisture and chemicals from pool of primary concern. Moisture may cause mold and high levels of moisture enhances off-gassing of building materials.

Further Remedial Action: Reduce humidity levels in building by covering pool when not in use; cover sump. Remove carpet from all areas of building. Seal subfloor with no-toxic sealer and make good floor finish. Wash basement to eliminate mold growth. Improve mechanical systems and eliminate duct leakage. Investigate and rectify moisture problems in master bedroom ceiling. Install a ventilation system. Isolate pool area from rest of house ventilate and slightly depressurize the room.

Seal all possible leakage points where moisture and gases from the pool area could enter the house.
