Isolating The Living Space From
Fungi and Gases In The Soil and
Foundation

ISOLATING THE LIVING SPACE FROM FUNGI AND GASES IN THE SOIL AND
FOUNDATION: A PILOT RETROFIT

Report to: Housing Technology Incentives Program, CMHC
from: Scanada Consultants Limited, Ottawa, 31 March 1990

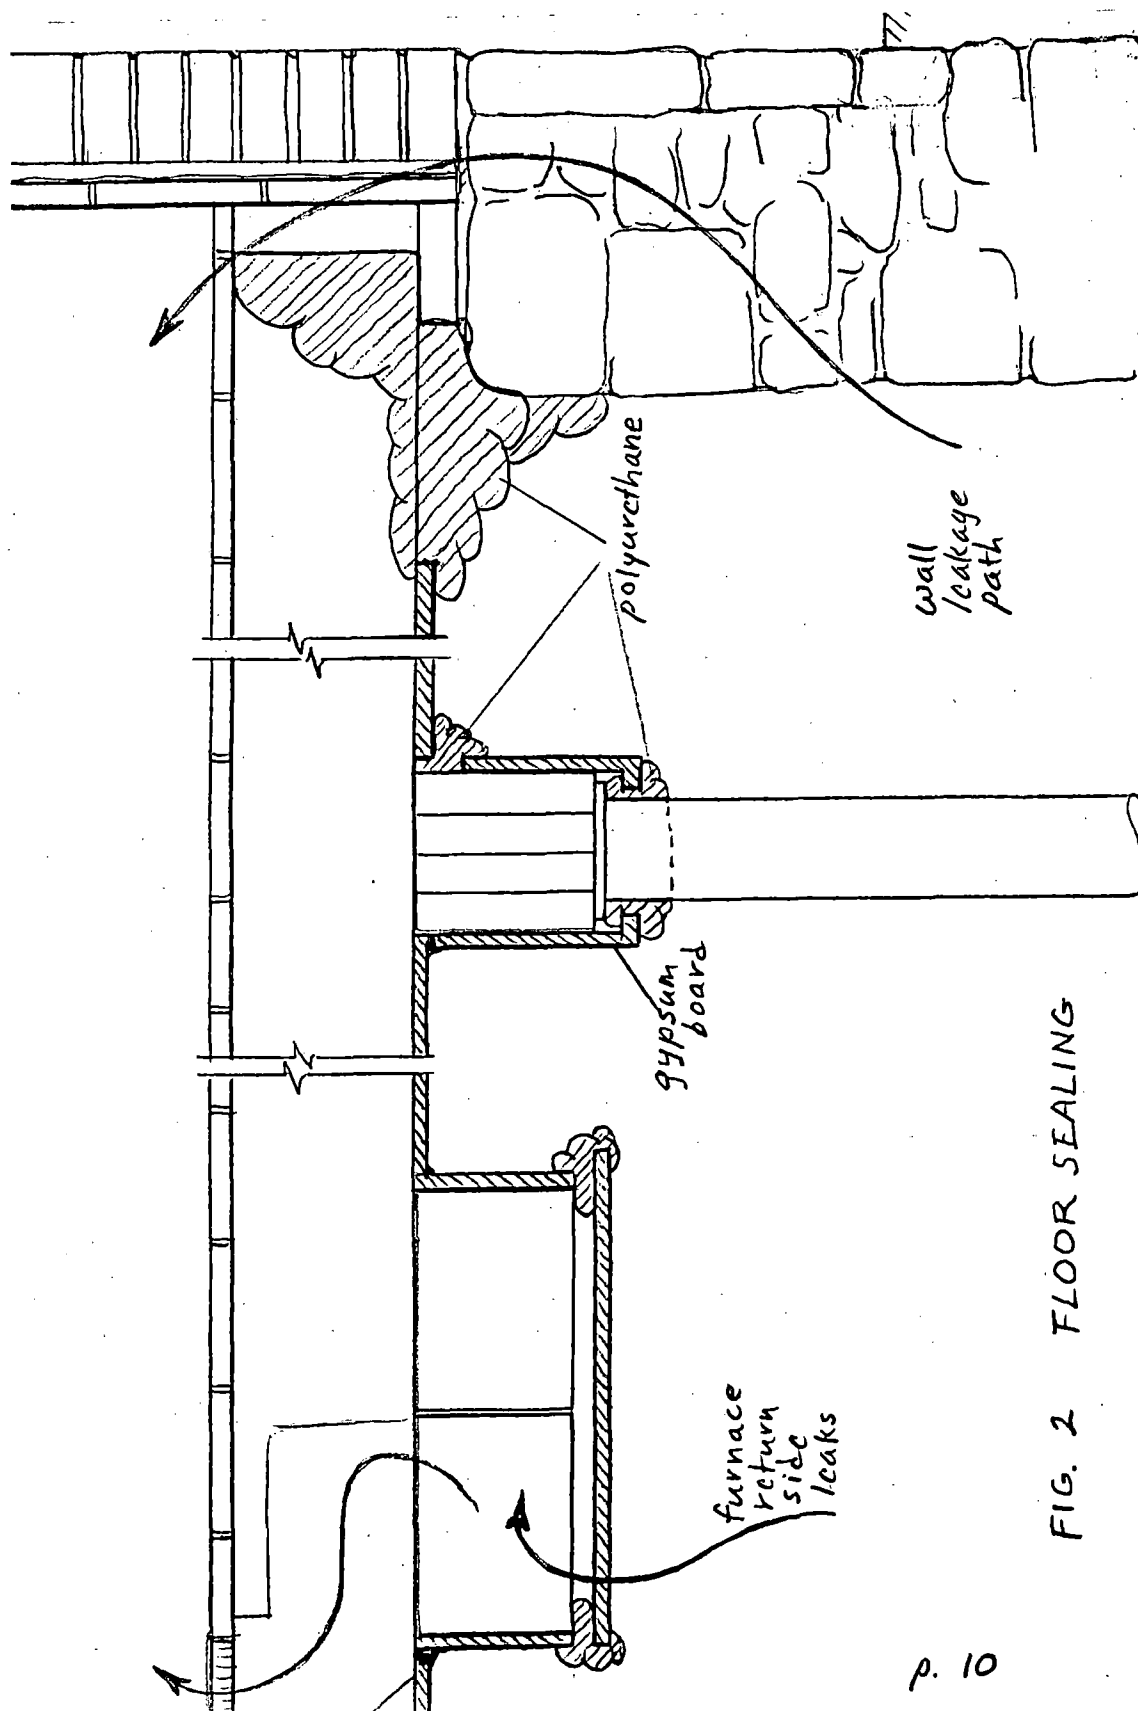
FIG. 2 FLOOR SEALING

It can be seen that the junction line of the rubblework with the brick/header/subfloor/sole plate planes could not be reached by the urethane to known and full effect; basement air can migrate through the rubble, up into the first floor walls or into the gaps between the floorboards, and thence into the room air above. However, that would be the case with the jacket retrofit as well, unless its "buffer" space were depressurized - which is exactly the case with the floor plane seal: the basement should be exhaust-depressurized with respect to the upstairs air if complete isolation is desired. The general airtightening of the basement - not just the first floor - may make it practicable to vent-depressurize it with just the 75 cfm fan that the householder had already installed.

Figure 1 is a photograph of the house. Figure 2 illustrates the barrier procedure followed in this case. CanAm Air Leakage Control undertook all the perimeter sealing and other gap filling/bulkheading to complete the ceiling plane as shown. The duct chase was also sealed off at the furnace room. All air leaks through the foundation above grade, and the few found just below, were also located by fan depressurization/smoke pencil and plugged with polyurethane. The householder sealed the stairway walls and weatherstripped the basement door.
