REMEDIAL MEASURES FOR HOUSING
ON HAZARDOUS LANDS

D. Fugler
Canada Mortgage and Housing Corporation (CMHC)
Research Division
Ottawa, Ontario
Canada K1A 0P7

M. Adomait
CH2M Hill Engineering Ltd.
Waterloo, Ontario
Canada N2J 1P8

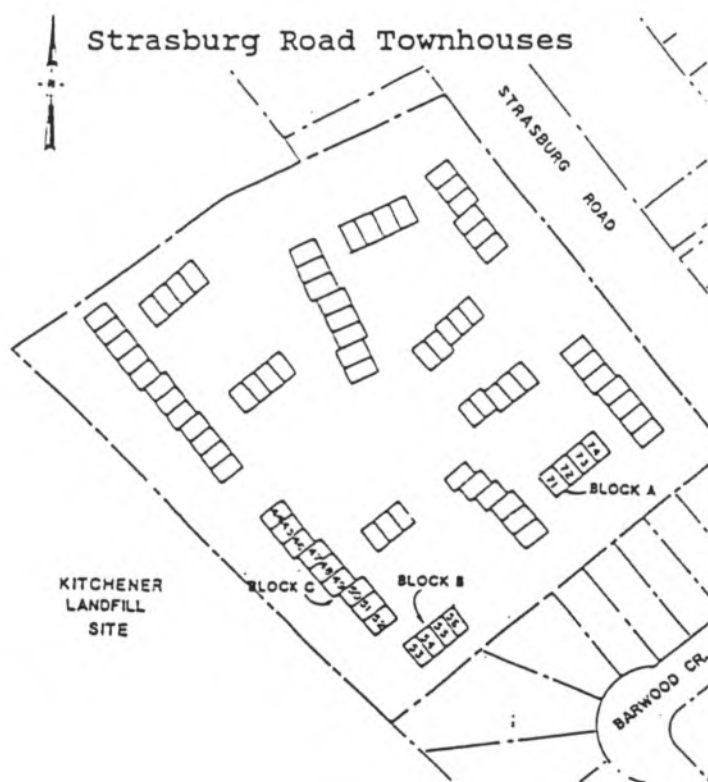
In the mid-1970's, an 81 unit townhouse project was built in Kitchener, Ontario. The units were all two storey with full basements. Figure 1 shows a plan of the project. As the site had been a municipal garbage dump, closed in the early 1950's, precautions were taken to avoid garbage gas entry. The buried refuse was, in theory, excavated from all the foundations, but not from the adjacent green areas, parking lots, and playground. (Note on Figure 1 that a municipal landfill is also adjacent to the project, sloping down into the back yards of the houses on the landfill perimeter.) A passive soil gas collection system was installed, consisting of 150 mm plastic drain tile around the perimeter of the foundation (located above the actual foundation drainage tile), and connected to 100 mm plastic risers that were spaced roughly every three units. Despite these precautions, odours and high methane levels plagued the occupants, and the townhouse project was largely deserted by 1980.

Testing was performed on a sample of the townhouses. Block A, in Figure 1, had the highest recorded concentrations of indoor methane. Block C had variable levels of methane and was adjacent to the municipal landfill site. Units in Block B had measurable levels of methane and would remain unmodified during the tests to act as controls. Methane emissions from the soil vary over time. Controls were critical to ensure that any methane reductions observed during monitoring could be properly attributed to either the remedial measures in place or to soil gas methane reductions.

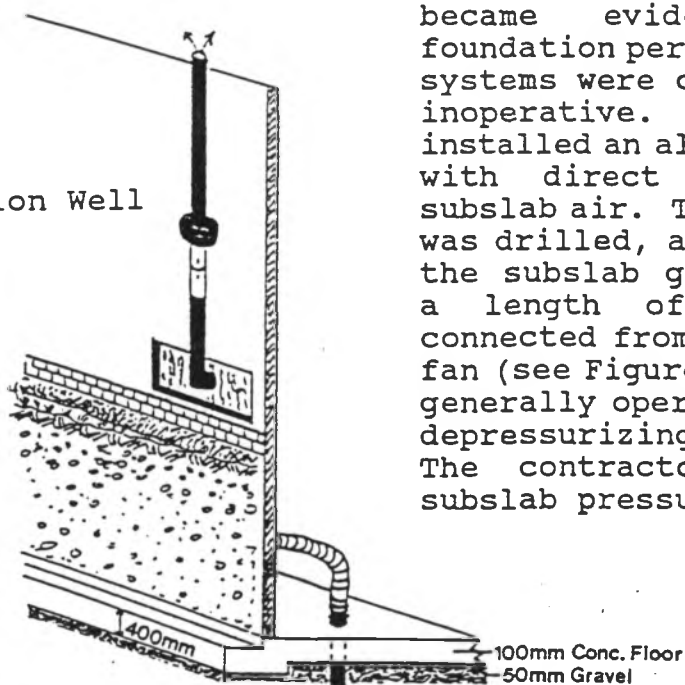
Figure 2
Soil Gas Extraction Well

As the testing proceeded, it became evident that the foundation perimeter collection systems were often plugged and inoperative. The contractors installed an alternative system, with direct access to the subslab air. The basement floor was drilled, a pipe inserted to the subslab gravel layer, and a length of flexible duct connected from this pipe to the fan (see Figure 2). This system generally operated with the fan depressurizing the subslab air. The contractors also tested subslab pressurization.

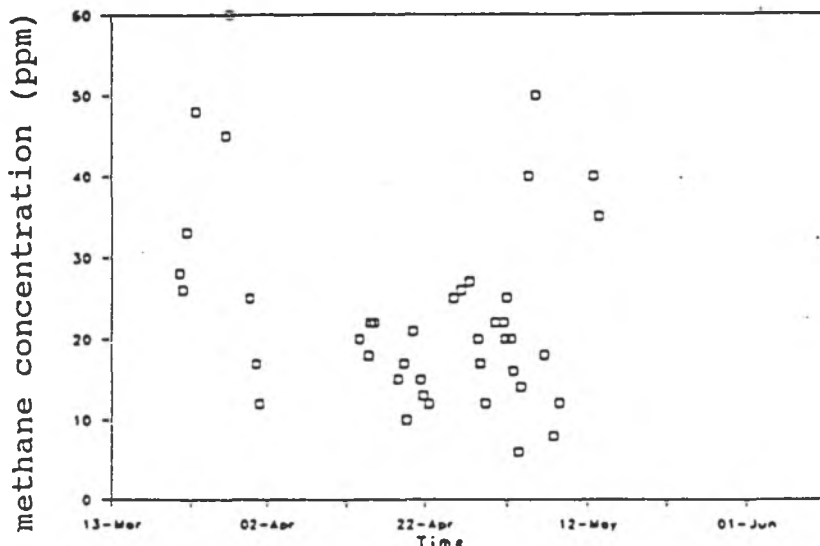
Figure 3: Methane in Unit 55

peaking usually after heavy rain. Figure 3 displays the type of variation observed in a single house in the control block, presumably due to fluctuating methane emission rates, changing house air infiltration patterns, and varying soil porosity following rainfall.

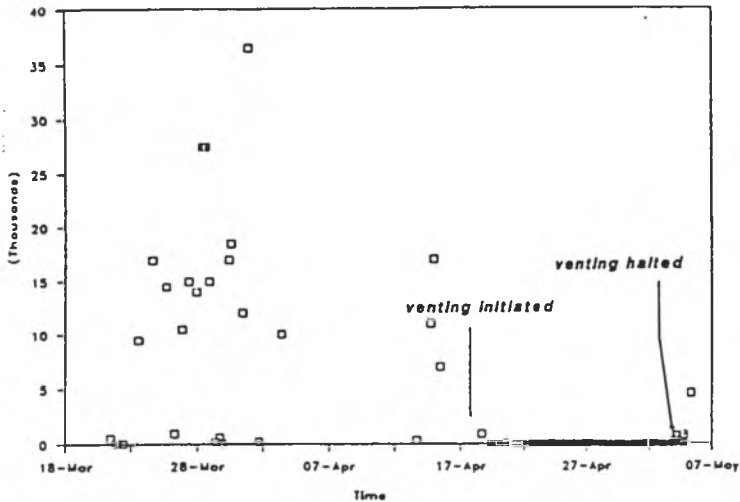
Figure 4: Methane in Unit 71 (early testing)

The methane levels in units 71 and 72 were considerably higher. These two townhouses were in the block with historically higher levels, and the monitoring confirmed the problem. Unit 72 peaked at 4650 ppm; unit 71 at 27,500 ppm. This latter peak is over 50% of the lower explosive limit (LEL) for methane. It is unlikely that the indoor air ever exceeded the LEL, as the standing pilot of the gas furnace would have ensured that such an event would not pass unnoticed.

reduction in indoor methane levels. See Figure 4 which shows spot methane concentrations before and during subslab venting. Abrupt changes in basement methane concentrations were evident upon the activation of the venting operation. As venting was halted on May 3, methane concentrations increased again. All other Block A units had similar results.

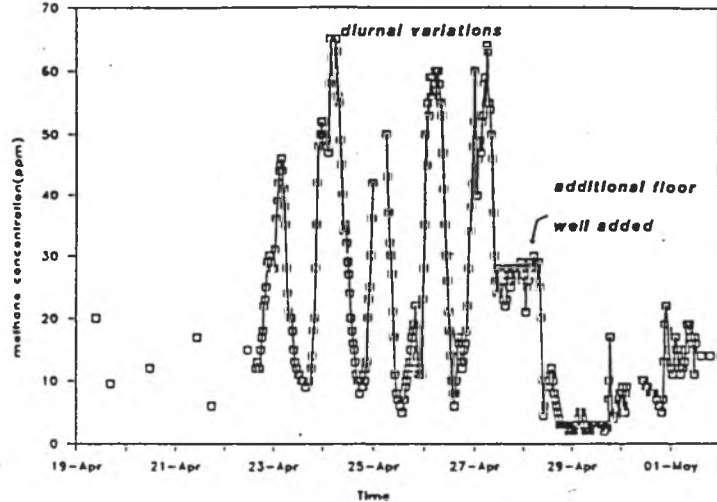
Figure 5: Methane in Unit 71 (testing with two wells)

During the initial stages of subslab venting, some significant diurnal methane variations were still observed in unit 71, up to 70 ppm (see Figure 5). The occurrence of higher methane levels during the early morning hours may be due to house stack effect, which is more pronounced during the colder outdoor temperatures of early morning. With the addition of another floor well, subslab depressurization increased and minimized the diurnal variations.
