ISSUE 1/2022

AVIATION SAFETY LETTER

TP 185E

TSB Final Report A20C0016—Runway Excursion

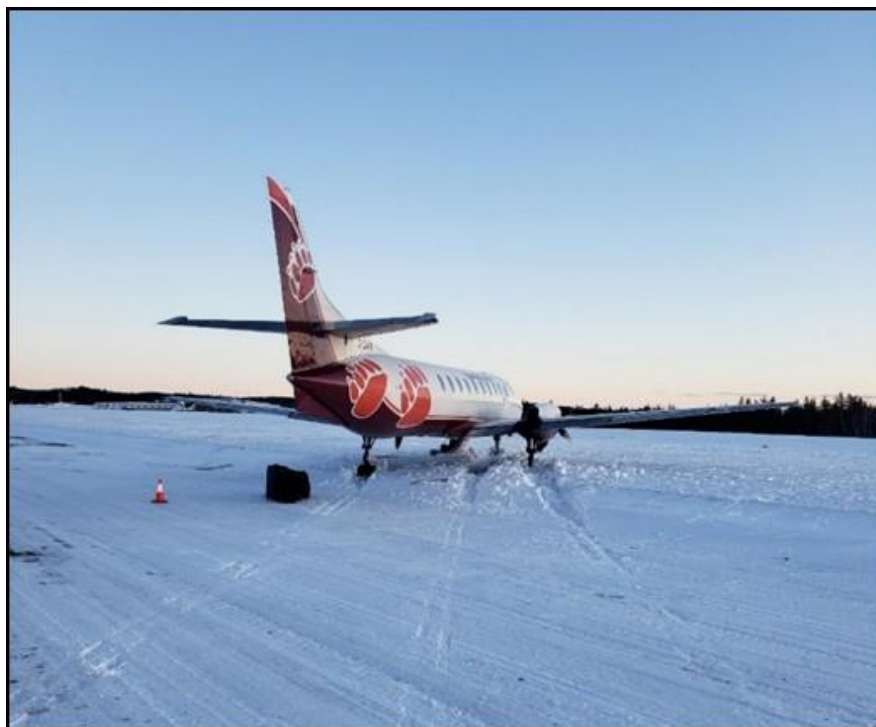
After completing the “Line Up” checklist, the captain transferred aircraft control to the FO. At approximately 1610, take-off power was applied and, while the aircraft was accelerating during the take-off roll, directional control was lost. The aircraft ran off the right side of the runway approximately 150 m from the runway threshold lights. The aircraft struck a frozen snowbank and came to rest in an upright position, about 18 m off the side of the runway

and in about 46 cm of snow (Figure 1). The crew then shut down the engines following the “Stopping Engines” checklist.

The aircraft was substantially damaged. One passenger sustained serious injuries to his hand from splintered wooden propeller blade pieces that penetrated the fuselage. All flight crew and passengers egressed the aircraft through the main cabin door and were met by emergency response.

*Figure 1. Occurrence aircraft after coming to a stop
(Source: Ontario Provincial Police)*

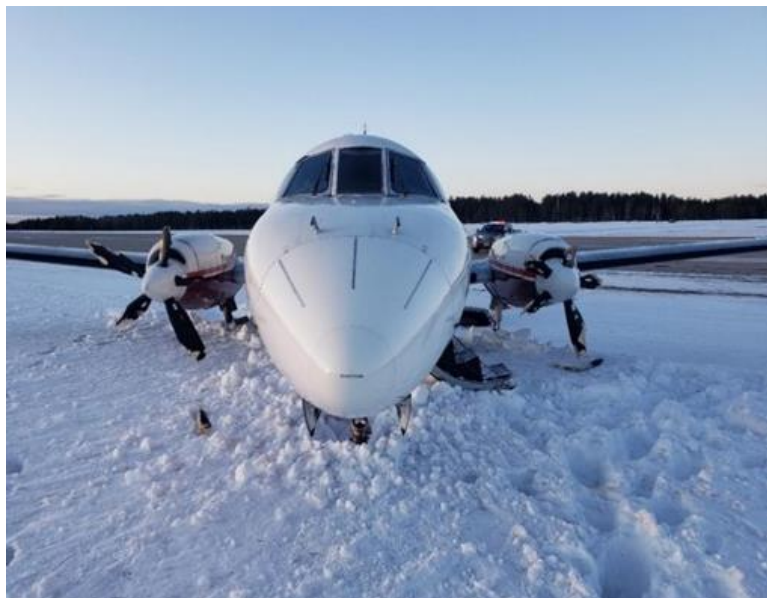
The occurrence aircraft came to a rest facing a southerly direction and was subsequently towed to a nearby hangar for further inspection by TSB investigators. The blades of both propellers were shattered and the remaining blade roots were found at a low blade angle (Figure 2). Both engine mounts were found fractured and bent and both nacelles sustained substantial distortion. Both inboard upper wing and forward fuselage skins exhibited slight wrinkling.

*Figure 2. Shattered propellers
(Source: Ontario Provincial Police)*

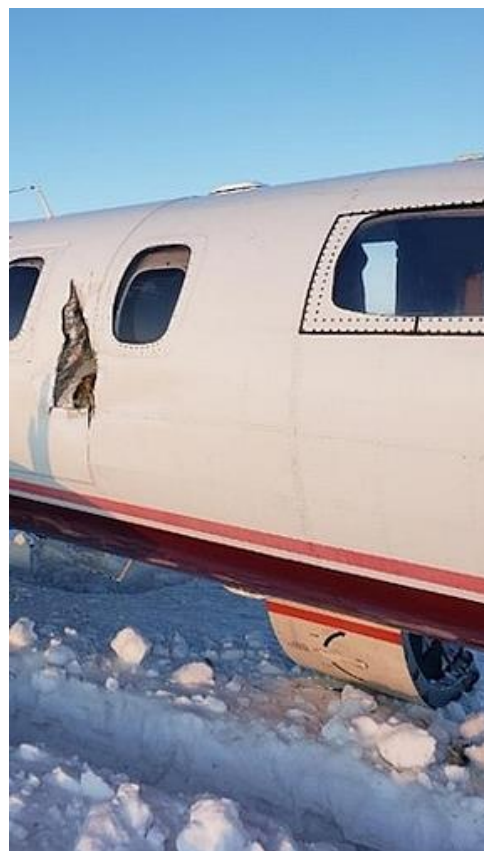
The forward fuselage area revealed complete penetration of both reinforcement panels and skins adjacent to the edge of each propeller disc (Figure 3 and Figure 4). The fuselage also sustained smaller punctures to the belly skin.

*Figure 3. Right-side fuselage
penetration
(Source: Ontario Provincial Police)*

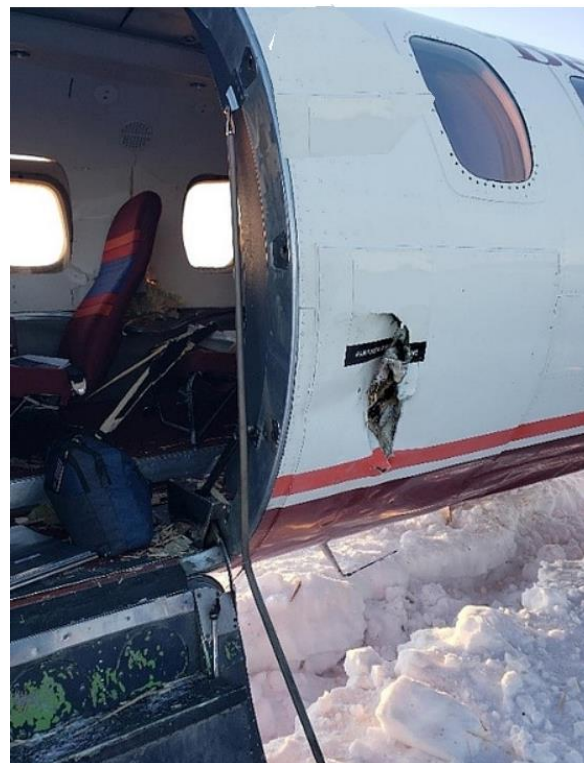
Figure 4. Left-side fuselage penetration
(Source: Ontario Provincial Police)

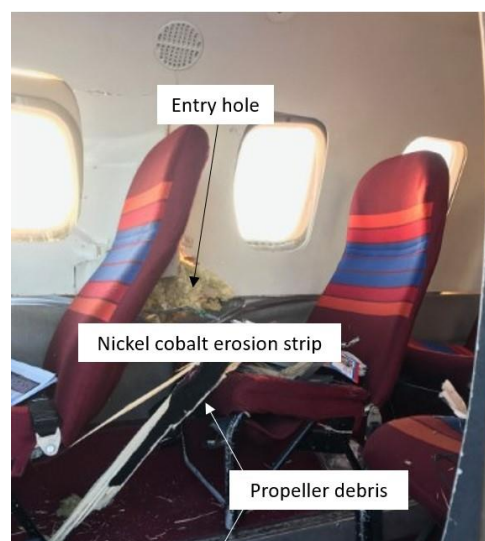
An inspection of the aircraft cabin area revealed large entry holes by the first seat in the left aisle and the second seat in the right aisle, and also revealed large amounts of propeller debris and splinters (Figure 5).

Figure 5. Propeller debris in cabin
(Source: Ontario Provincial Police, with TSB annotations)

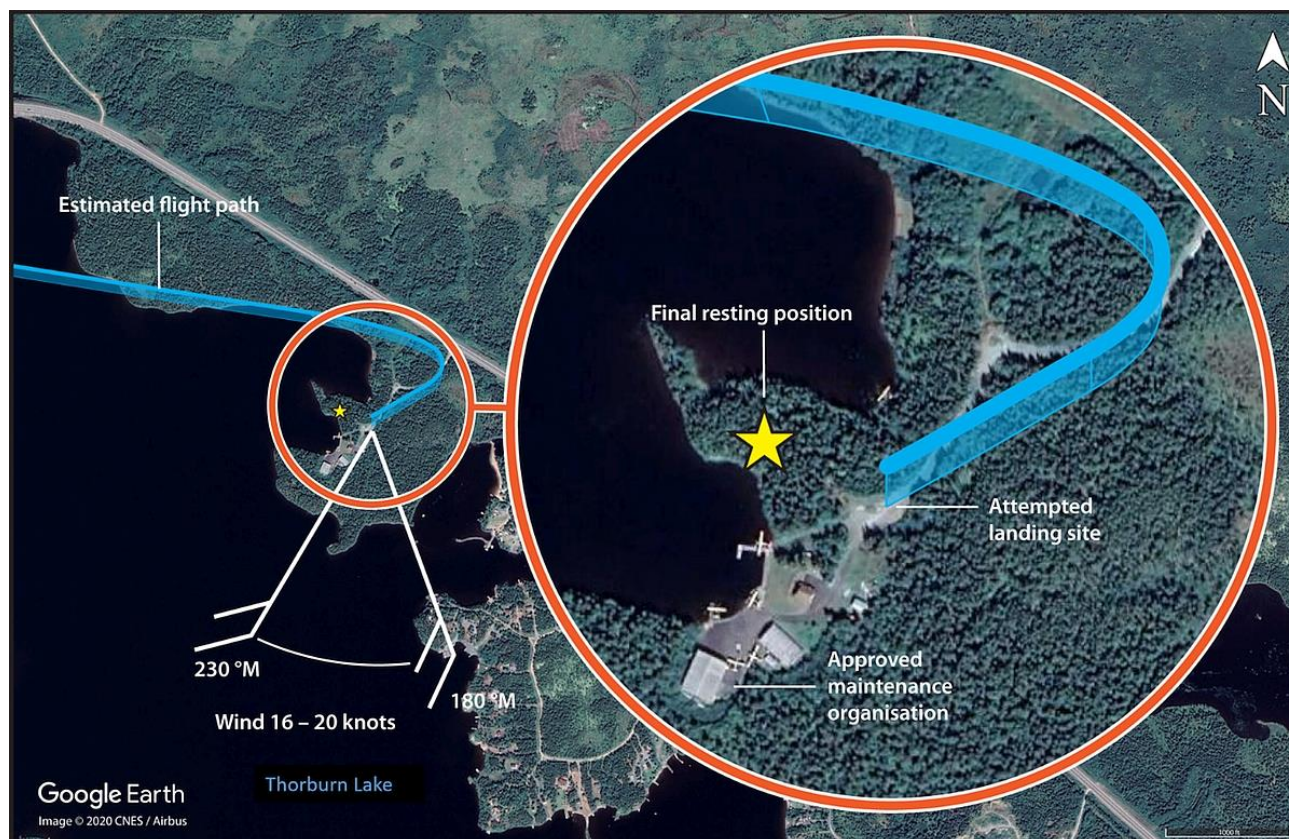
At approximately 1535, the occurrence helicopter made a right base leg turn onto the final approach heading of 240° magnetic (M). The wind direction at the time varied from 180° M to 230° M at an estimated speed of 16 to 20 kt. The occurrence pilot continued his approach to the landing site and entered an out-of-ground-effect hover over the landing site, just below the treetops (Figure 1). Once established in the hover, the pilot determined there was not enough room to continue with the landing and initiated a vertical climb.

*Figure 1. Estimated flight path, derived from global positioning system data
(Source: Google Earth, with TSB annotations)*

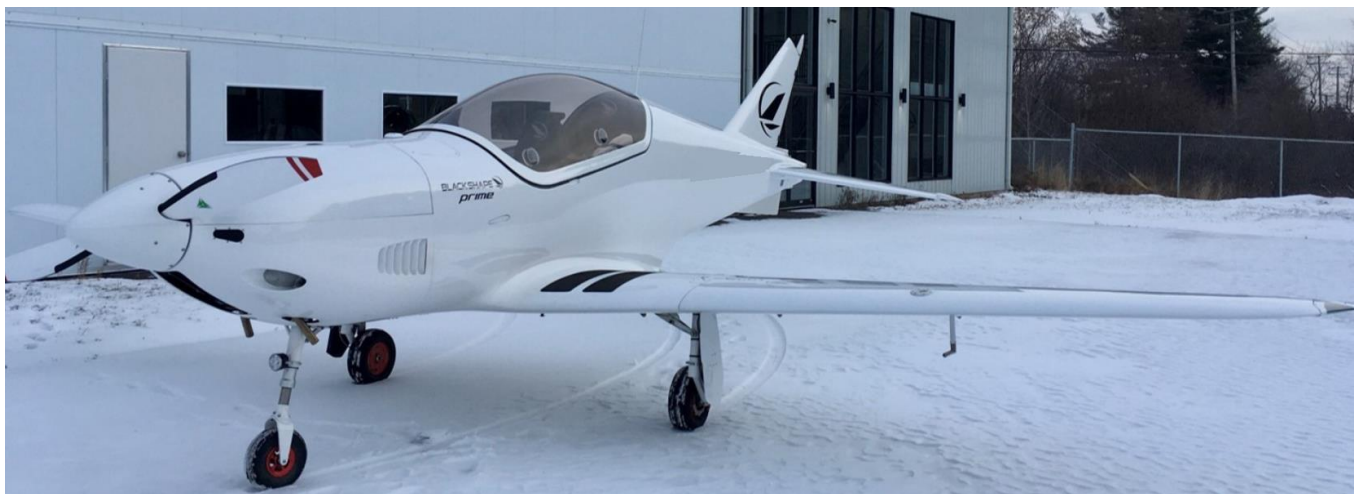
Figure 1. The occurrence aircraft (Source: N. Horn, with permission)

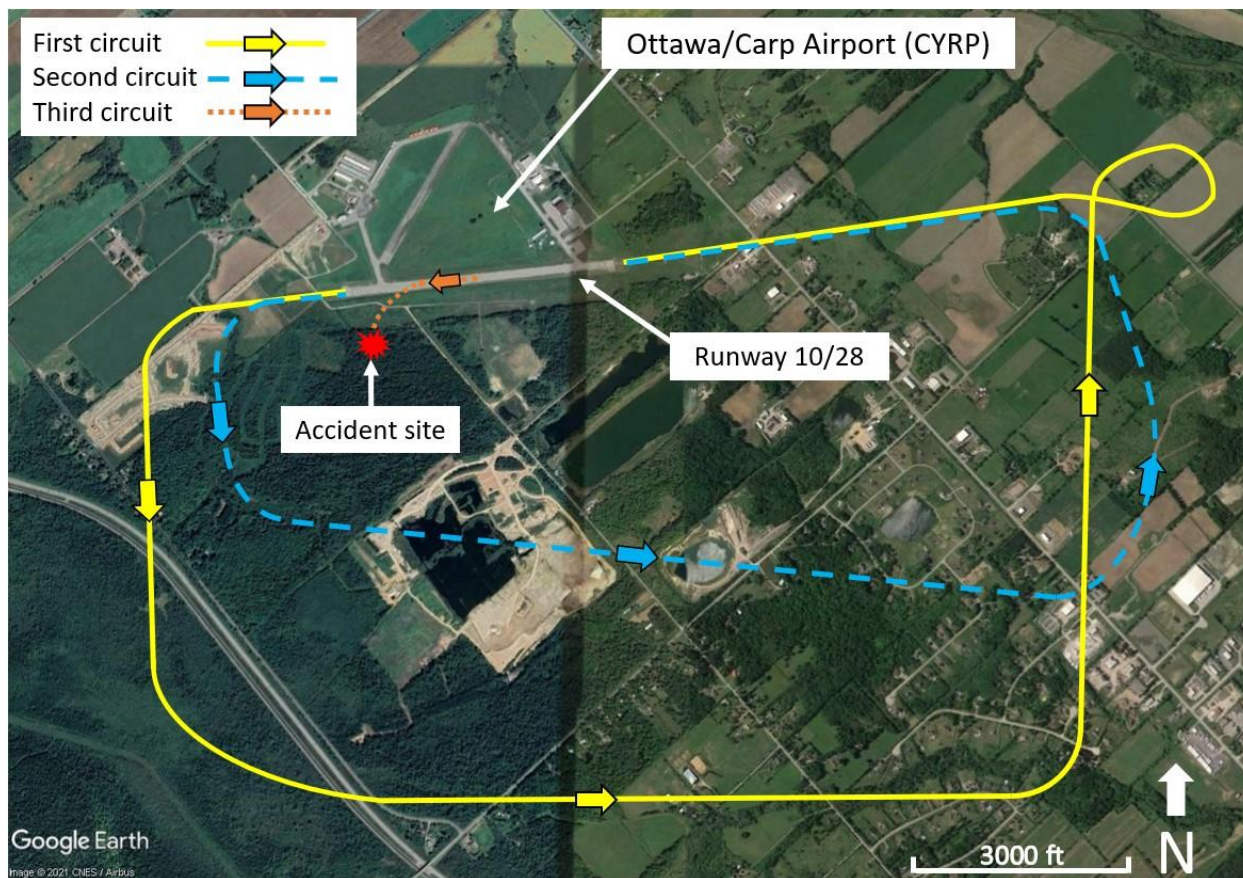
At approximately 1300, when the aircraft was approximately 787 ft (240 m) south of the runway and still in the left turn, a loss of control occurred and the aircraft entered a near-vertical descent, impacting the ground in a wooded area (Figure 2). The exact altitude at which the loss of control occurred could not be determined; however, based on primary radar data supplied by NAV CANADA, it was determined that the loss of control happened at an altitude below 550 ft above ground level (AGL).

Figure 2. Map showing the occurrence aircraft's circuits and the accident site
(Source: Google Earth, with TSB annotations)
