Transport
Canada

ISSUE 2/2022

AVIATION **S**AFETY **L**ETTER

TP 185E

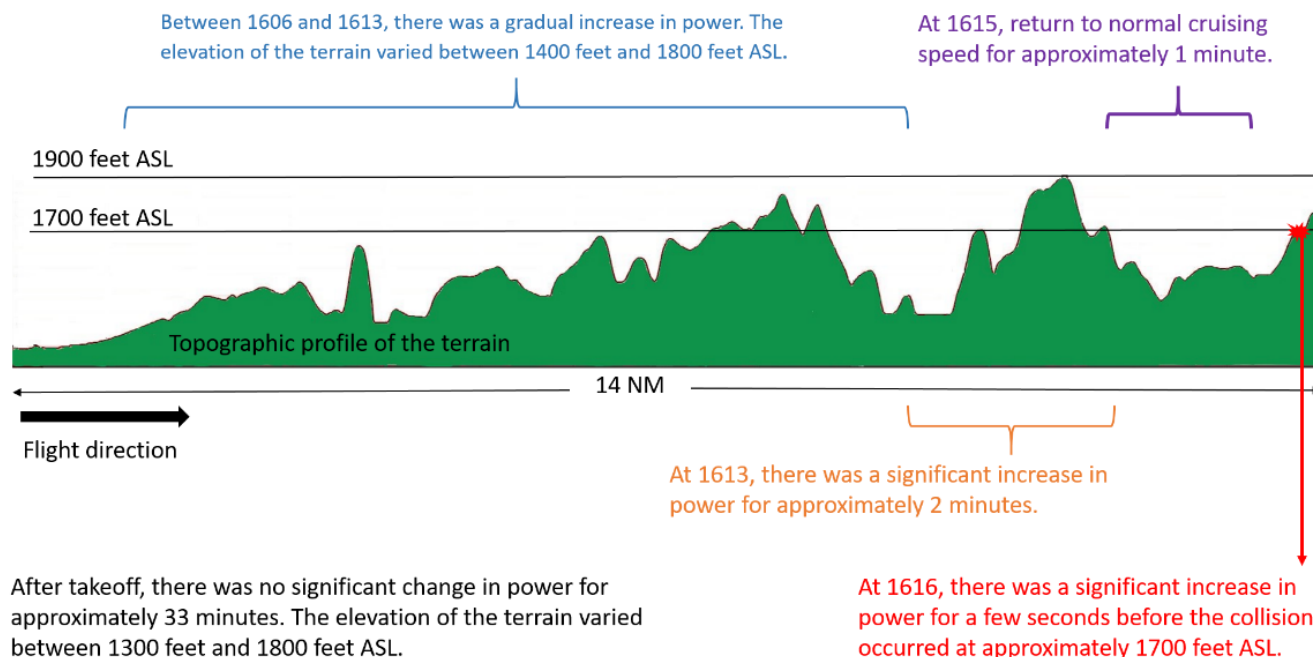
Using the aircraft's estimated straight path and comparing the data from the engine data recording and monitoring system, the estimated ground speeds, and the topography, a correlation was found between the use of the power lever and the topography of the terrain (Figure 2). It was also found that the aircraft's altitude in relation to the terrain lessened as the flight progressed.

Figure 2. Correlation between the topographic profile of the terrain and power parameters (Source: TSB)

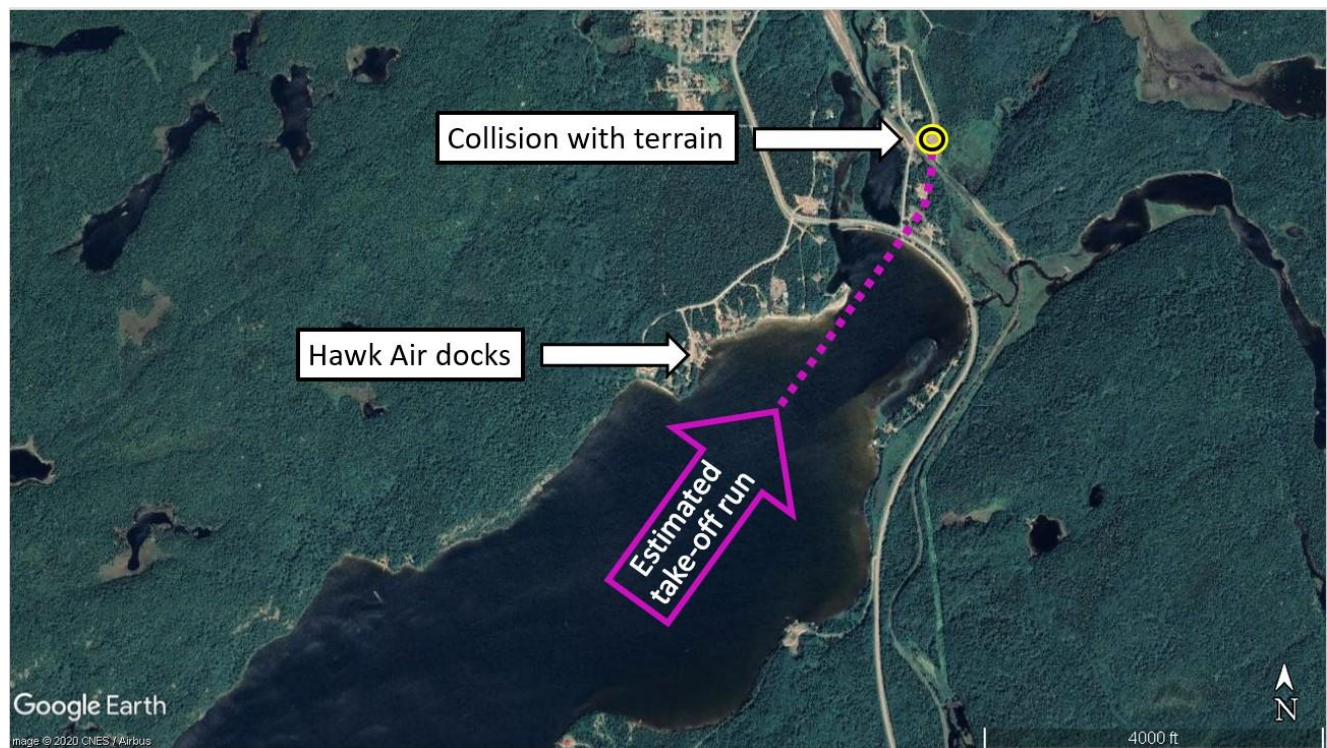
At approximately 0852, the aircraft began its take-off run. It became airborne approximately abeam the dock (Figure 1) and climbed to an estimated height of 300 to 400 ft above ground level (AGL). The aircraft was observed to be climbing normally before entering a sudden left bank and an extreme nose-down attitude.

Figure 1. View of occurrence site, with dashed magenta line showing estimated flight path
(Source: Google Earth, with TSB annotations)

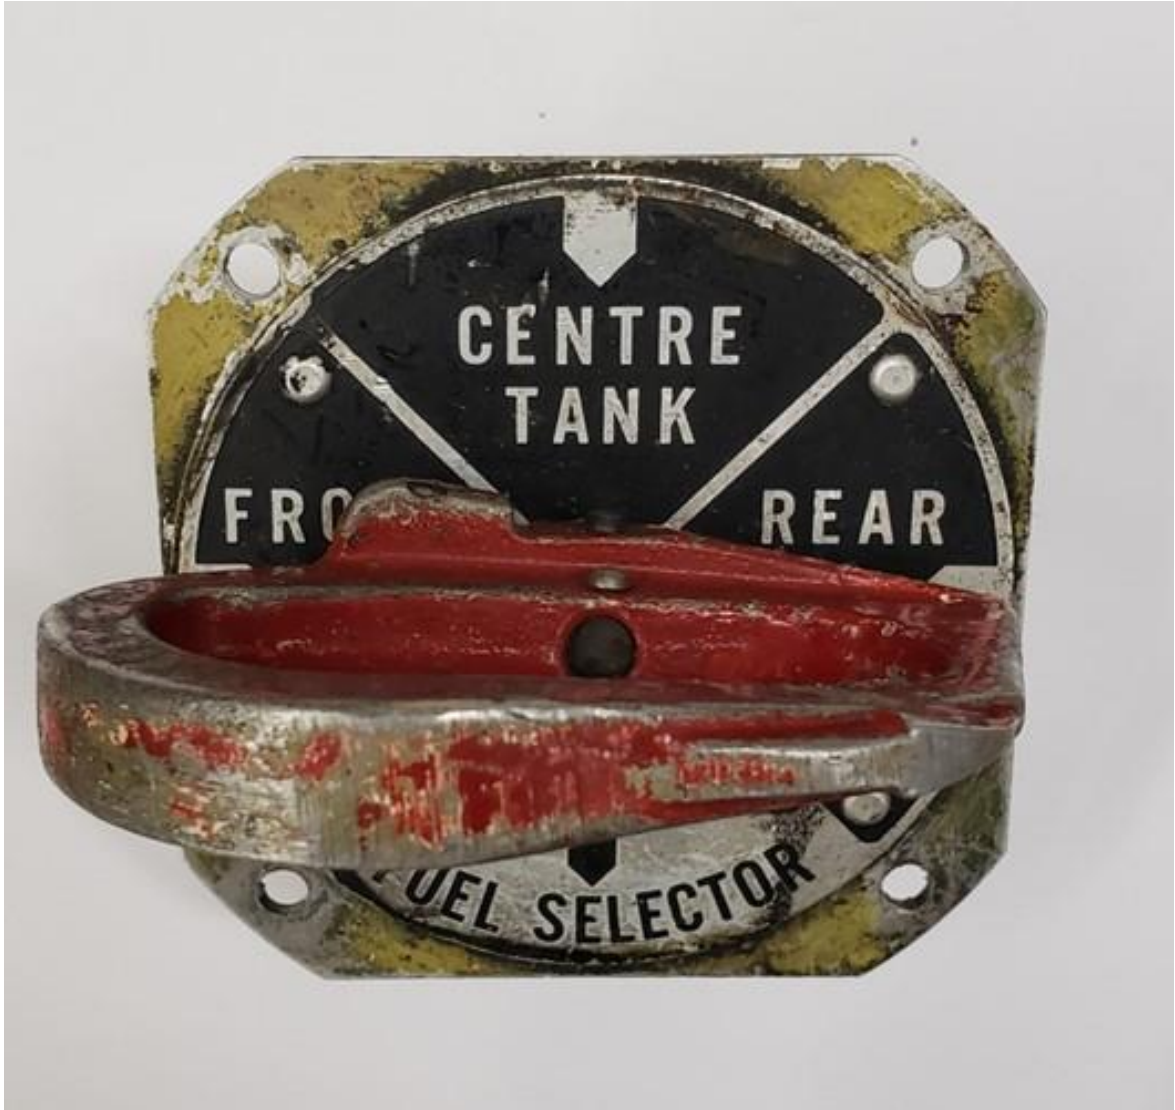
Figure 2. Fuel selector from the occurrence aircraft, with the rear tank selected (Source: TSB)

The fuel selector was found to be set to the REAR TANK position at the occurrence site, as shown in Figure 2. The cable-actuated selector valve was also found to be positioned for the rear fuel tank to be the fuel source.

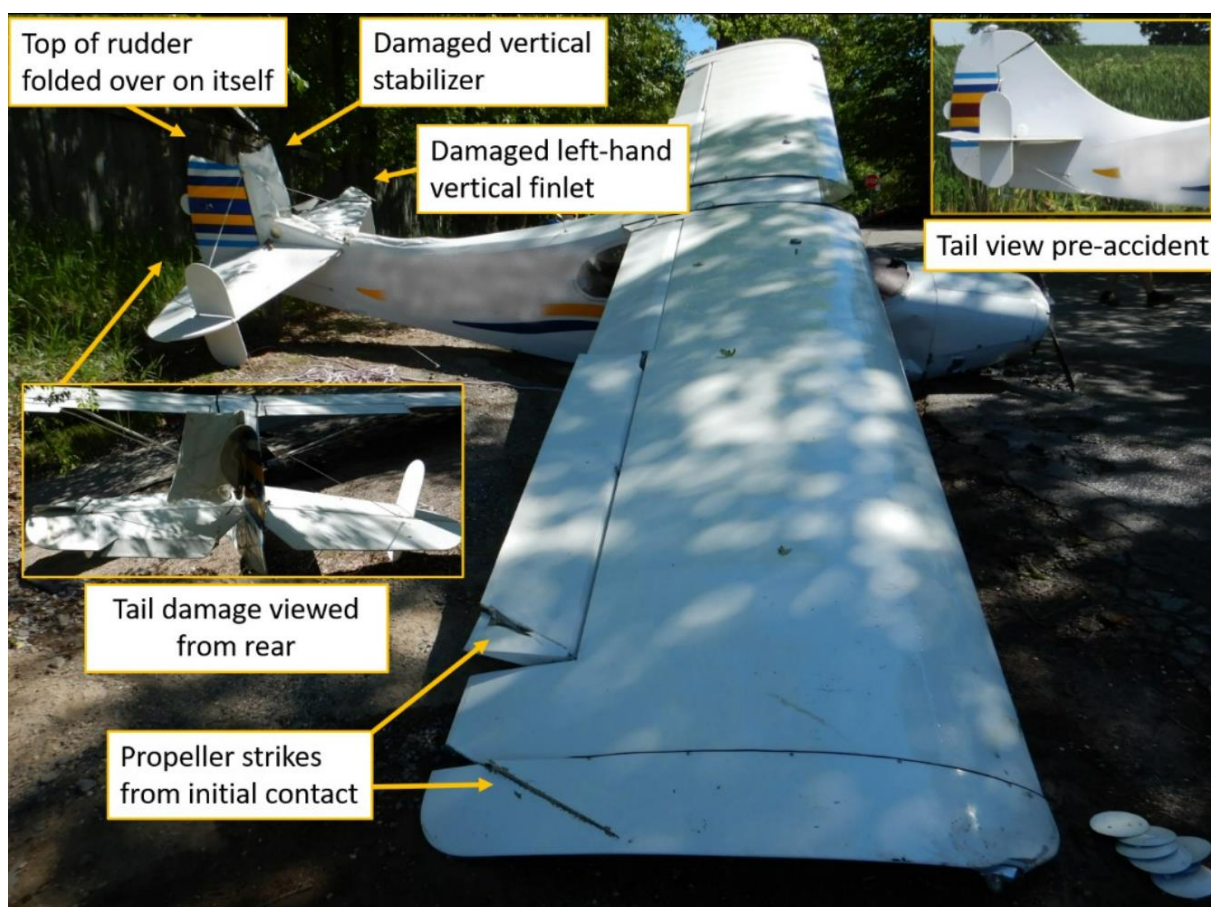
During the collision sequence, the Champion sustained two propeller strikes on the top of the right wing: one close to the wing tip, along the trailing edge of the wing, and the other on the right aileron. The tail was extensively damaged in the collision (Figure 2). The damage caused the pilot to lose the ability to control the aircraft using the ailerons, horizontal stabilizer, or the rudder. He was, however, able to control the pitch of the aircraft using engine power. Increasing the engine power would pitch the nose of the aircraft up, while decreasing it would pitch the nose down.

Figure 2. Damage to the Champion (Source of main image and tail damage inset image: TSB. Source of tail view pre-accident inset image: third party, with permission)

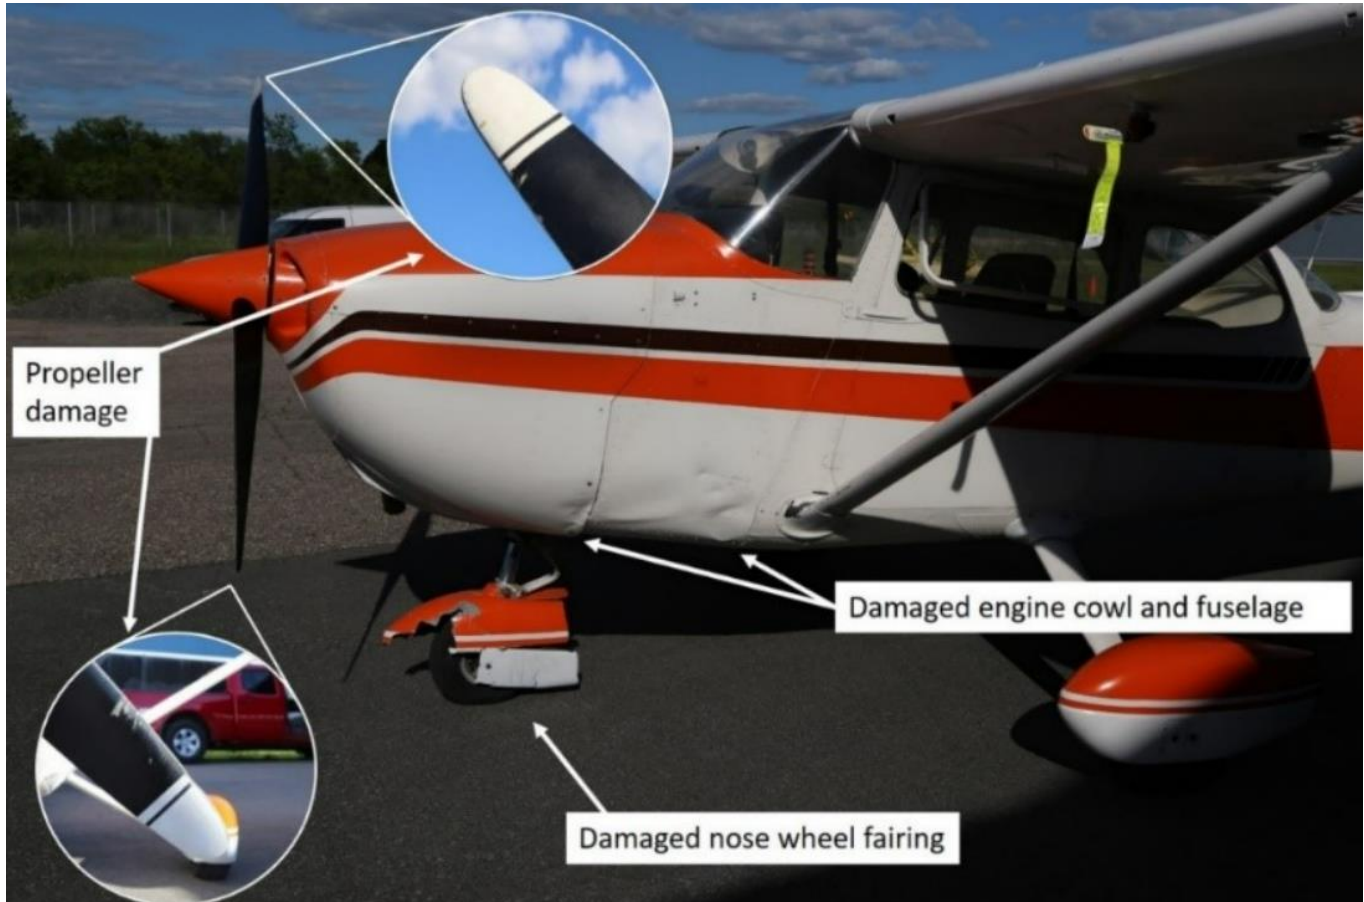
The damage to the Cessna consisted of some scraping and paint marks on both propeller blades, a damaged front wheel fairing, and some damage to the left-hand engine cowl and lower left-hand portion of the fuselage immediately aft of the firewall (Figure 3). The damage did not lead to any control issues for the pilot.

Figure 3. Damage to the Cessna (Source: Ottawa Police Service, with TSB annotations)
