AIR TRANSPORTATION SAFETY INVESTIGATION REPORT A17C0146

LOSS OF CONTROL AND COLLISION WITH TERRAIN

West Wind Aviation L.P.
Avions de Transport Régional ATR 42-320, C-GWEA
Fond-du-Lac, Saskatchewan
13 December 2017

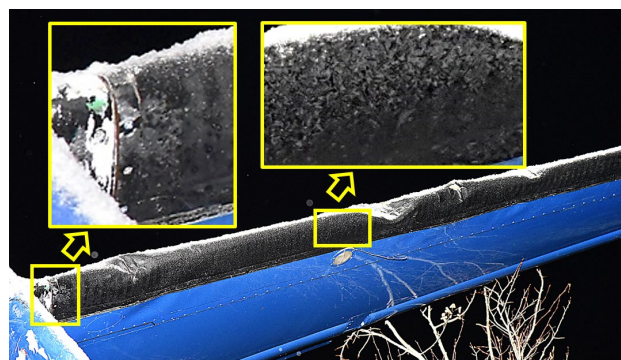
Although there was no observable precipitation or fog while the aircraft was on the ground, weather conditions were conducive to ice or frost formation. This, combined with the residual mixed ice on the aircraft, which acted as nucleation sites that allowed the formation of ice crystals, resulted in the formation of additional ice or frost on the aircraft's critical surfaces.

Figure S1. Ice contamination on leading edge of left horizontal stabilizer following the accident (Source: Royal Canadian Mounted Police, with TSB annotations)

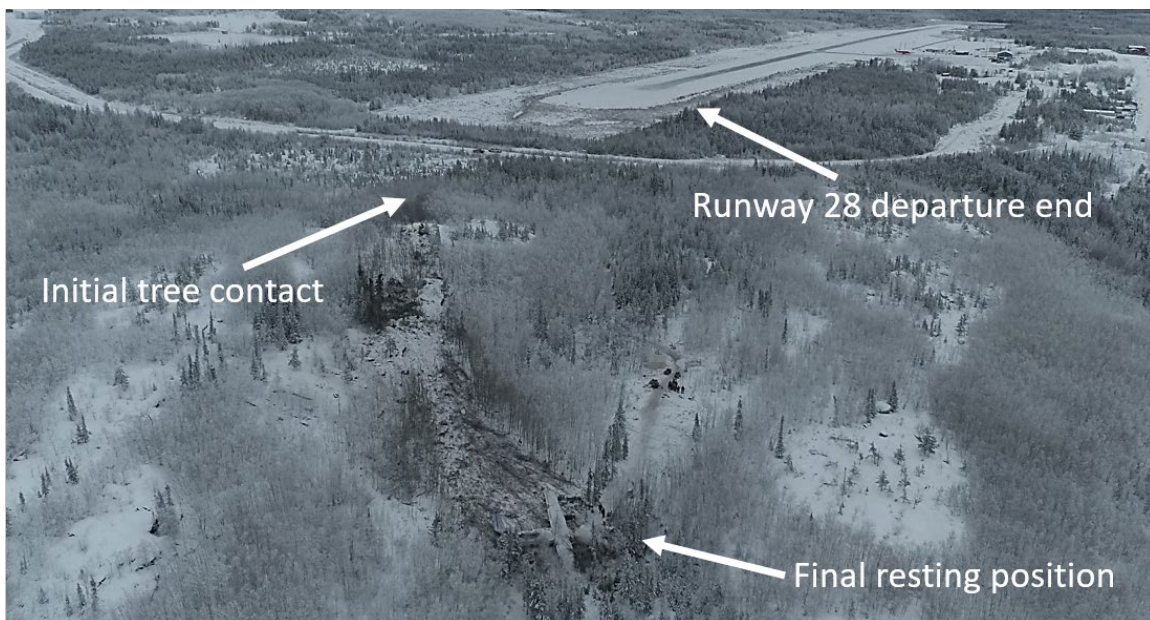
Figure S2. Aerial view of occurrence site (Source: Royal Canadian Mounted Police, with TSB annotations)

The aircraft collided with the ground in a relatively level pitch, with a bank angle of 30° left. As a result of the sudden vertical deceleration upon contact with the ground, the aircraft

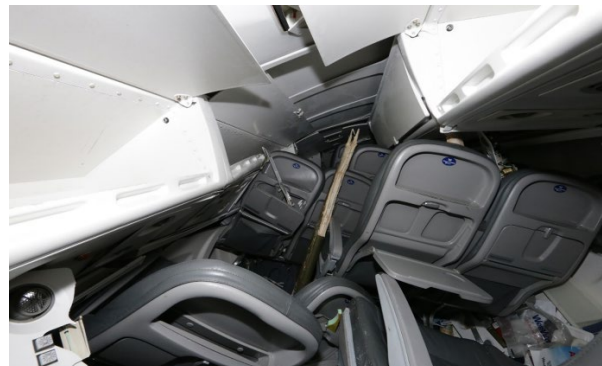
The reduced survivable space between the floor above the main landing gear and the collapsed upper fuselage caused crushing injuries, such as major head, body, and leg trauma, to passengers in the middle-forward left section of the aircraft. Of the 3 passengers in this area, 2 experienced, serious life-changing injuries, and 1 passenger subsequently died.

Figure S3. Image of the displaced cabin seats
(Source: TSB)

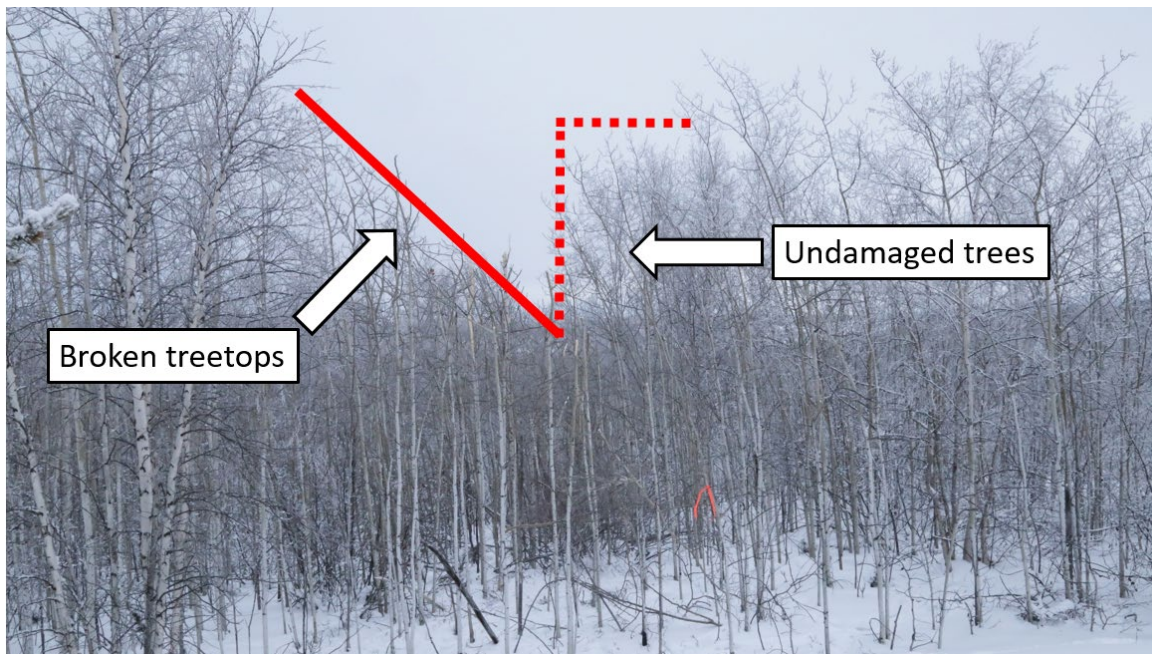
Figure 7. Photo of initial impact with trees (image facing towards the airport and showing the aircraft's bank angle at the time of impact) (Source: TSB)

The aircraft made initial ground contact about 20 m following these tree strikes, on a track of approximately 258°T, which matched the track through the trees.

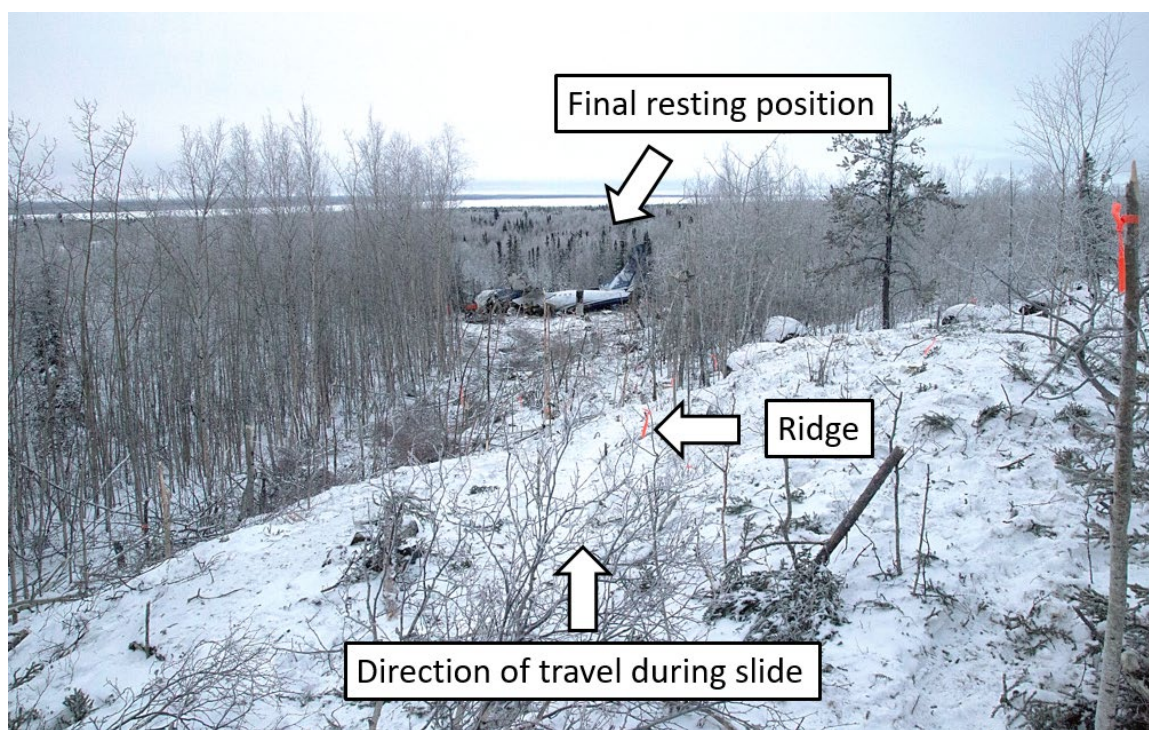
Figure 8. Photo showing the path of the aircraft's slide over the ridge (Source: TSB)

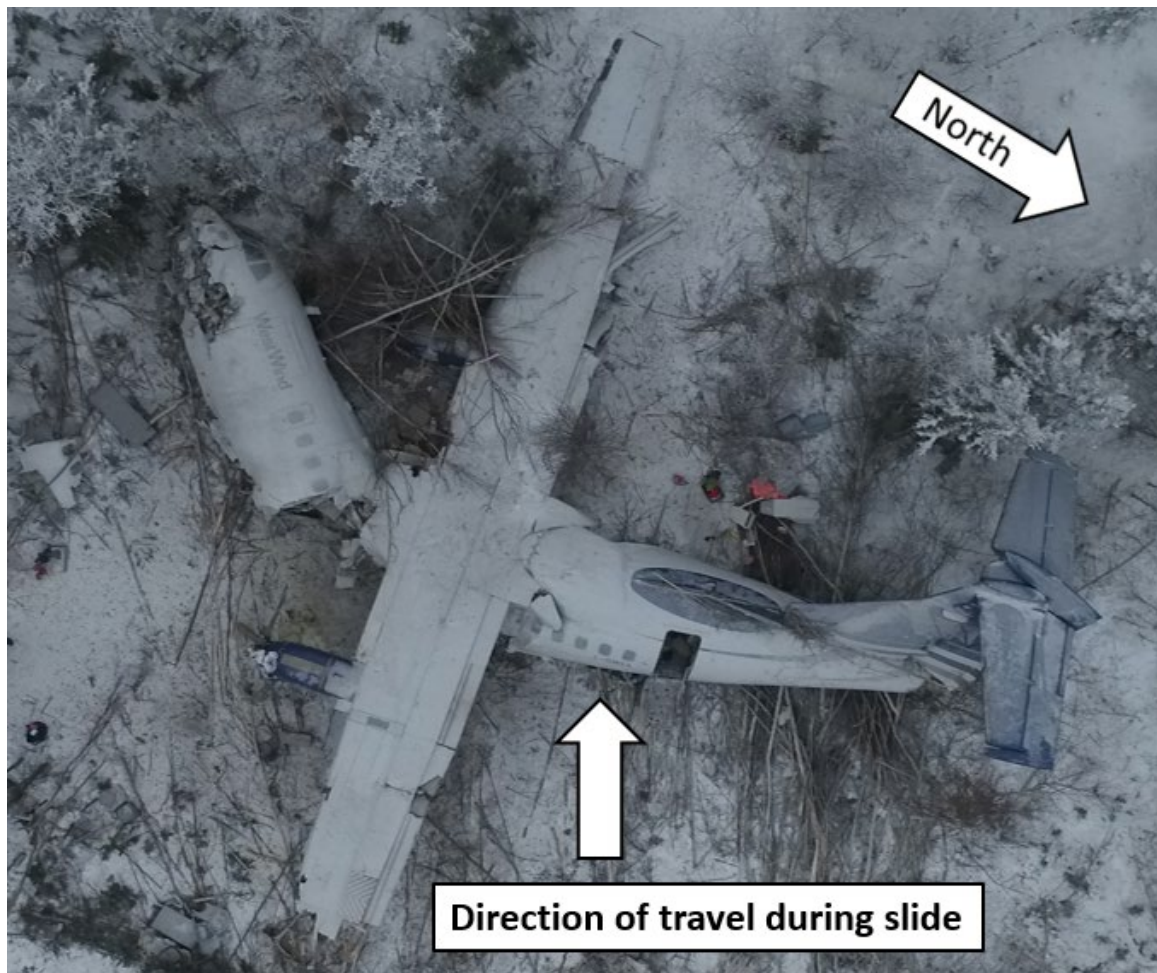
Figure 9. Photo of aircraft wreckage, as seen from above (Source: Royal Canadian Mounted Police, with TSB annotations)

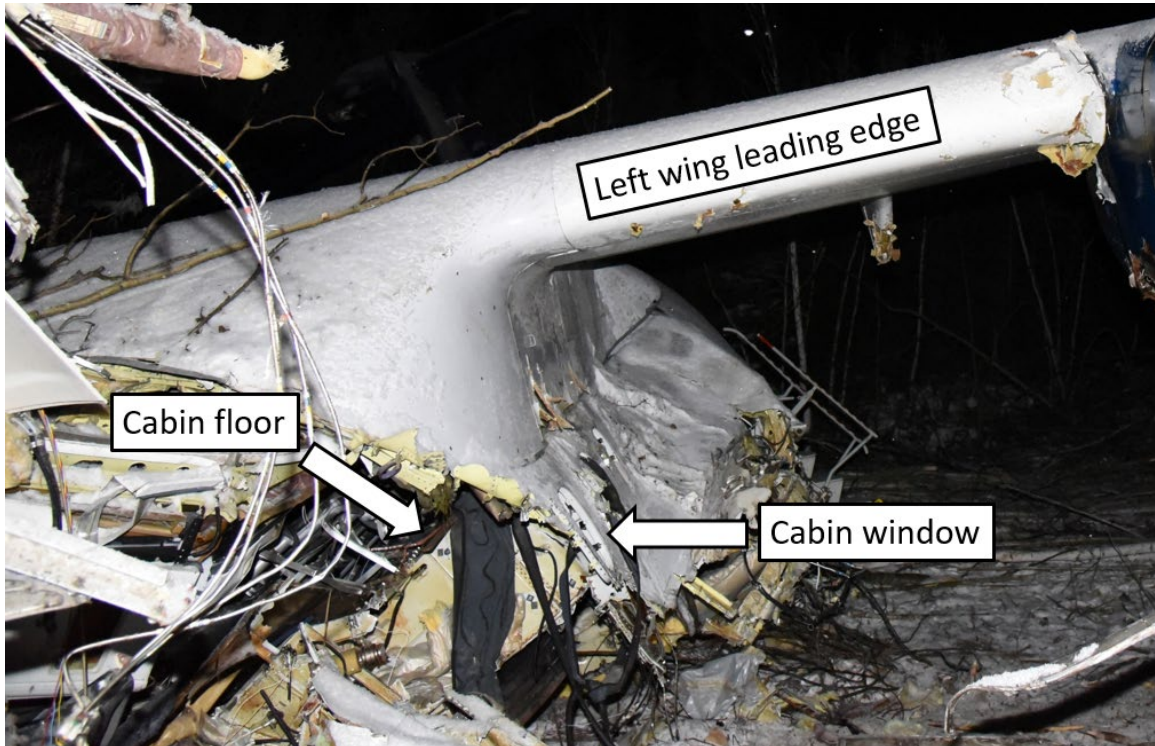
Figure 10. Close-up view of the fractured fuselage forward of the wing (Source: Royal Canadian Mounted Police, with TSB annotations)

Examination of the upper portion of this centre fuselage section underneath the wing showed that the 2 strongest circular frames (frames 25 and 27), also called lift frames, had fractured. Since these lift frames support the wing and maintain the circular integrity of the cabin, these fractures had resulted in the collapse of this fuselage section.

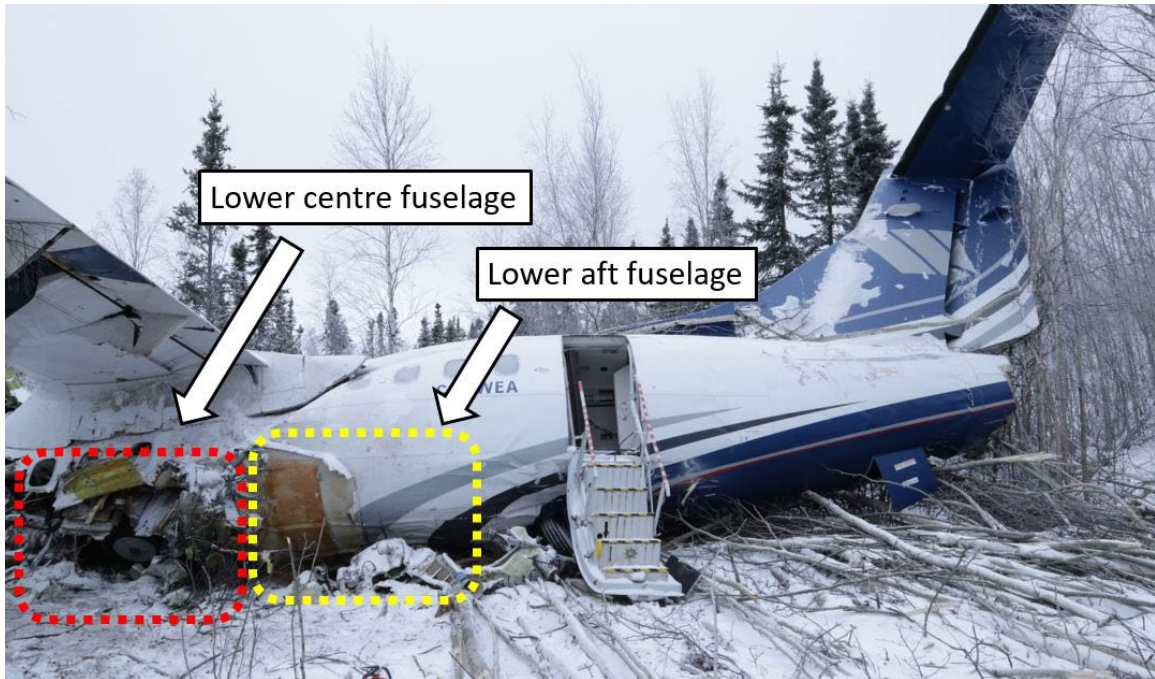
Figure 11. Left side view of the lower centre and aft fuselage sections of the aircraft at the crash site
(Source: TSB)

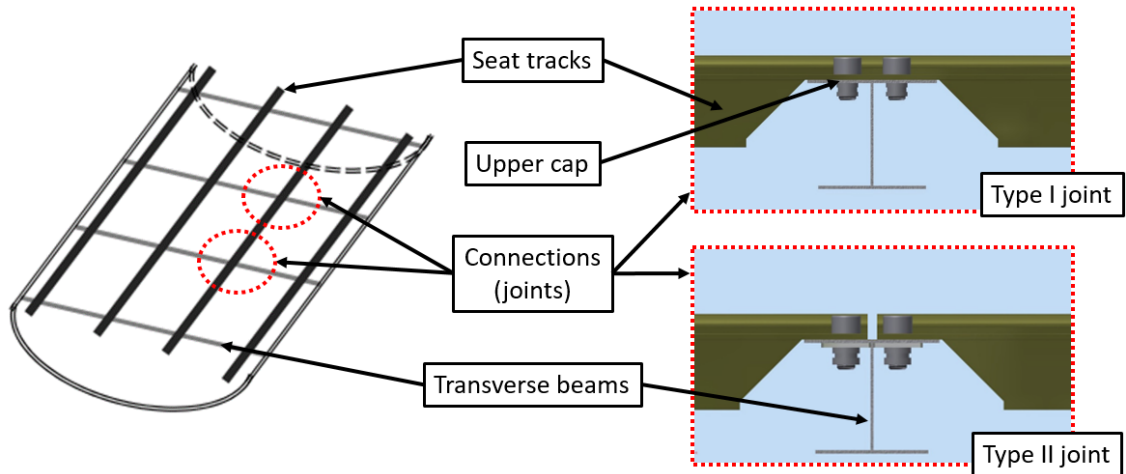
The floor structure, including the seat tracks, failed and buckled in several locations. Examination found that, among all seat tracks examined, several type II joints had failed, whereas none of the type I joints had failed. The failure modes were either failure of the bolt or shear failure of the plate with the bolt holes on the upper cap of the transverse beam.

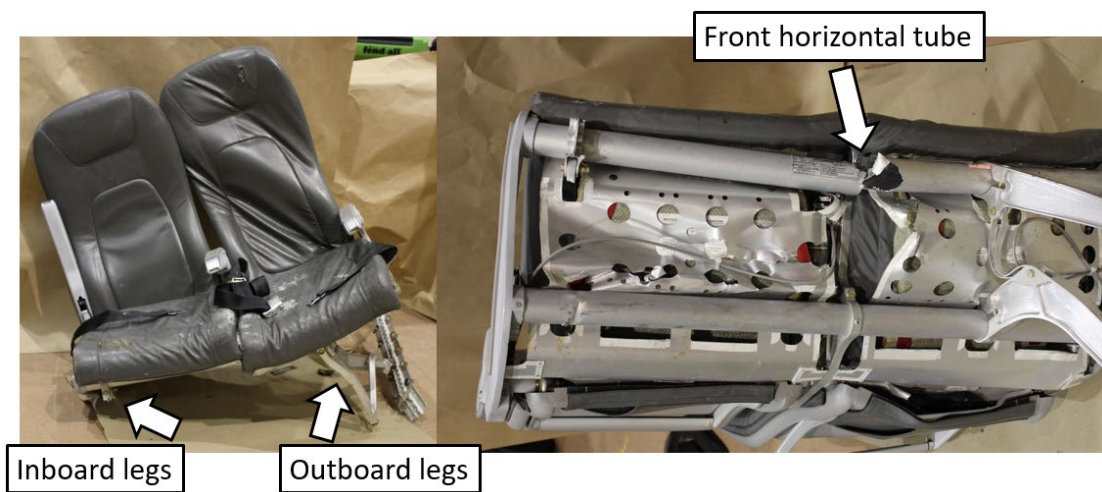
Figure 14. Photo showing damage to the left-side seat pair from row 6 (Source: TSB)

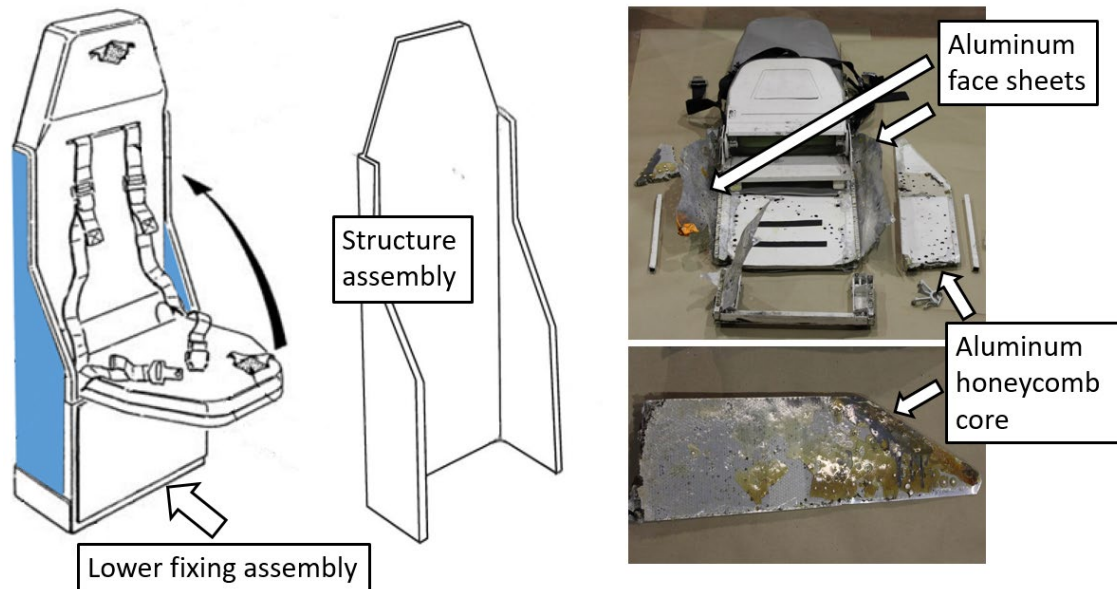
As a result of unapproved repairs, the flight attendant seat failed on impact, resulting in injuries that impeded her ability to perform evacuation and survival actions in a timely manner.

The structure assembly was found broken into pieces. Both the left and right legs had separated from the back panel and from their lower portions, which were still inserted into the slots of the lower fixing assembly.

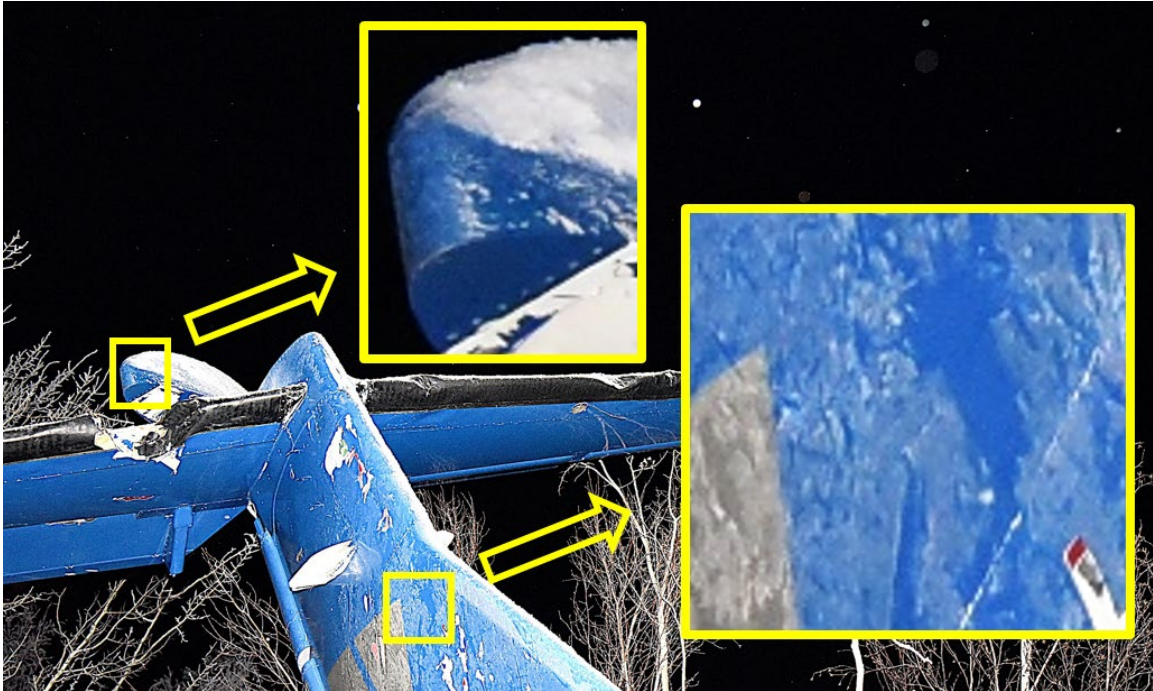
Figure 17. Photo of vertical stabilizer, with 2 inset images showing ice contamination on the leading edge of rudder horn and the right side of the stabilizer (Source: Royal Canadian Mounted Police, with TSB annotations)

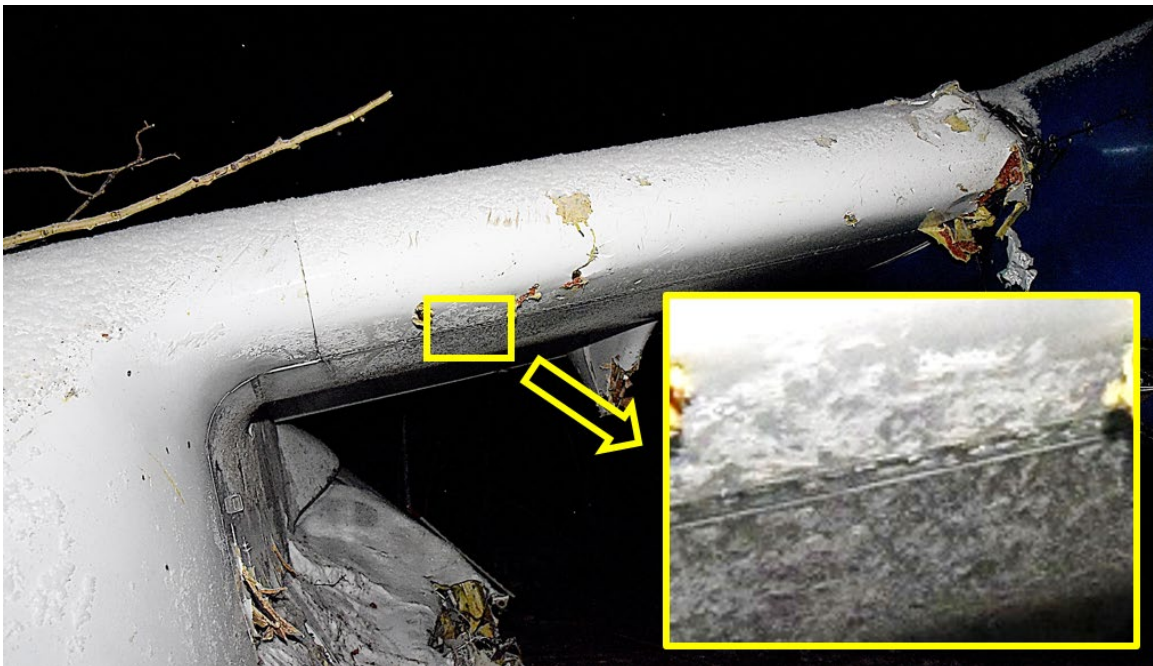
Figure 18. Photo of inner left wing with inset image showing surface contamination on lower leading edge (Source: Royal Canadian Mounted Police, with TSB annotations)

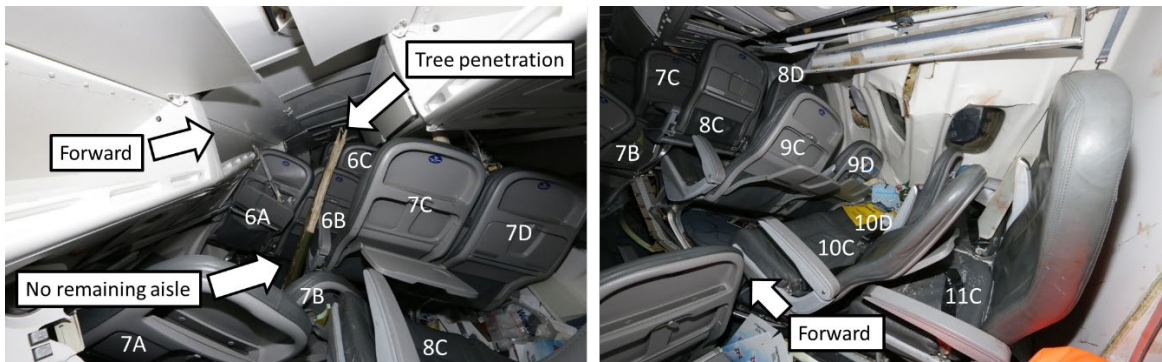
The tops of the seatbacks of the seats in rows 4 and 5 on the right side of the aisle had contacted or penetrated the overhead luggage compartment. The survivable space for each seat in rows 4 to 6 had been reduced to 1 to 2 feet, and the head space had been reduced in many other nearby rows (Figure 22).
