# AIR TRANSPORTATION SAFETY INVESTIGATION REPORT A21Q0024

## **COLLISION BETWEEN SLING LOAD AND TAIL ROTOR**

Héli-Express Inc.  
Airbus AS350 B2 (helicopter), C-GHEX  
Les Escoumins, Quebec, 1.5 NM NNE  
11 May 2021

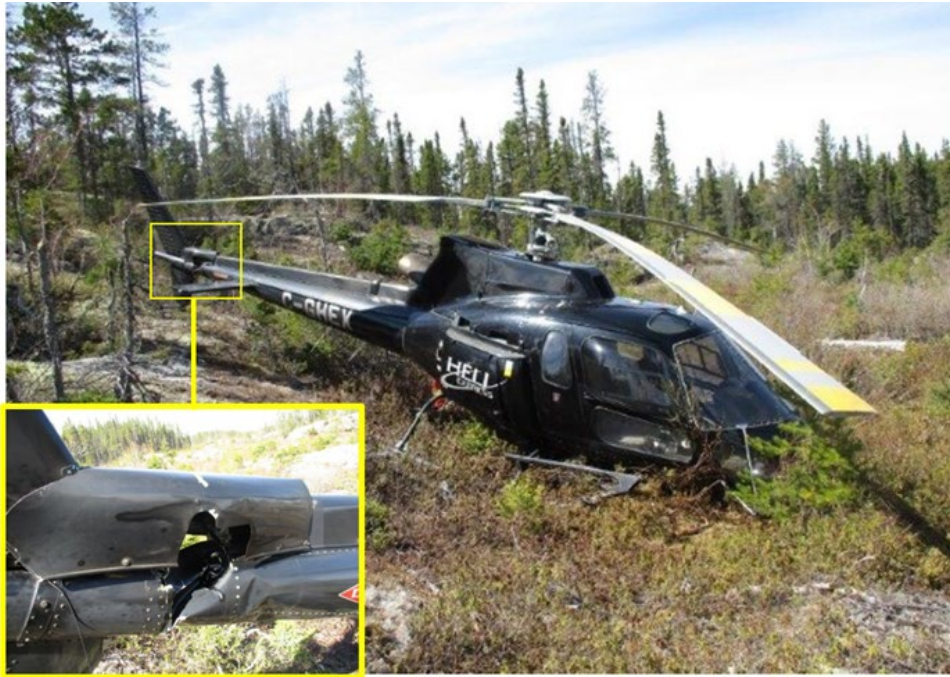
Figure 3. Photo of the wreckage, with inset image showing a magnified view of the damage to the tail (Source: Sûreté du Québec)

The aircraft made a hard landing on rugged terrain with sparse patches of low vegetation. It was found standing on its skids. The landing gear had collapsed and was deformed by the force of the impact (Figure 3).

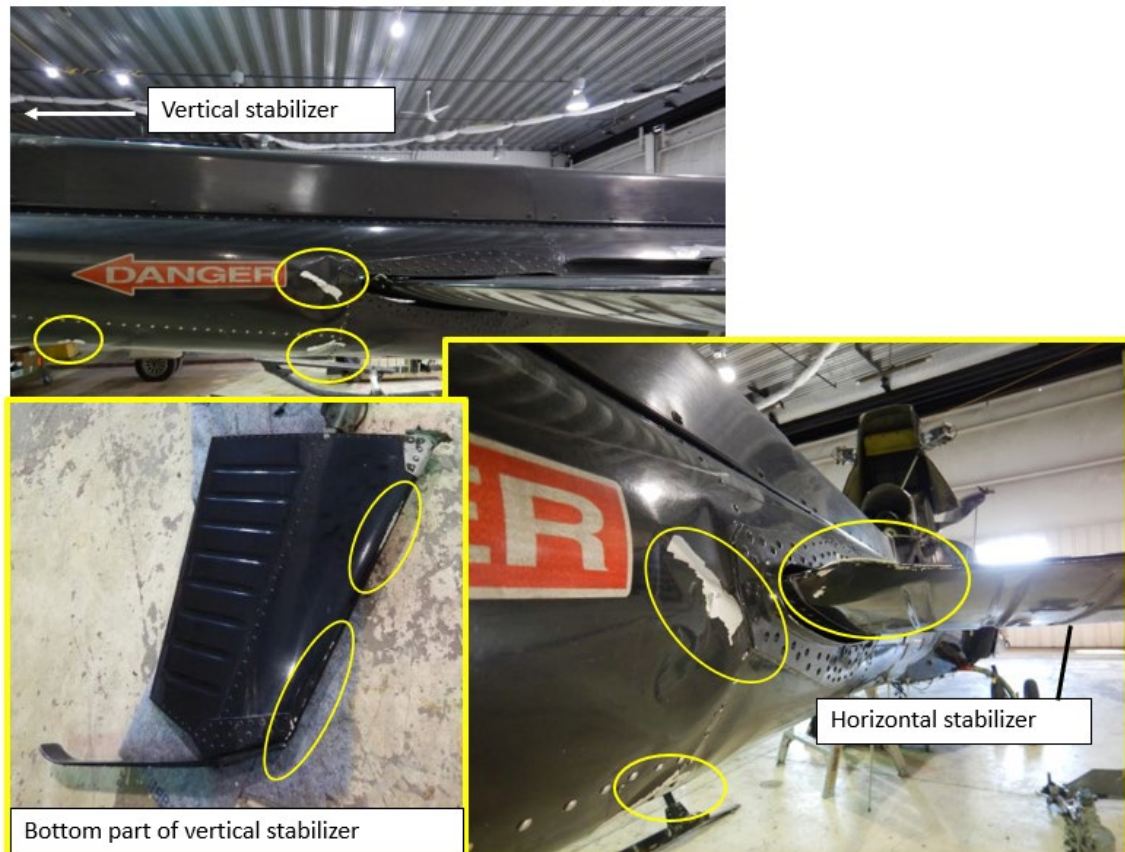
Figure 4. Photos showing the damage to the tail boom and horizontal and vertical stabilizers (Source: TSB)

The tail rotor and gearbox were missing from the end of the tail boom. The right horizontal stabilizer was curved at the trailing edge, near the tail boom, over approximately 4 inches. Also, impact marks and scratches were visible in several locations along the right side of the tail boom, between the horizontal stabilizer and vertical stabilizer, and along the bottom part of the leading edge of the vertical stabilizer (Figure 4).

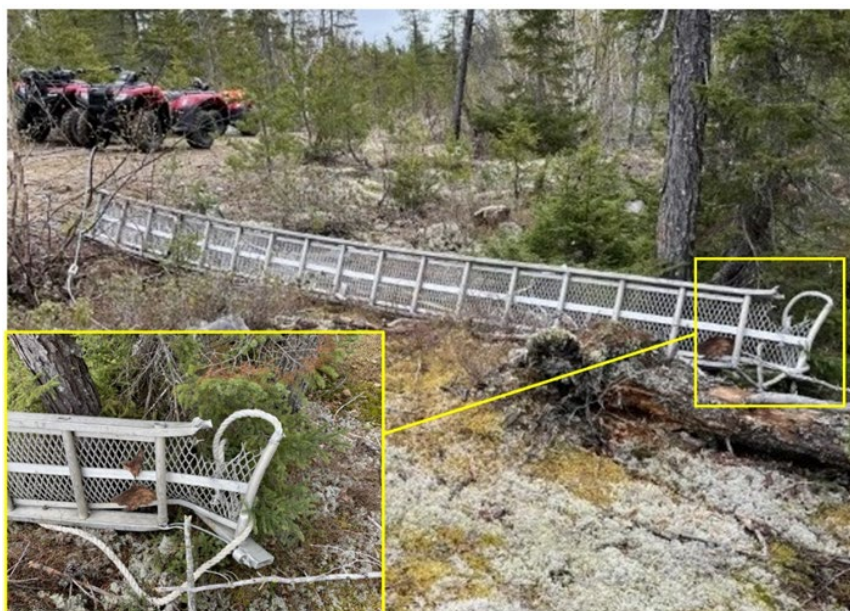
Figure 5. Photo of the damaged platform, with inset image showing magnification of the damaged end (Source: Hélic-Express)

The tail rotor and gearbox were found approximately 70 feet from where the platform fell after it was released by the pilot. The platform was found to be substantially damaged at one end. The lifting straps were still attached (Figure 5).

The platform (model LG18, serial number C17-C15-8-1) had been manufactured in March 2021 in accordance with engineering drawings designed to meet GLR's needs. It was approximately 18 feet long and weighed approximately 121 pounds. The damage to one end was caused by the impact of an object hitting it from underneath.

An analysis of the marks observed on the leading edge of one of the tail rotor blades confirmed that it hit the platform in an upward motion.

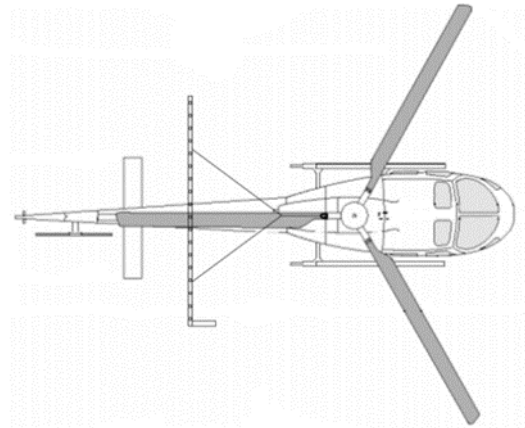
Figure 6. Illustration showing the view from the top of the helicopter with the platform perpendicular to the helicopter's longitudinal axis (not to scale) (Source: TSB)

Figure 6 shows a configuration where the platform is perpendicular to the helicopter's longitudinal axis, with the strap attachment points on the platform perfectly symmetrical. According to calculations, in this configuration, the maximum distance that could be reached by any part of the platform is 128 inches from the cargo hook. The configuration assumes symmetrical drag factors, which was not the case for the occurrence platform. It was found attached asymmetrically (one strap was attached 51 inches from the tip, the other 39 inches from the other tip). Therefore, the symmetrical configuration shown in Figure 6 would not be representative of the typical flight attitude of the occurrence platform.

These 3 configurations assume that the platform is parallel to the horizontal plane, which was not the case in this occurrence. By applying all the factors (drag, helicopter speed, etc.), it was estimated that the closest the platform would have been to horizontal was  $24^\circ$  to the horizontal plane of the helicopter, as it would have been in the first configuration (perpendicular platform, shown in Figure 6).

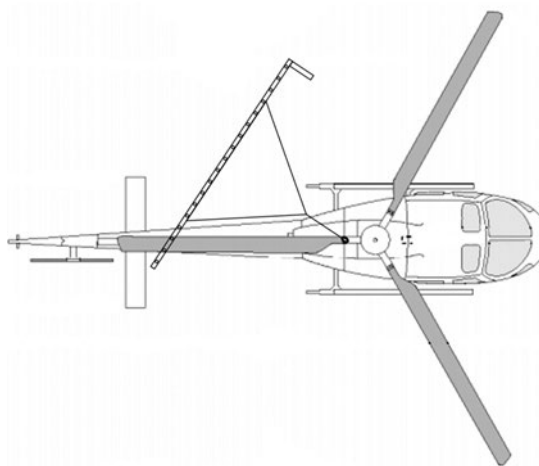
Figure 8. Illustration showing the view from the top of the helicopter with the platform carried at an angle to the helicopter's longitudinal axis (not to scale) (Source: TSB)

Figure 8 shows a configuration where the platform is at an angle (approximately 40° to the tail rotor disk) to the helicopter's longitudinal axis. This configuration is the most probable based on the test carried out in flight before the occurrence. In this configuration, the 2 straps are held taut by the tension of the aerodynamic load. According to calculations, in this configuration, the maximum distance that could be reached by any part of the platform is 170 inches. Knowing that the damage was approximately 10 inches from the tip of the platform, and taking into account the angle, the distance between the cargo hook and the damage was estimated to be 164 inches.

The impact marks on the tail rotor indicate the direction from which the damage was caused. The deformation of the platform clearly shows that the tail rotor struck the underside of the platform at an angle of approximately  $40^\circ$  to the tail rotor's plane of rotation. When the damage is looked at as a whole, for the damage to the platform to be possible, the platform must have been oriented approximately  $40^\circ$  to the direction of flight and offset to the left, which corresponds to the configuration shown in Figure 8.

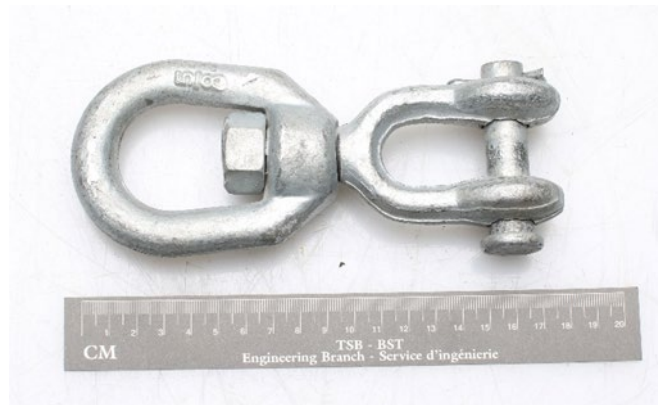
Figure 9. Photo of the Crosby G-403 jaw end swivel used in the occurrence (Source: TSB)

The Crosby G-403 jaw end swivel (Figure 9) used to carry the occurrence platform was designed for cable pulling (to roll out electrical wiring when installing a line above ground or underground, for example), not for lifting a load.<sup>7</sup> To determine whether this particular swivel allowed the platform to pivot in flight, the TSB laboratory carried out a torque test<sup>8</sup> on different loads. A load of 82 pounds produced little friction and allowed the swivel to

The platform's tension load while moving in the air at a speed of 65 knots was assessed at 268 pounds.<sup>10</sup> Given the positioning of the straps found on the platform and the drag experienced by the platform while airborne, an imbalance could be expected. Under these conditions, the torque produced by the aerodynamic forces in was from 7.5 to 10 times greater than what was needed to pivot the platform. Consequently, it is highly likely that the platform turned or swung during the occurrence flight.

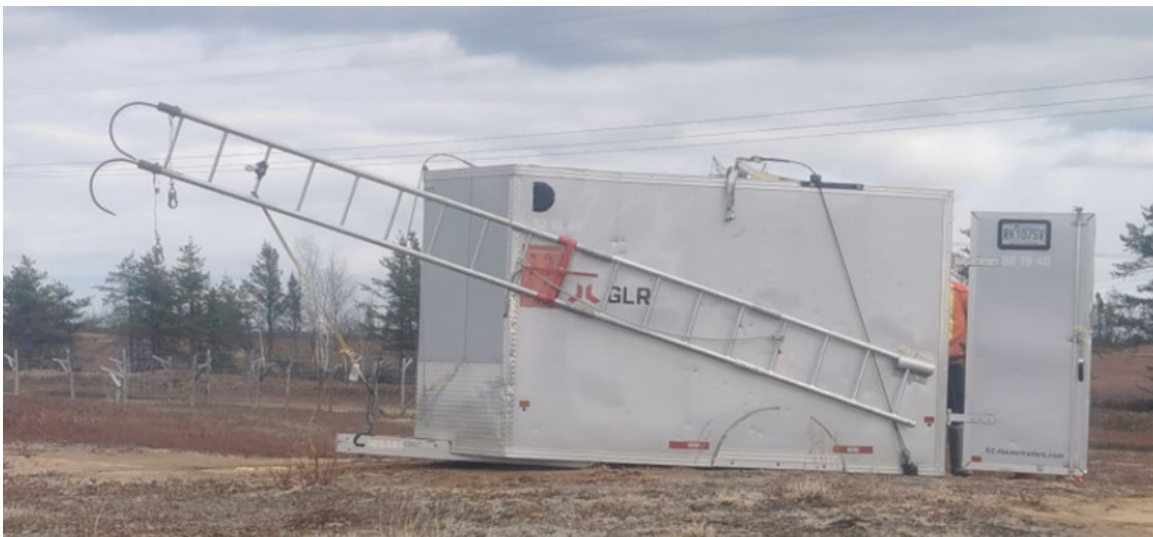
Figure 12. Ladder secured to the side of an equipment trailer (Source: Héli-Express)

Once work began, GLR decided to secure the ladders to the side of equipment trailers to transport them, but the ladders were collapsed and did not extend beyond the trailer. Then, to save time, some workers decided to secure the ladders to the side of the trailers without collapsing them (Figure 12).

The Héli-Express operations manager was later notified of this practice by the occurrence pilot, who felt that this practice was dangerous because the trailer was suspended directly from the cargo hook mounted on the belly of the helicopter. The Héli-Express operations

manager immediately informed the site manager that he did not approve of this method, and said that from now on, ladders needed to be collapsed and stored in the trailers if they were being transported without a sling. GLR, which had adopted this method and deemed it safe and efficient, found this decision frustrating and did not understand the reason for it, especially since the first pilots had accepted it without expressing any particular safety concerns.

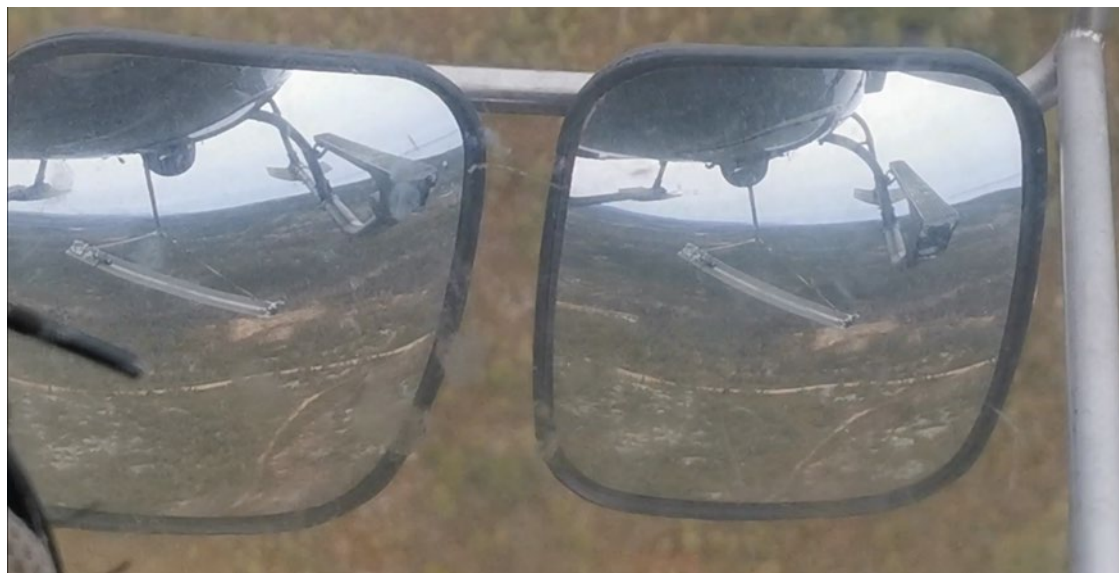
Figure 13. Images reflected in the helicopter's mirrors, showing the position of the platform while being carried horizontally, without a sling, during the test flight (Source: screen shot of a video filmed by the occurrence pilot during the test flight)

Having observed the instability of the platform while it was being transported vertically, the occurrence pilot wanted to find a better way to sling the platform in case the situation happened again. He conducted a test flight, carrying the platform secured horizontally without a sling. He was satisfied with the results of this test. He then contacted Héli-Express's operations manager, informed him of the method chosen to transport a platform or ladder, and sent him a video filmed during the test flight (Figure 13). GLR and the loadmaster were informed of the decision and how the straps should be installed. No concerns were raised.

After this decision, platforms were transported horizontally on at least 2 occasions without incident. Only a slight oscillation was observed on takeoff when the helicopter was carrying a platform, but it was quickly stabilized by increasing speed.
