AIR TRANSPORTATION SAFETY INVESTIGATION REPORT A21W0045

IN-FLIGHT BREAKUP

Yellowhead Helicopters Ltd.
Bell Textron Inc. 212 (helicopter), C-GYHQ
Evansburg, Alberta, 4 NM WNW
28 June 2021

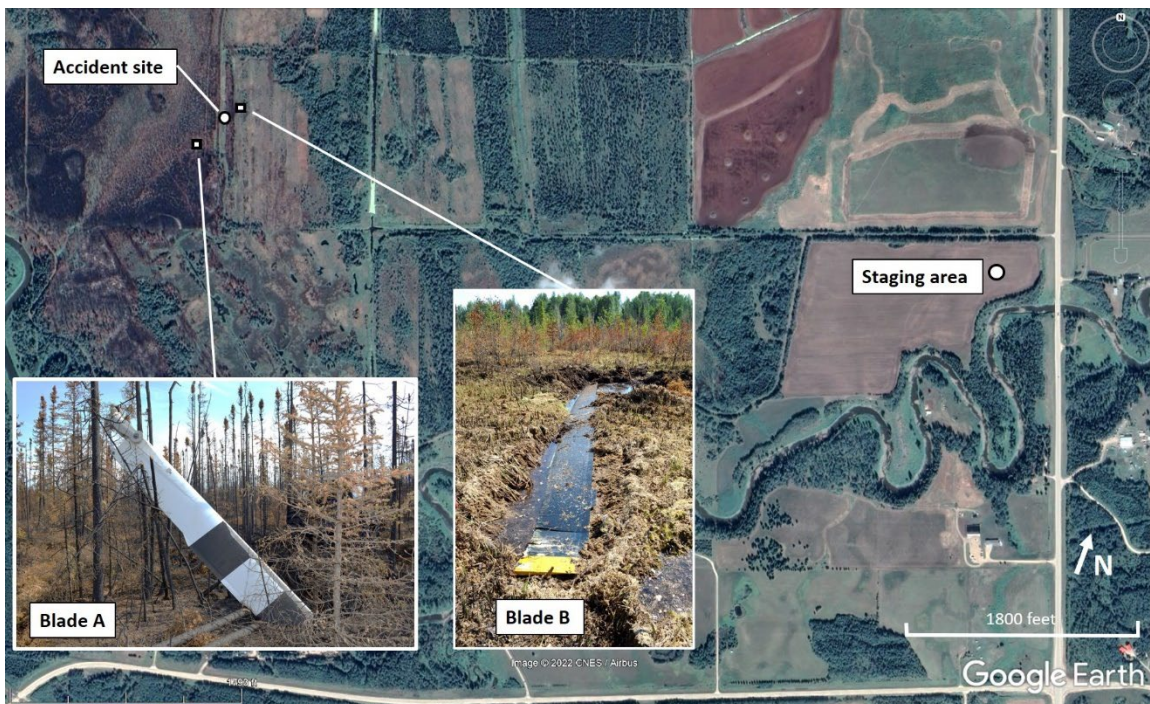
Figure 3. Map showing the location of the staging area and accident site, with inset photos of the 2 main rotor blades (Blade A and Blade B) (Source: Google Earth, with TSB annotations)

The first main rotor blade to separate from the helicopter (blade A, Figure 3) came to rest in a burned out bush area approximately 460 feet southwest of the main wreckage site. The tip of this blade was buried in the muskeg approximately 10 feet deep, with the blade grip end pointing up.

The second main rotor blade (blade B, Figure 3) separated from the helicopter with the rotor head assembly still attached and came to rest on top of wet muskeg 85 feet northeast of the main wreckage site.

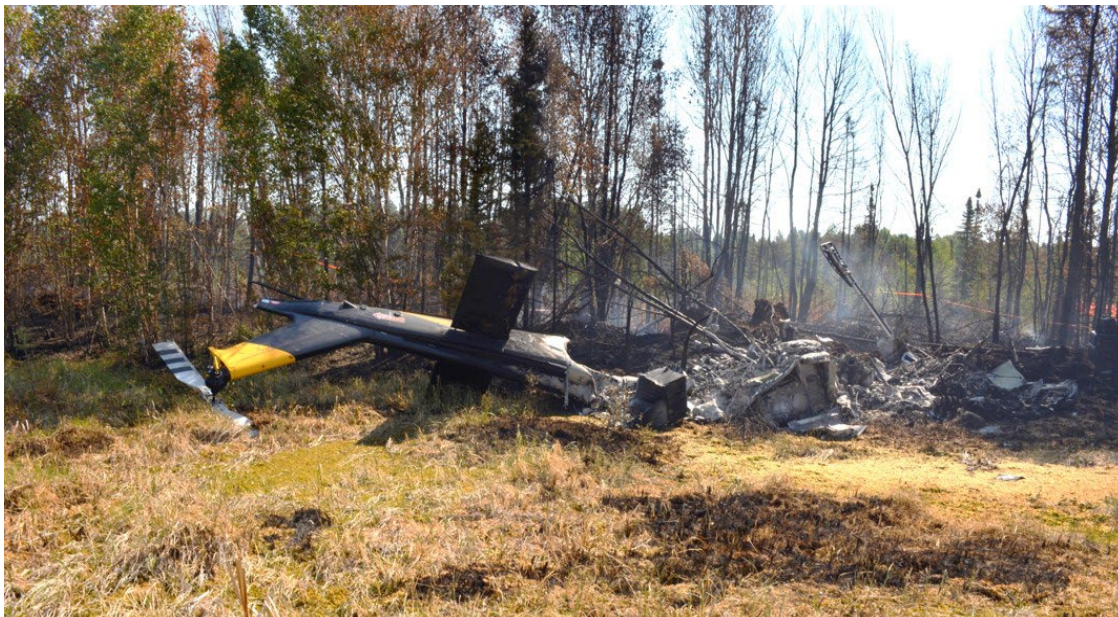
The helicopter came to rest on its right side in muskeg (Figure 4). The east side of the fuselage wreckage site was accessible via stable but burned out earth and trees. The west side of the fuselage wreckage was in a muskeg area in water that was several feet deep. The majority of the fuselage was consumed by the post-impact fire. The tail boom remained largely intact.

Figure 4. Accident site looking east (Source: TSB)

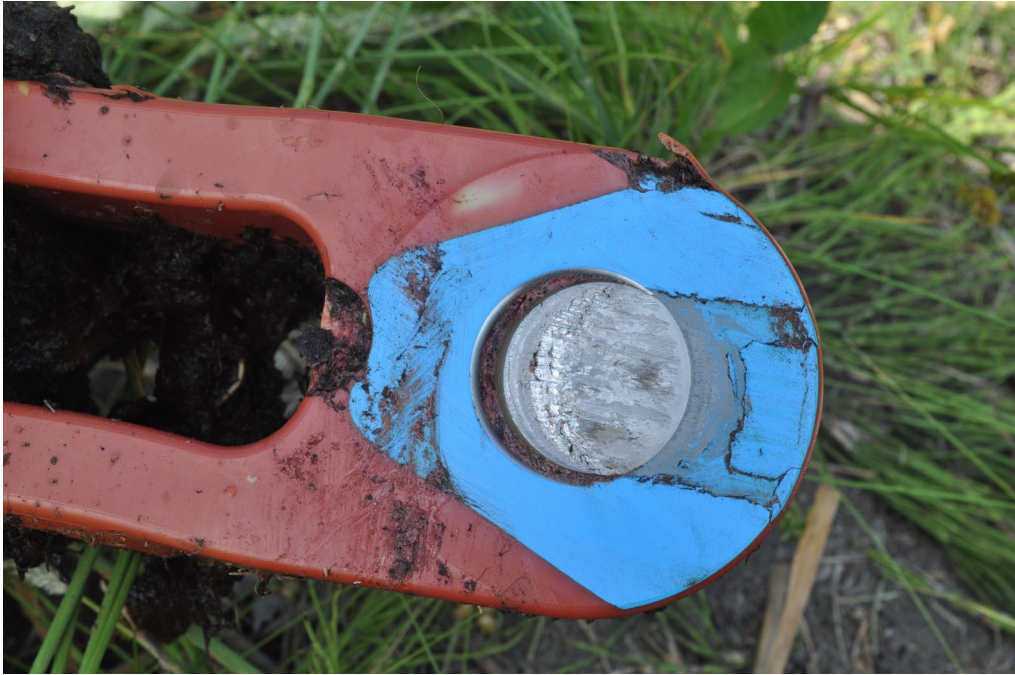
Both main rotor blades were recovered from the muskeg and brought to the staging area where the main rotor blades were removed from their respective blade grips (Figure 5, Figure 6). Investigators observed that the main rotor hub strap retaining pin of blade A had failed. Both grips and the main rotor head assembly were shipped to the TSB Engineering Laboratory in Ottawa, Ontario, for a detailed examination, and metallurgical analysis (see section 1.16 *Tests and research*).

Figure 5. Photo of main rotor blade A strap and failed hub strap retaining pin (Source: TSB)

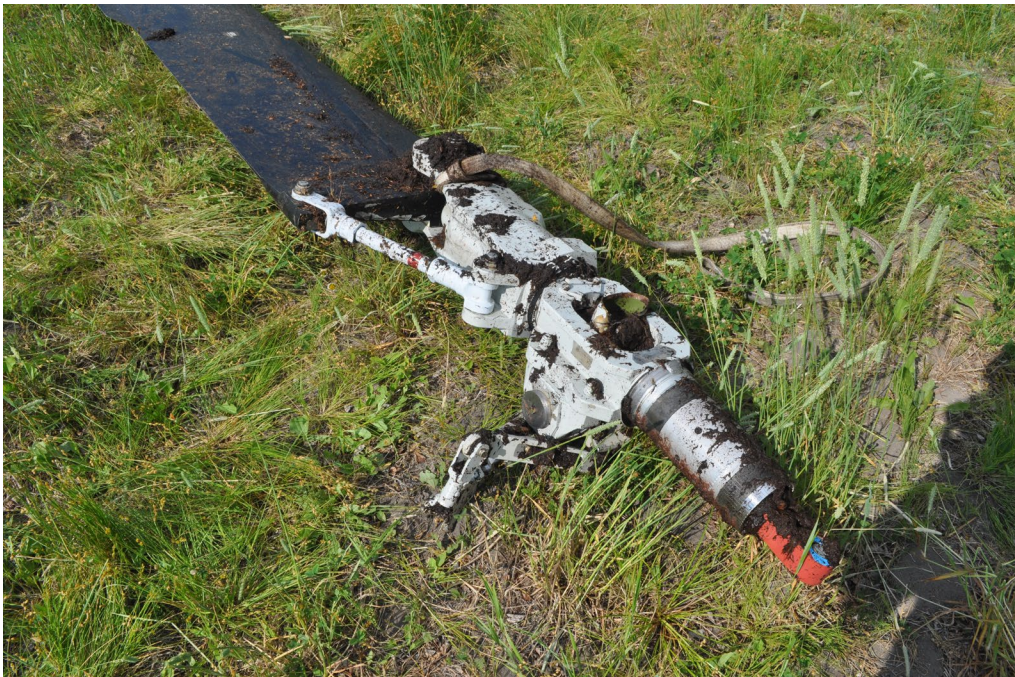
Figure 6. Photo of the main rotor blade B and rotor head assembly (Source: TSB)

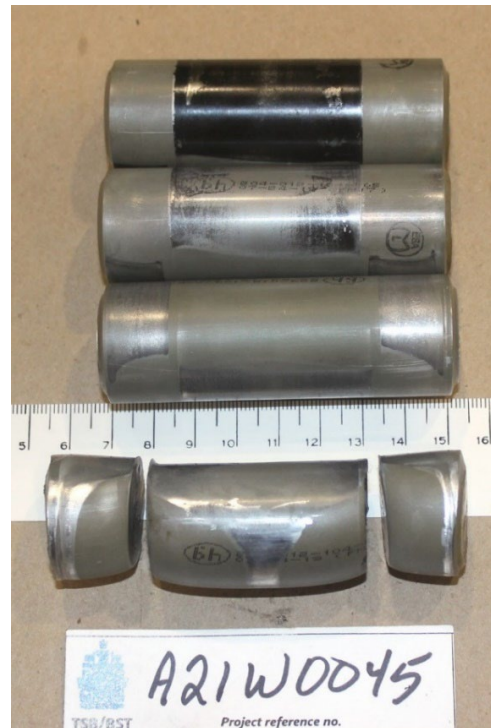
Metallurgical analysis of the 4 pins (part number 204-012-104-005) revealed that the failed pin (serial number FNFS90, bottom of Figure 7) was manufactured from 316 stainless steel, whereas the other 3 pins (serial numbers FNFS49, FNFS54, and FNFS75) were manufactured from H11 tool steel. The TSB Rockwell hardness test of the failed pin averaged 7.6 on the C scale² (see section 1.18.2.4 *Detailed inspection and hardness test*).

Figure 7. Photo of the occurrence helicopter's 4 main rotor hub strap retaining pins (Source: TSB)

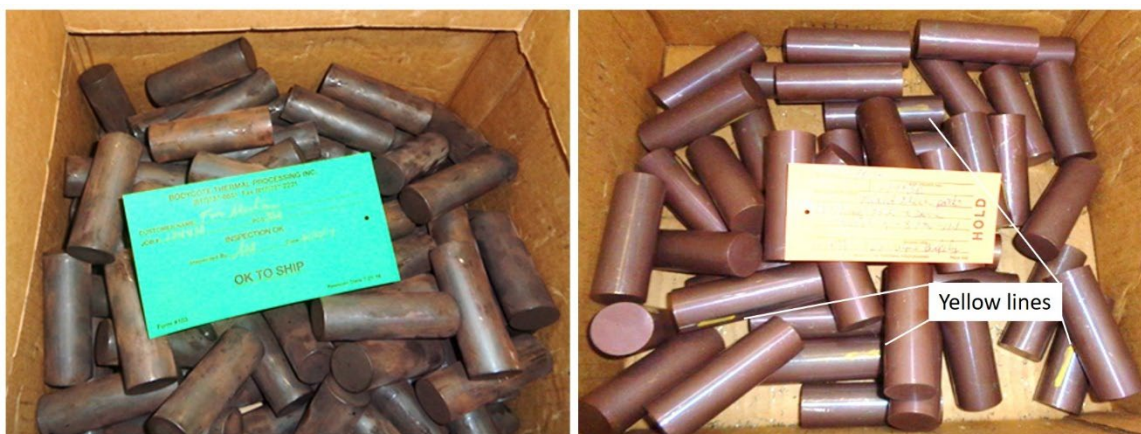
In the end, Bodycote performed hardness testing on all pins in the lot and marked the non-conforming pins with a short yellow line down the pin (Figure 10).

Figure 10. Pictures showing the shipments of conforming pins (left) and non-conforming pins (right) (Source: Bodycote, with TSB annotations)

A normal part of the receiving inspection process is a visual inspection of the parts being received. As shown in Figure 10, there is a distinct difference in the visual appearance of the raw pin blanks (H11 tool steel vs. 316 stainless steel) being returned from the heat treatment vendor. In addition, the pins that did not meet the hardness specification were identified with a yellow line marked down the side of the pin.

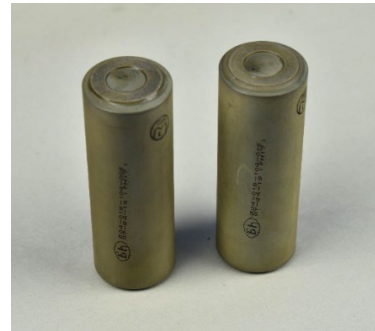
After reviewing the documentation that the company received with the part from Bell, and reviewing the physical characteristics of the non-conforming pin against a conforming pin, the investigation determined that it would be unreasonable to expect the aircraft maintenance engineer to have been able to identify the differences between the 2 parts (Figure 11). The physical appearance of each pin was essentially identical, and the weight difference between the 2 of them was approximately 13 grams, a discrepancy of 3.2%.

Figure 11. Example of 316 stainless steel pin on the left and H11 tool steel pin on the right (Source: Bell Textron Inc.)
