AIR TRANSPORTATION SAFETY INVESTIGATION REPORT A21C0078

LOSS OF CONTROL AND COLLISION WITH TERRAIN

MAG Aerospace Canada Corp.
Rockwell International Aero Commander 690B, C-GYLD
Thunder Bay Airport, Ontario
16 August 2021

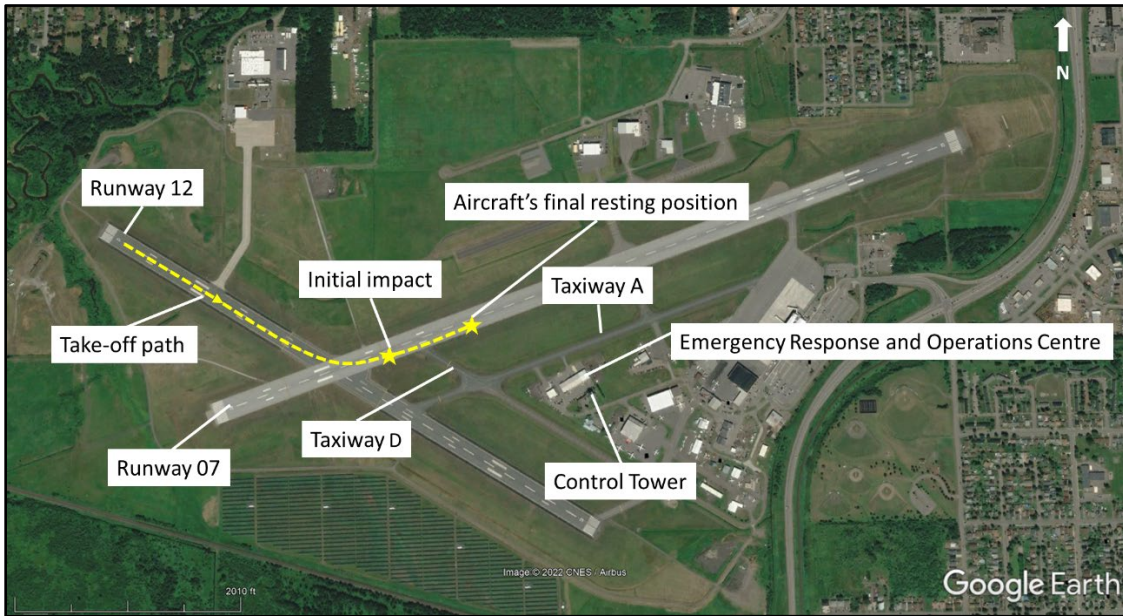
At 2109:50, the aircraft struck the surface of Runway 07 in an inverted attitude (Figure 1). The pilot was fatally injured. The aircraft was destroyed by the impact and post-impact fire. The emergency locator transmitter activated on impact.

Figure 1. Map showing the occurrence aircraft’s take-off path, point of initial impact, and final resting position at Thunder Bay Airport (Source: Google Earth, with TSB annotations)
