AIR TRANSPORTATION SAFETY INVESTIGATION REPORT A21Q0087

RUNWAY OVERRUN

Airmédic Inc.
Pilatus PC-12/47E, C-GIOX
Sept-Îles Airport, Quebec
12 September 2021

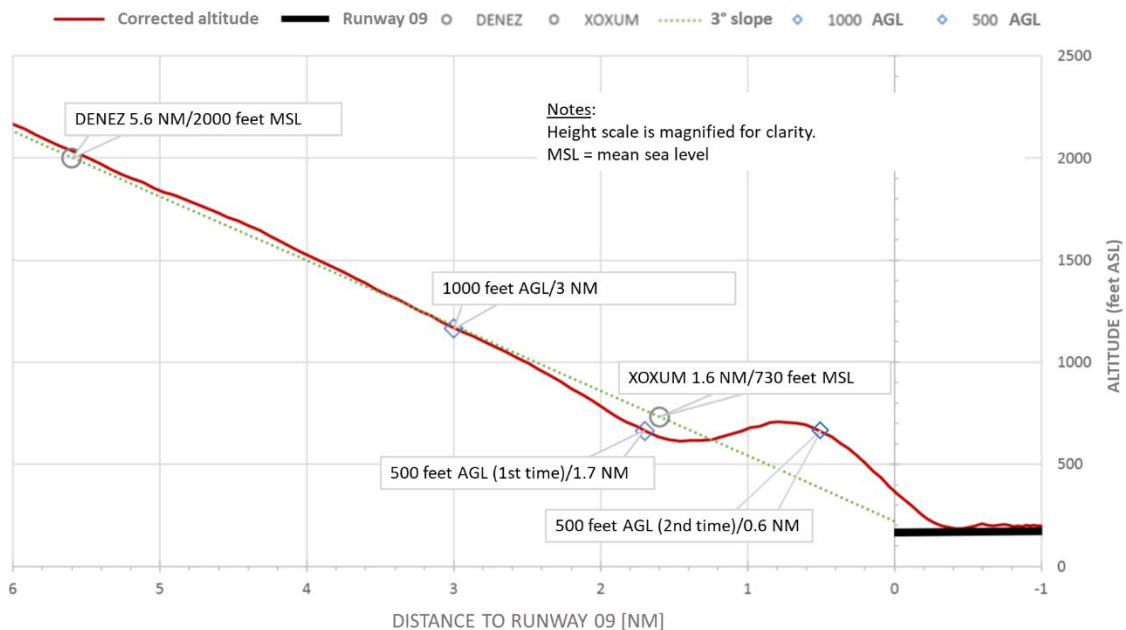
Figure 5. Graph illustrating the aircraft’s vertical path (solid line) in relation to the nominal 3° approach slope (dotted line) (Source: TSB)

The aircraft crossed the runway threshold at 200 feet AGL, at 180 KIAS (ground speed of 191 knots), with a rate of descent of 2000 fpm, the landing gear was in transit, and the flaps were in the fully retracted position. In such a situation, even if the pilot manages the flight path for a landing within the first $\frac{1}{3}$ of the runway, the aircraft has excessive vertical and horizontal speeds. To recognize that a change of plan is needed and to react in time, a pilot must perceive the condition or stimulus as important enough to warrant immediate action. Plan continuation bias becomes even stronger when a goal is on the verge of being achieved.

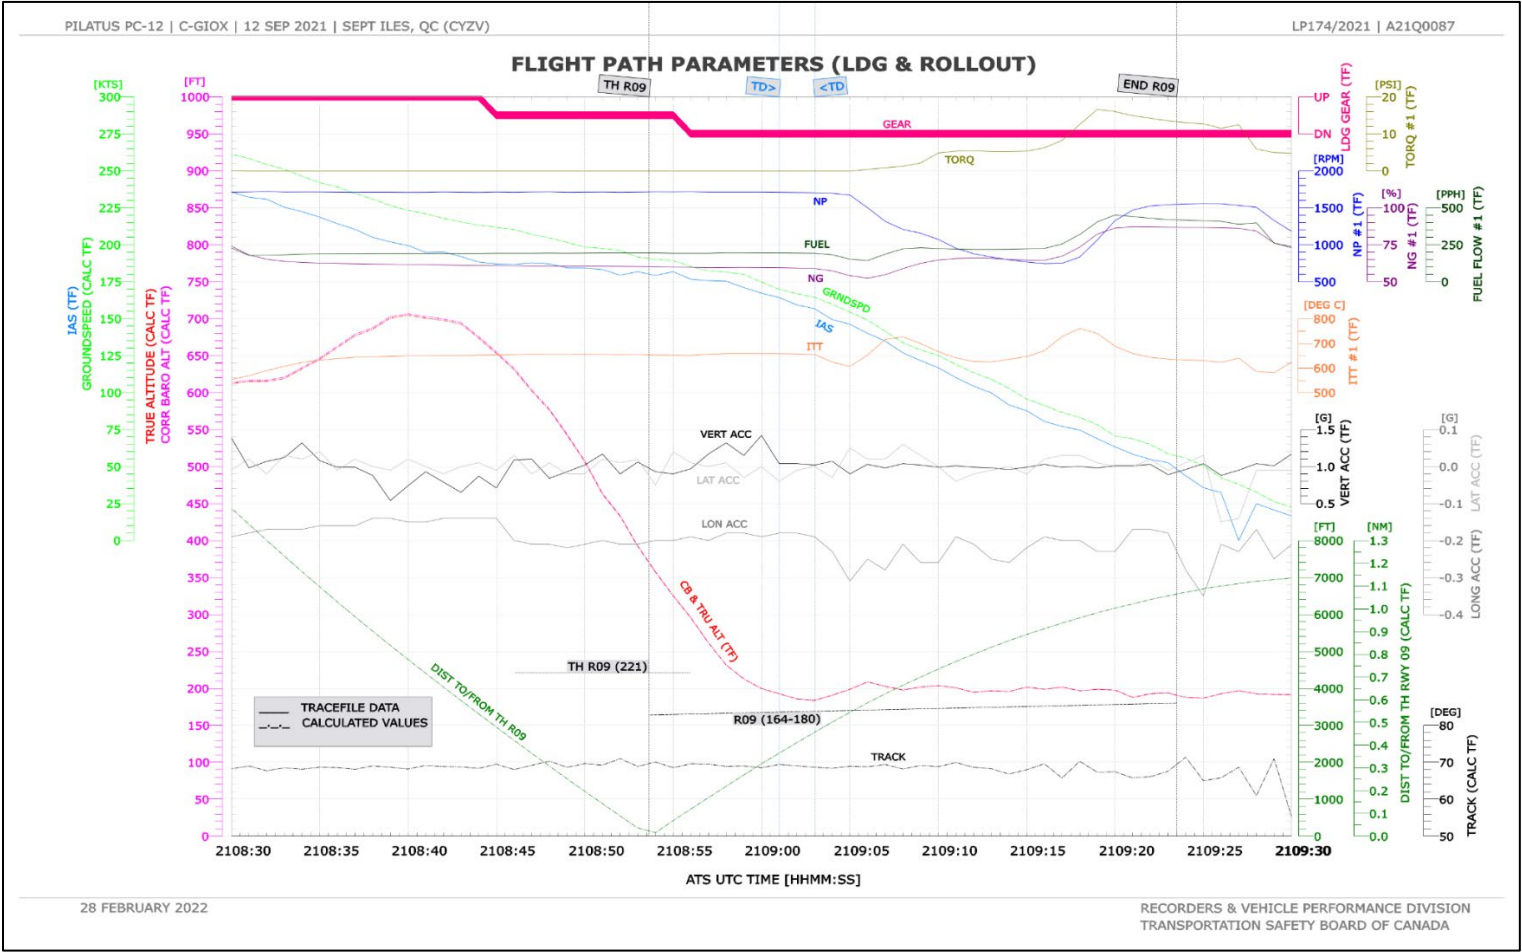
Figure D3. Flight path data plots during the landing and landing roll
