AIR TRANSPORTATION SAFETY INVESTIGATION REPORT A22P0023

ENGINE FAILURE AND COLLISION WITH TERRAIN

Kestrel Helicopters Ltd.

Hughes Helicopters, Inc. 369D (helicopter), C-GJLC

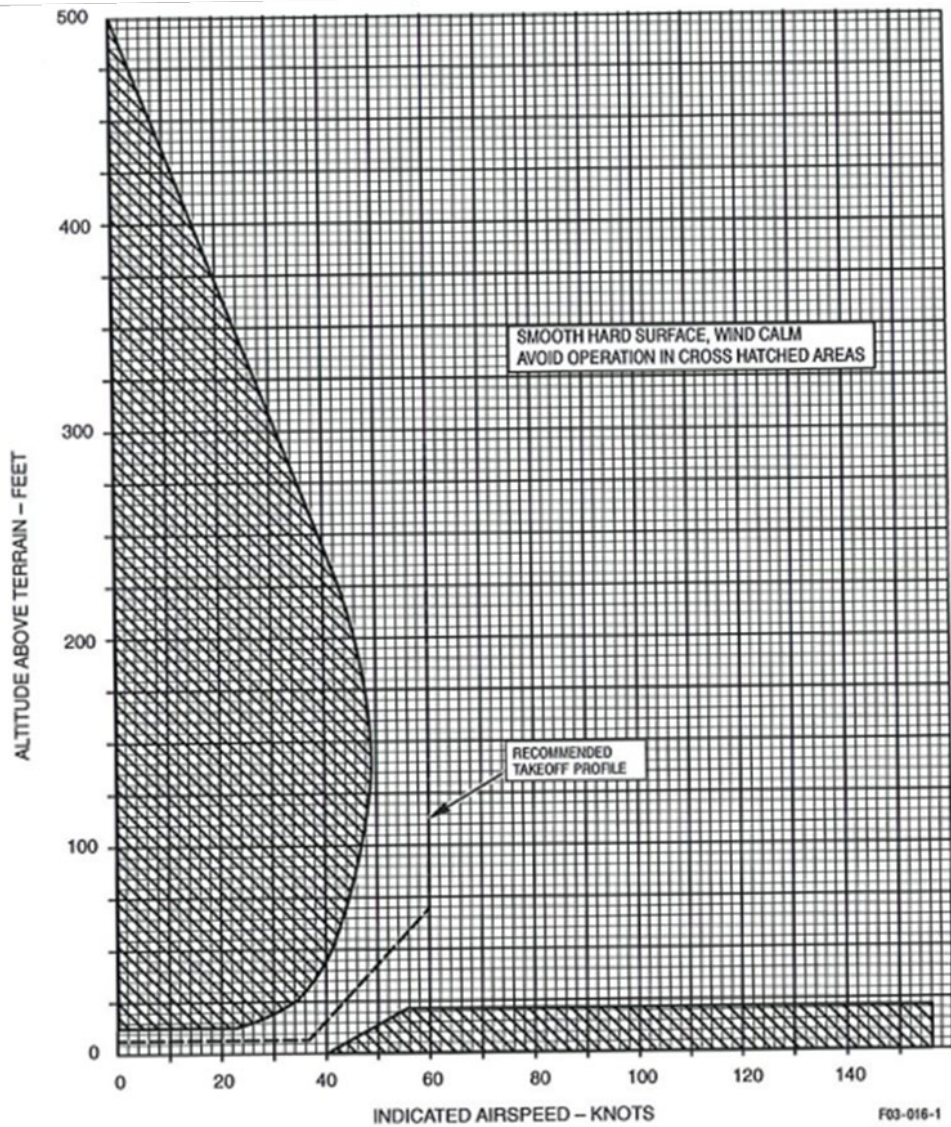
Figure 2. Height velocity diagram for the 369D (Source: MD Helicopters, LLC., MD 500D Rotorcraft Flight Manual [Model 369D], Revision 13 [21 July 2016], Section V: Performance Data, p. 5-21.)

At the time of the engine failure, the occurrence helicopter was likely at a height of 200 to 300 feet above ground level, with little to no forward airspeed.

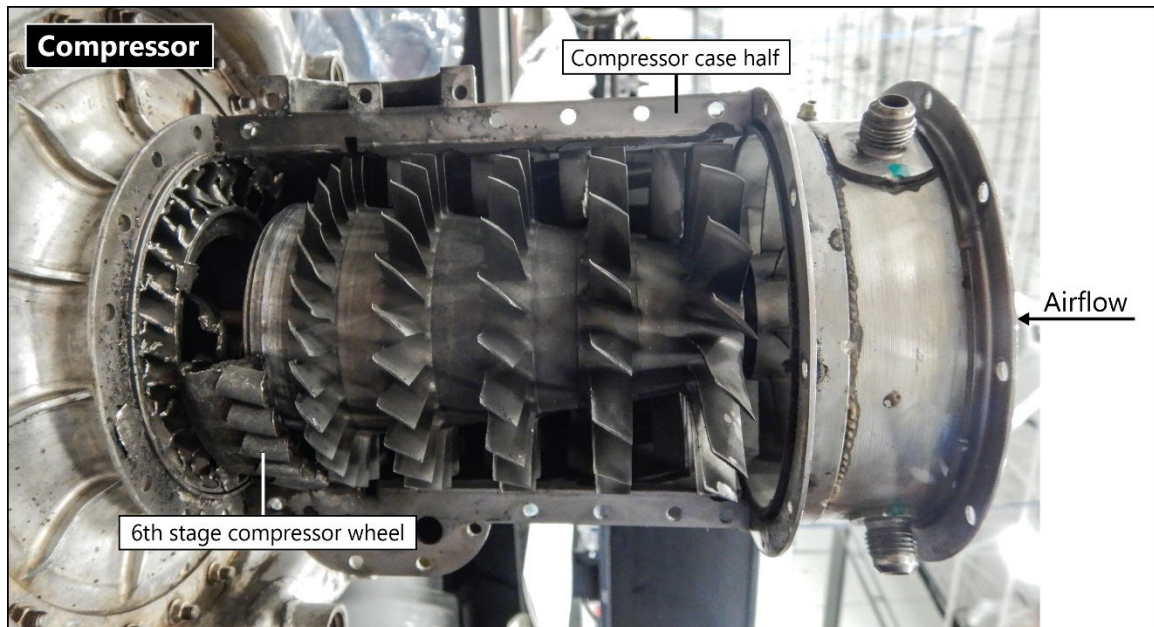
Figure 5. Compressor assembly (Source: TSB)

During this examination, it was determined that the compressor blades and guide vanes of the compressor assembly were damaged. In particular the compressor blades on the first through fifth stage compressor wheels were damaged but still in place. On the sixth stage compressor wheel, all of the blades were fractured or curled over. The guide vanes on the first through fourth stages were bent and damaged but still in place, whereas all of the guide vanes on the fifth and sixth stages were either liberated or bent over completely in the direction of engine rotation. There was no obvious damage noted on the outside of the case

halves. The sixth stage compressor wheel was broken and wedged within the assembly. Gross plastic deformation of the wheel was also noted.

The tie bolt, which holds the compressor assembly together, had failed at the aft end. Visual examinations of the bearings were completed as the compressor was disassembled, and all bearings rotated freely with no obvious damage observed.

It was determined that the blade failures in the compressor assembly had been caused by overstress and that the tie bolt failed in torsional overstress. These failures were incidental to the fatigue failure of the sixth stage compressor wheel.

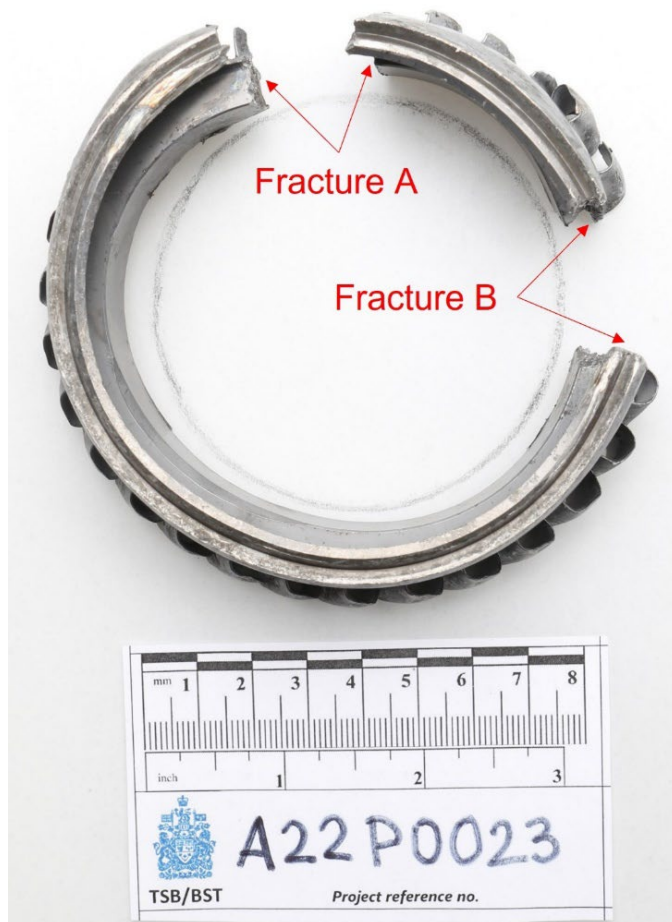
Figure 6. Fractured sixth stage compressor wheel. The drawn circle indicates the circumference of the wheel before it was fractured (Source: TSB)

The sixth stage compressor wheel (part number 23057116, serial number KR59007) was extracted from the compressor assembly and found to have fractured into 2 pieces, with no pieces missing (Figure 6).

One of these fractures (fracture A) was caused by multiple fatigue cracks that had propagated inward from the forward face of the wheel. This cracking developed at shrinkage voids⁷ that were partially open to the edge, located on the forward face, closer to the inner circumference of the wheel (Figure 7). The final separation at this fracture was due to overstress. The 2nd fracture (fracture B) was caused entirely by overstress.

The sixth stage compressor wheel separated into 2 pieces, resulting from 2 fractures. One of these fractures was caused by multiple fatigue cracks that had propagated inward from the forward face of the wheel. This cracking developed at shrinkage voids that were partially

open to the edge, located on the forward face, closer to the inner circumference of the wheel. The final separation at this fracture was due to overstress. The other fracture was entirely due to overstress.

The sixth stage compressor wheel eventually failed when 2 separate fractures, one due to fatigue caused by shrinkage voids and the other due to overstress, occurred. The failure of the sixth stage compressor wheel resulted in a catastrophic engine failure.

On 18 May 2023, the engine manufacturer re-issued Commercial Service Letter 1255, which includes a recommendation that its customers convert the compressor to the new wheel design during the next overhaul.

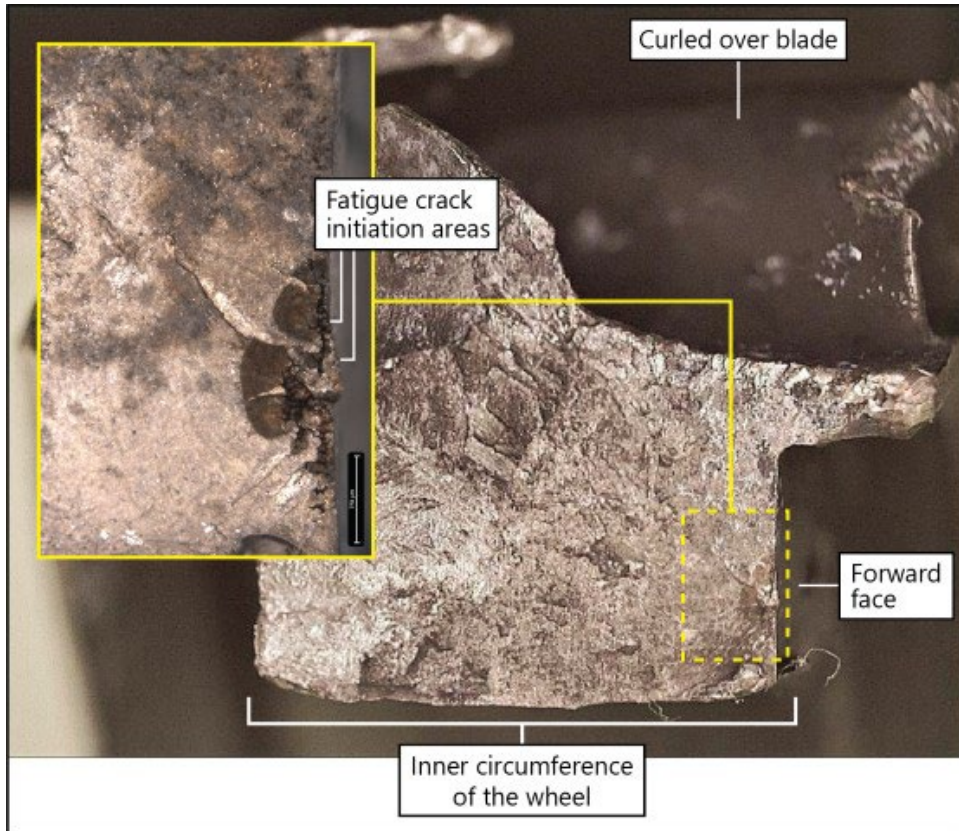
Figure 7. Occurrence sixth stage wheel cross-section showing estimated location of fatigue crack initiation areas (fracture A) and orientation to the inner circumference of the wheel (Source: TSB)

⁷ Shrinkage voids are casting defects caused when there is an insufficient volume of metal in the mold. As the molten metal shrinks on cooling, porosity is left behind in the finished part.

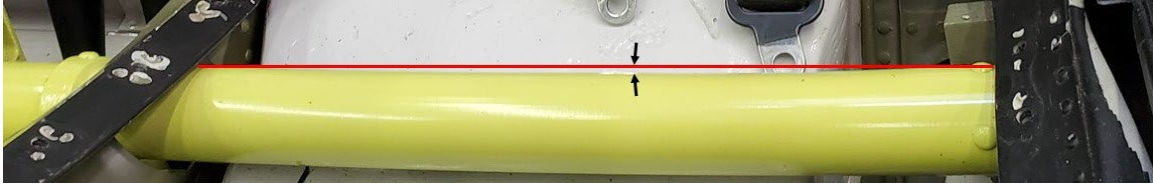
Figure 8. Collective control torque tube deformation (Source: TSB)

The 3rd protective structure, the seat, was partially and unevenly crushed as a result of the occurrence. Per crashworthiness design principles, the seat is typically designed to assume the inertial load during the whole process of its yielding or collapse in order to absorb the impact energy. Because of the relatively small clearance between the seat panel and collective control torque tube, the yielding of the seat structure results in contact between them. As a result, part of the inertial load from the occupant is transferred to the collective control torque tube, as was the case in this occurrence (Figure 8).

A calculation based on the structural damage to the seat and collective control torque tube of the occurrence helicopter indicates that the occupant experienced an estimated vertical acceleration force greater than 53 *g*.¹¹

Based on an examination of the structural damage to the helicopter's seat and collective control torque tube, investigators estimated that the vertical acceleration force experienced by the occurrence pilot was greater than 53 *g*. Studies conducted by the Federal Aviation Administration of the United States and the National Aeronautics and Space Administration concluded that *g* force levels beyond 27 will result in serious injury and could potentially be fatal.

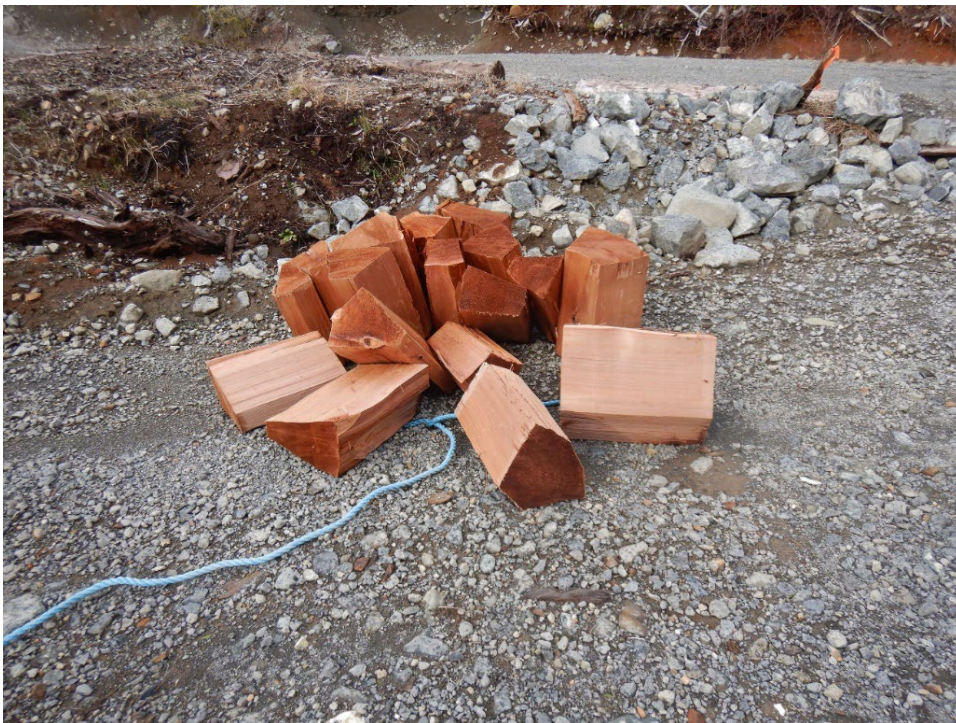
Figure 9. One of the 2 bundles of cedar blocks released by the pilot before the accident (Source: TSB)

The occurrence ground crew estimated that the 2 bundles released by the pilot before the helicopter's collision with terrain each weighed approximately 800 pounds (Figure 9).
