AIR TRANSPORTATION SAFETY INVESTIGATION REPORT A22C0058

COLLISION WITH TERRAIN

Pembina Air 1999 Ltd.
Rockwell International, Commander Aircraft Division S-2R, C-GOKD
Treherne (South Norfolk Airpark) Aerodrome, Manitoba, 12 NM NE
02 August 2022

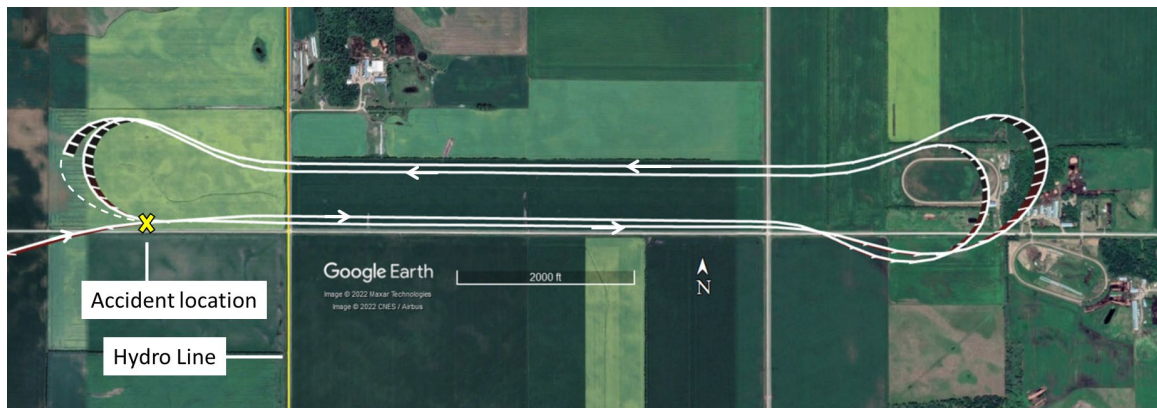
The occurrence flight departed CTN6 at approximately 1950 and the aircraft arrived at the field to be sprayed, located approximately 12 nautical miles (NM) northeast of CTN6, at 2000. The weather was suitable for flight under visual flight rules (VFR). At 2000, an automated weather station³ located at St. Claude, Manitoba (7 NM south-southeast of the occurrence site), recorded the winds as coming from 287° true at 13 knots, gusting to 21 knots. The aircraft conducted 4 runs over the field at approximately 30 feet above ground level and was in a turn to conduct a 5th run when it collided with terrain. The GPS (global positioning system) installed on the aircraft did not record the last moments of the flight (Figure 1).

Figure 1. Actual (solid line) and estimated (dashed line) occurrence flight path based on GPS (global positioning system) data (Source: Google Earth, with TSB annotations)
