# AIR TRANSPORTATION SAFETY INVESTIGATION REPORT A22Q0142

## MAIN ROTOR BLADE FAILURE IN FLIGHT

Unregistered  
RotorWay Exec (amateur-built helicopter)  
Lefebvre, Quebec  
29 November 2022

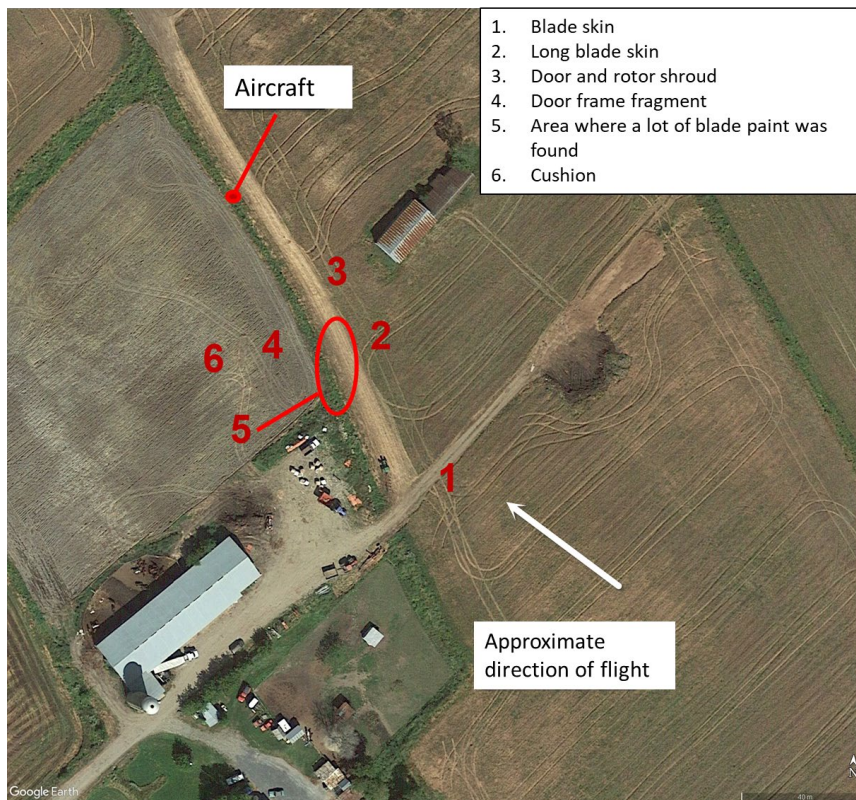
Figure 3. Satellite photo showing where the debris was scattered (Source: Google Earth, with TSB annotations)

One of the 2 main rotor blades was still in one piece and showed damage consistent with that caused by the impact that had occurred. However, the aluminum skins on the upper and lower surfaces of the 2nd blade (see the *Main rotor blades* section) were missing. The leading edge of the 2nd blade was still attached to the rotor head and showed no signs of having struck a bird or object in flight. Several fragments of the main rotor blade skin were found southwest of the wreckage, with the furthest being approximately 116 m from the point of impact (Figure 3). The cockpit doors and roof broke off in flight and were found between the aircraft and the furthest blade fragment.

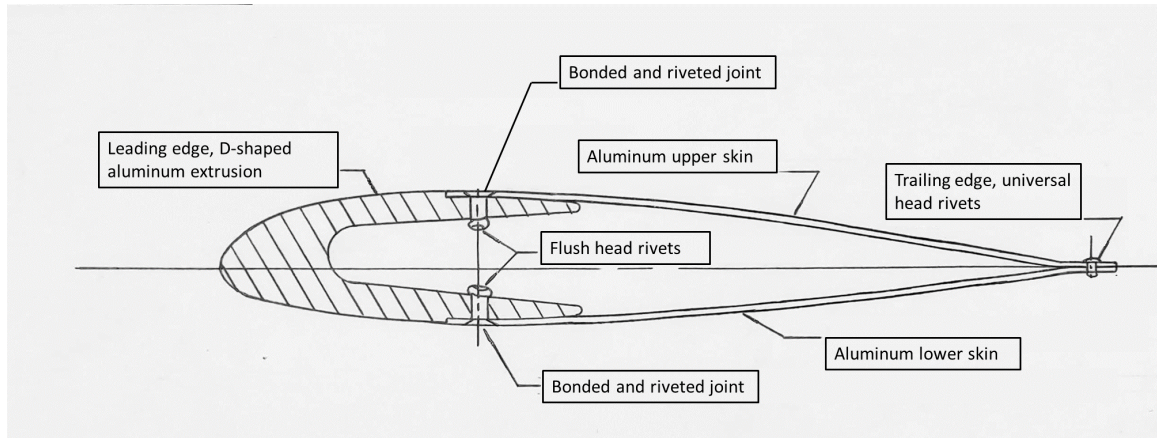
**Figure 4. Cross-sectional view of a main rotor blade (Source: RotorWay International, drawing 1 of 2 E20-1000, Main rotor blade assembly [17 July 1982], with TSB annotations)**

The technical examination of the blade fragments and the video showing the start of the accident sequence helped to determine that the joint between the leading edge and the skin had separated, resulting in the complete separation of the skins and the loss of control of the aircraft by the pilot.

After a thorough examination, it was determined that the helicopter experienced an in-flight breakup of one of its main rotor blade assemblies. There was no pre-existing damage to the skins themselves, although the skin bond lines exhibited significant areas of adhesive failure.

It is most probable that the adhesive failures on both the upper and lower skins near the leading edge of the rotor tip allowed the high tip aerodynamic loads to force the skins from the main spar. A subsequent loss of torsional stiffness allowed the blade spar to deflect, causing the complete loss of both the upper and lower skins.

Owners and pilots of amateur-built aircraft and of owner-maintained aircraft must ensure that they fully understand the regulations and that they have all technical data applicable to their aircraft, including data from the kit provider, the manufacturer, and the component manufacturer.

They must also ensure that all maintenance activities, including inspections, and operating procedures comply with these technical data to ensure that the aircraft remains airworthy.
