# AIR TRANSPORTATION SAFETY INVESTIGATION REPORT A2200165

## COLLISION WITH TERRAIN

Privately registered  
Cessna 150G, C-FQCS  
Bainsville, Ontario  
05 December 2022

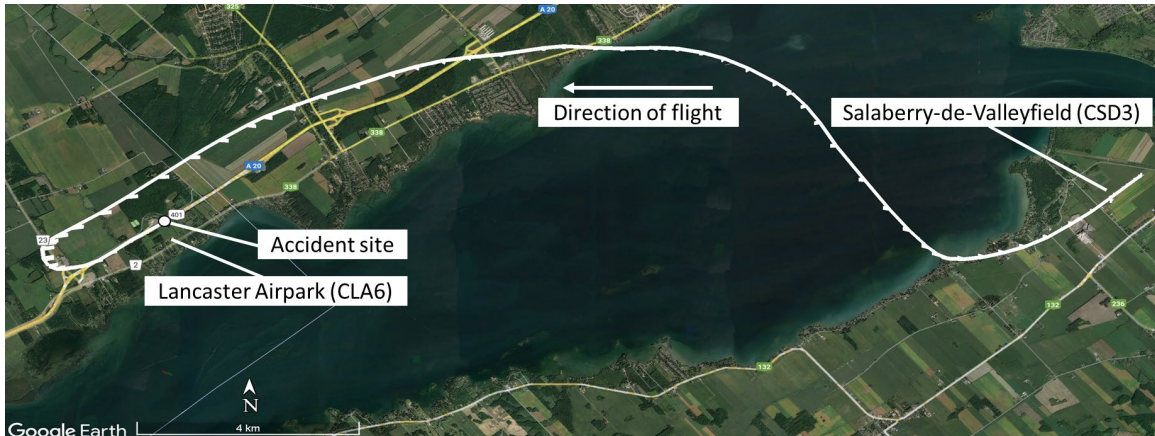
The aircraft departed CSD3 at 1952,<sup>2</sup> turned toward the northwest, and climbed to 1500 feet above sea level. After crossing the St. Lawrence River, the aircraft turned to the southwest toward CYCC, flying north of the shoreline along Quebec provincial Highway A20 (Figure 1).

Figure 1. Satellite image showing the route flown (Source: Google Earth, with TSB annotations based on aircraft global positioning system data)

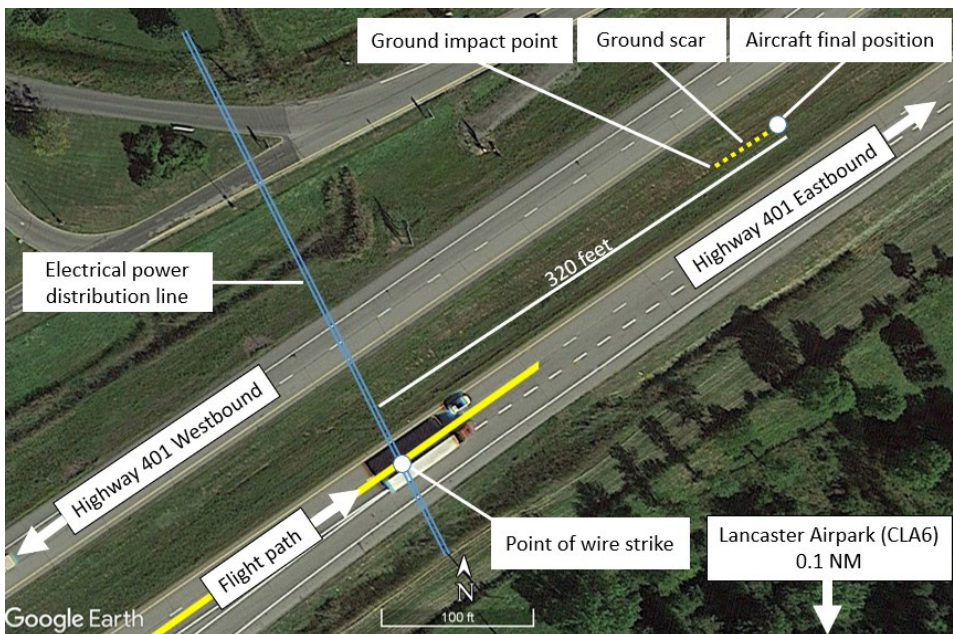
At approximately 2001, shortly after the aircraft crossed the Ontario–Quebec provincial border, the pilot heard a noise and the engine lost power. The pilot, seated in the right seat, conducted a descending 180° left turn toward the northeast and aligned the aircraft with Ontario provincial Highway 401. At 2003, the aircraft struck a set of 4 electrical power distribution lines before colliding with terrain in the grassy median between the highway’s eastbound and westbound lanes, and coming to rest in an inverted position (Figure 2). There was no fire. The accident site was 0.1 nautical miles (NM) north of Lancaster Airpark (CLA6), Ontario. CLA6 is not equipped with runway lighting.

Figure 2. Aerial view of the accident location (Source: Google Earth, with TSB annotations)

The occurrence aircraft struck a set of electrical power distribution lines before colliding with terrain. The aircraft damage is consistent with the aircraft having impacted the ground inverted on its right side. The aircraft then slid and came to rest—still inverted—on the grassy median of Ontario provincial Highway 401, approximately 320 feet from the wire strike location.

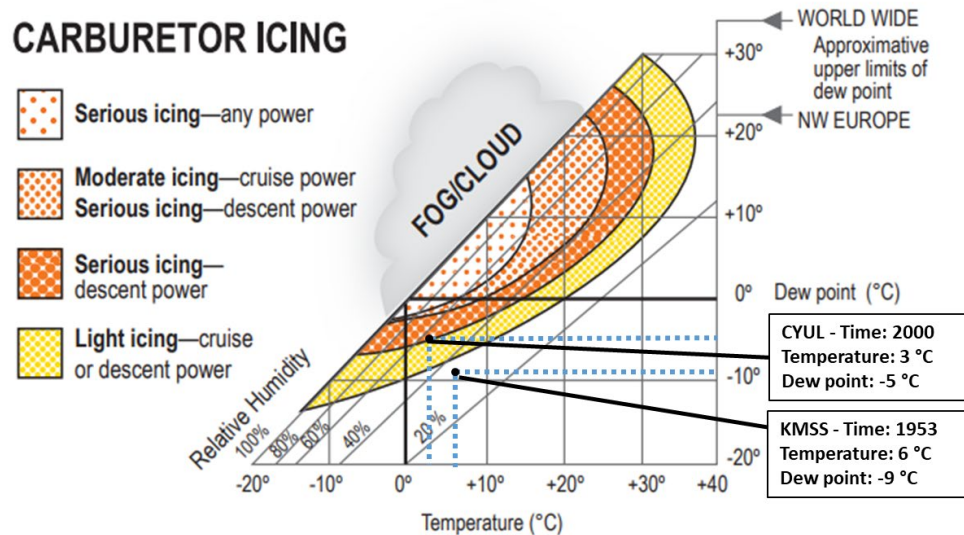
Figure 3. Carburetor icing potential based on ground-level weather conditions near Montréal/Pierre Elliott Trudeau International Airport, and Massena International-Richards Field Airport (Source: Transport Canada, TP 14371, *Transport Canada Aeronautical Information Manual* [TC AIM], AIR – Airmanship [06 October 2022], section 2.3, with TSB annotations)

Although the chart indicates that the temperature and dew point at KMSS were not conducive to carburetor icing at the time of the occurrence, it indicates that there was potential for serious carburetor icing at descent power in the CYUL area.

Based on the conditions at the time of the occurrence, there was a potential for serious carburetor icing with descent power. Even though the investigation was unable to determine if carburetor icing was a factor in this occurrence, pilots are reminded that carburetor icing can occur at various temperatures and all engine power settings.
