# RAIL TRANSPORTATION SAFETY INVESTIGATION REPORT R19V0002

## **MAIN-TRACK TRAIN DERAILMENT**

Canadian Pacific Railway Company  
Freight train 401-02  
Mile 128.9, Laggan Subdivision  
Partridge, British Columbia  
03 January 2019

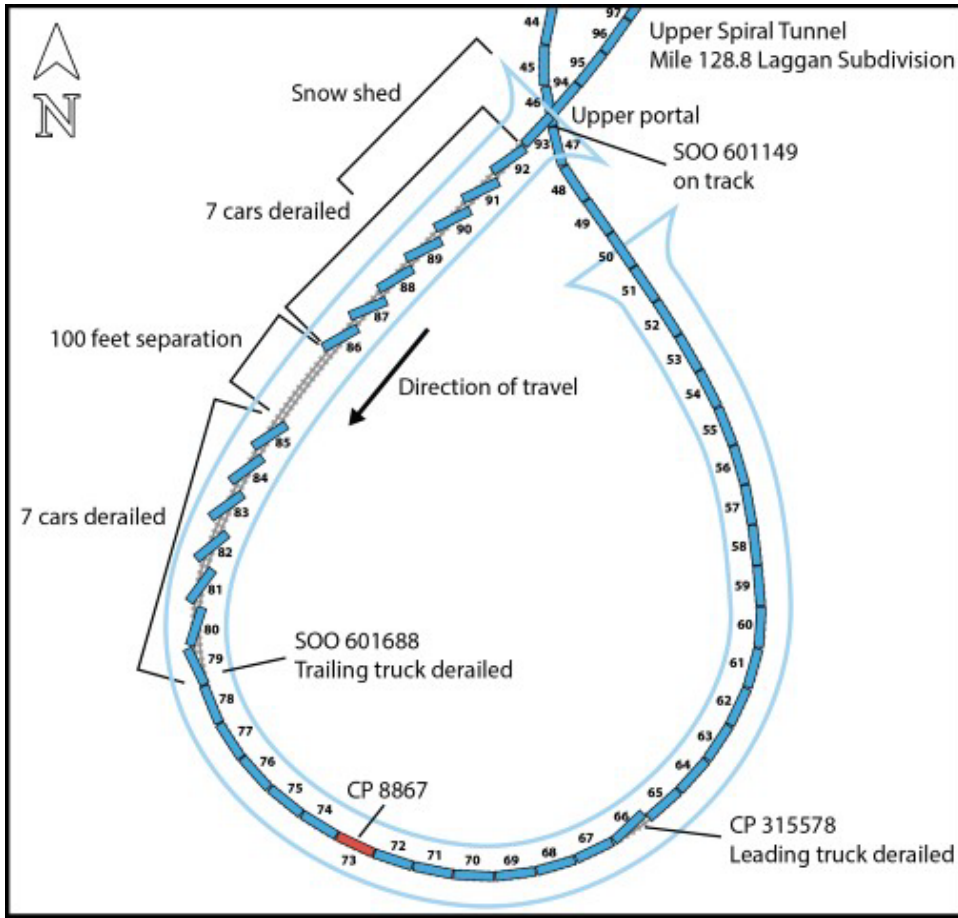
An inspection determined that a total of 15 empty rail cars had derailed in the Upper Spiral Tunnel (Figure 1). There was no fire, and no dangerous goods were involved in the derailment. No one was injured.

Figure 2. Diagram of the Upper Spiral Tunnel showing the relative locations of the derailed cars (Source: TSB)

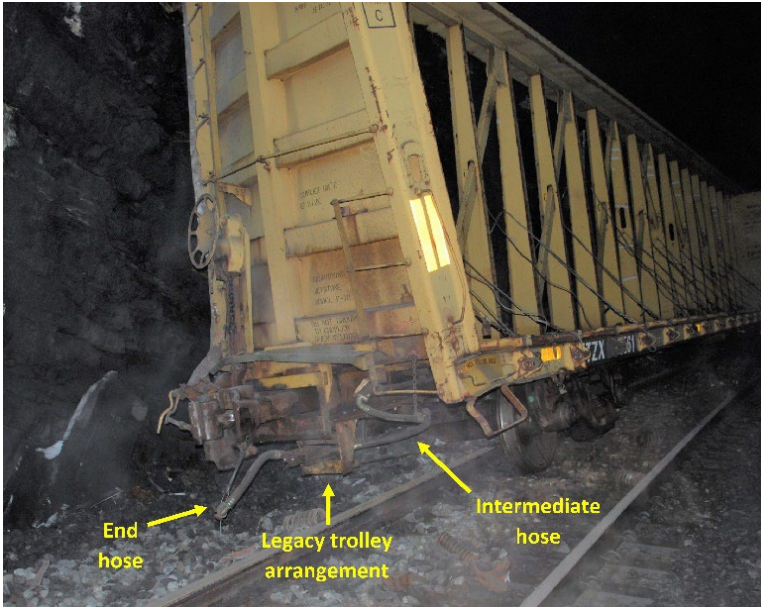
While inspecting the remaining derailed cars, the investigators noted that centrebeam flat car TTZX 85561 (position 85, the first car immediately before the 100-foot separation) was equipped with an older end-of-car trolley arrangement (Figure 3).<sup>13</sup>

Figure 3. Centrebeam flat car TTZX 85561 with older end-of-car trolley arrangement on leading end (Source: TSB)

In this occurrence, 1 or more cars in the TTZX series were equipped with an older end-of-car intermediate hose and trolley arrangement based on the previous version of MSRP Standard S-4003.<sup>21</sup> Derailed cars in this series included car TTZX 85561 (position 85), which was observed to have the older trolley arrangement during site examination, and car TTZX 86441 (position 96).

CP found that some of the centrebeam cars in the TTZX series had intermediate hose and trolley arrangements equipped with non-standard lengths of intermediate hose. Of these, 3 also had trolley misalignment issues. These non-standard configurations would create a high potential for end hoses, and particularly intermediate hoses, to kink on these cars when the slack was in a buff state. In the train consist, 5 of the TTZX series cars were located between positions 77 and 104, inclusive, close to the remote locomotive in position 73.

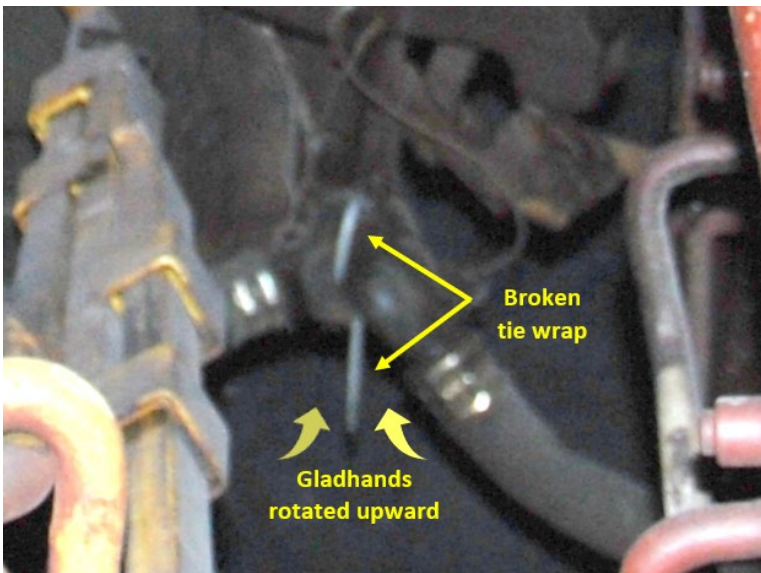
They also noted that the end hose gladhand couplings on some derailed centrebeam flat cars in the SOO series had been tie-wrapped; in one instance, the gladhand couplings were found rotated upward (Figure 4).

Figure 4. End hose gladhand couplings tie-wrapped together on one of the derailed SOO centrebeam cars (Source: TSB)

During site examination, it was observed that the gladhand couplings on some derailed centrebeam flat cars in the SOO series had been secured with tie wraps. The tie wraps would have been applied to the gladhand couplings when the cars were coupled together to assemble the train in Alyth Yard, in accordance with a mechanical services bulletin issued by CP in December 2002 and still in effect at the time of the occurrence. This bulletin required that gladhand couplings be secured with a tie wrap in certain situations—for instance, on any car with EOCCDs coupled to a car with a standard draft gear.<sup>23</sup>

Securing gladhand couplings with tie wraps, however, can interfere with their intended operation. When tie-wrapped gladhand couplings are rotated upward into a peaked orientation and do not separate, they can partially open, leaking compressed air through the gladhand gaskets. Such leakage is intermittent and stops when the gladhand couplings return to a neutral position. In addition, the tie-wrapped gladhand couplings can place additional stress on the flexible end hoses and intermediate hoses (if the cars are equipped with these), creating a risk that the hose will kink.

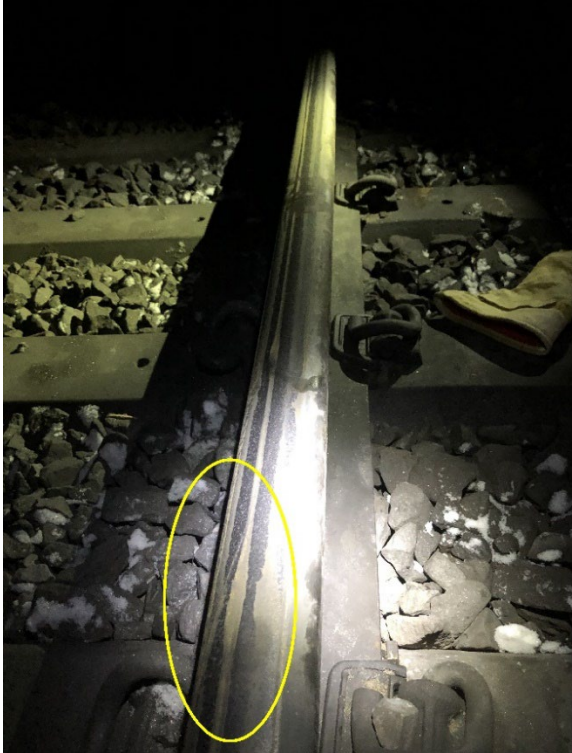
Wheel flange marks were present on the top of the rail at Mile 128.9, indicating that a wheel had climbed up and over the outside rail (Figure 5). This was determined to be the point of derailment.

Figure 5. Wheel flange mark (circled) indicating that a wheel had climbed up and over the outside rail (Source: Canadian Pacific, with TSB annotations)

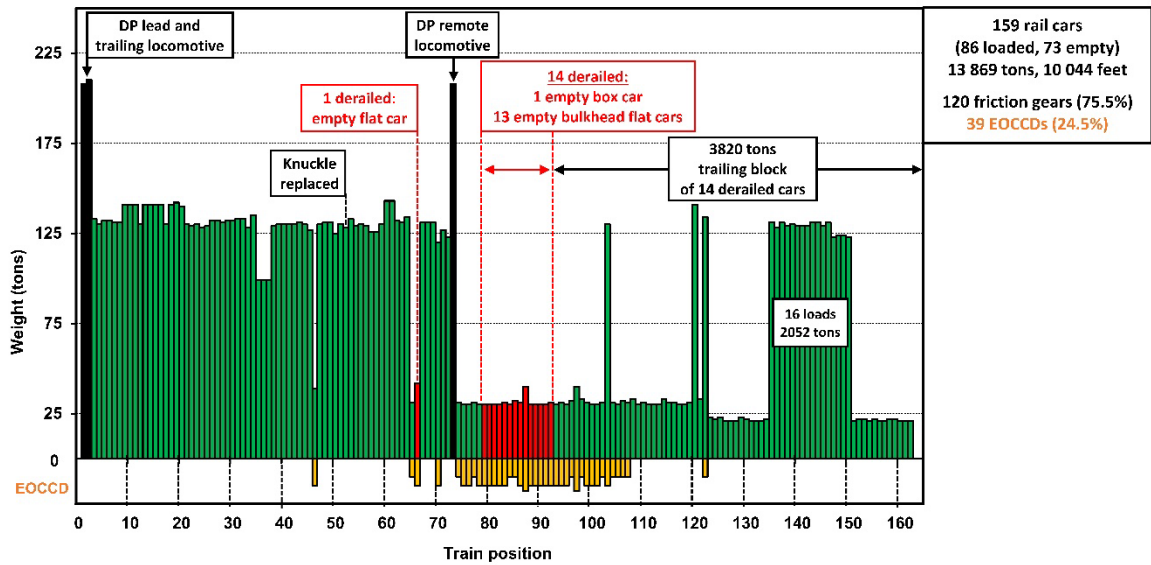
Figure 15 shows the weight distribution on the train and the position of the derailed cars.

Figure 15. Train weight distribution showing the location of the derailed cars (Source: TSB)

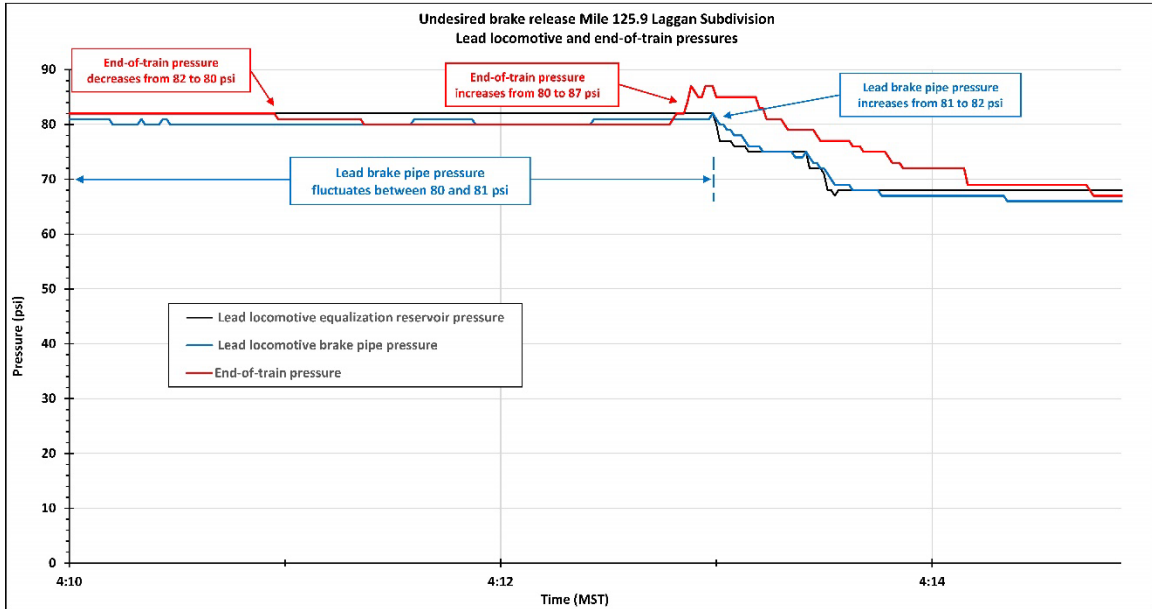
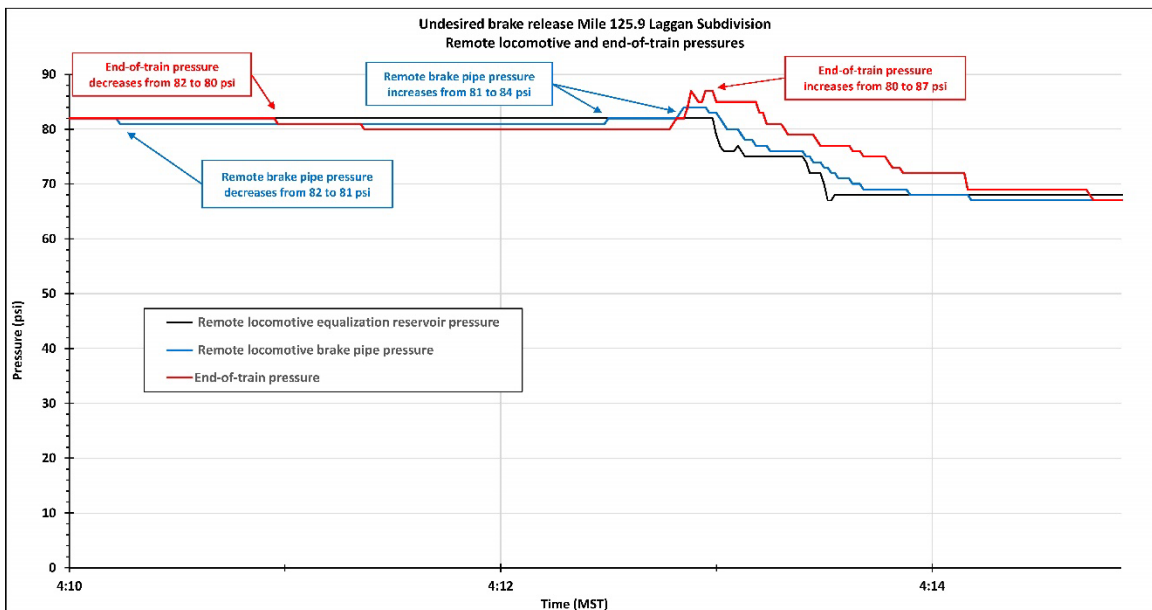
To better illustrate the relative timing and real-time changes in brake pipe pressure, as captured by the LERs, figures B1 and B2 show all of the air brake events in a graphic format, starting at 0410 and ending when the train came to a controlled stop. The EOT device pressure data, captured exclusively by the lead locomotive LER, are also included in the plot for the remote locomotive (Figure B2) for reference purposes.

Figure B1. Lead locomotive and end-of-train brake events during the undesired release of the air brakes while descending Field Hill (Source: TSB)

Figure B2. Remote locomotive and end-of-train brake events during the undesired release of the air brakes while descending Field Hill (Source: TSB)

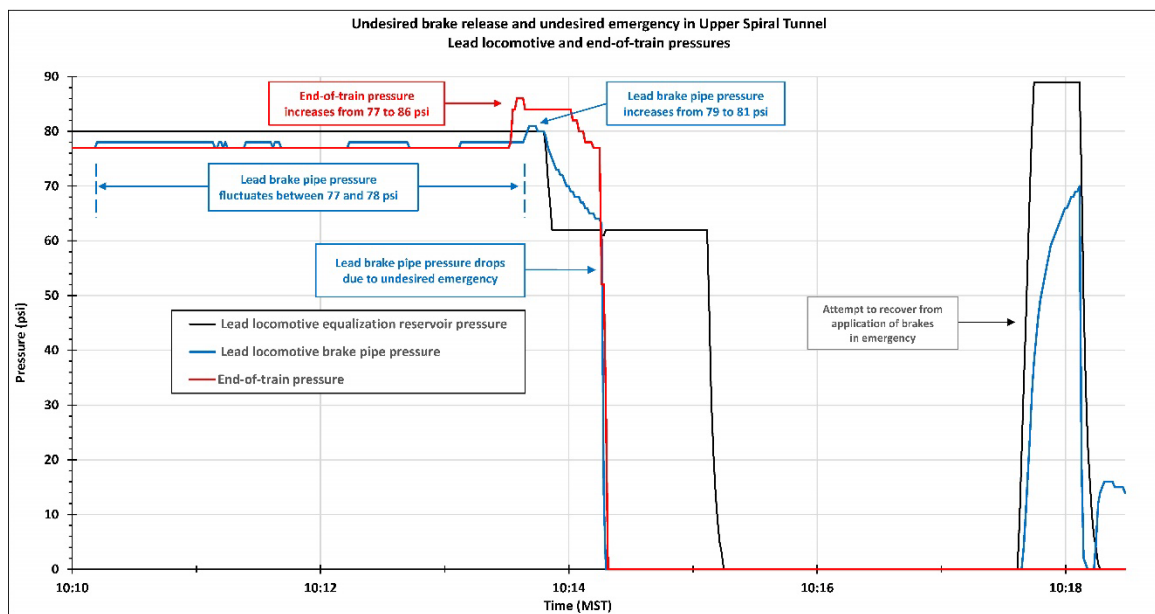
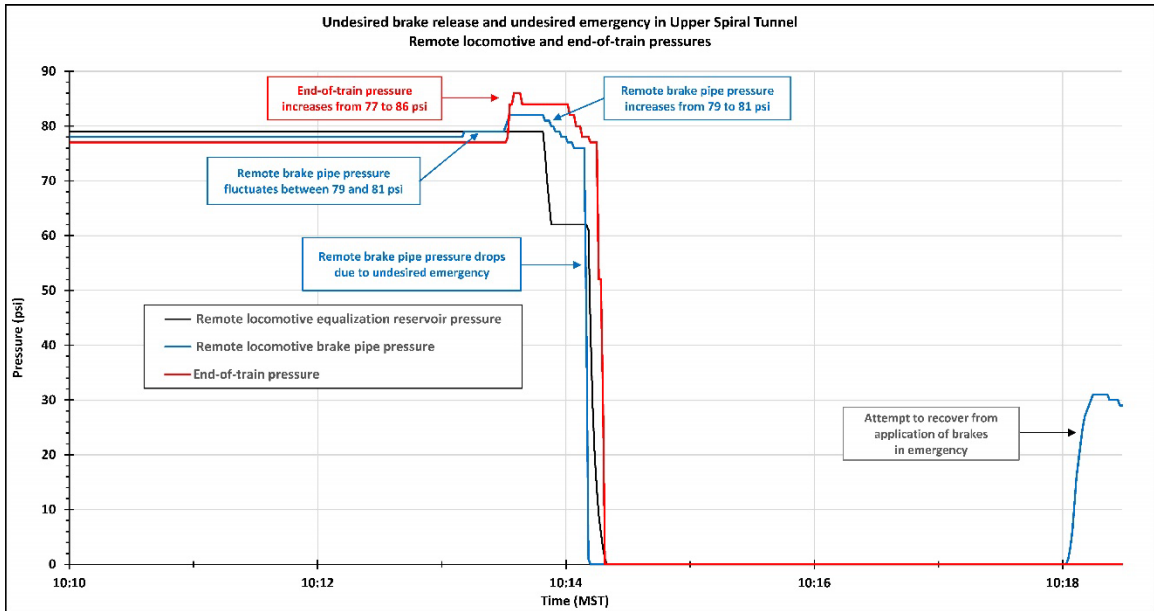
To better illustrate the relative timing and real-time changes in brake pipe pressure as captured by the LERs, figures B3 and B4 show all of the air brake events in a graphic format, starting at 1010 and ending when train came to a controlled stop. The EOT device pressure data, captured exclusively by the lead locomotive LER, are also included in the plot for the remote locomotive (Figure B4) for reference purposes. The plot also shows how the brake pipe pressure at the lead and remote locomotives responded after the LE attempted to recover the emergency air brake application after the train came to a stop. A comparison of figures B3 and B4, and specifically the momentary rise in brake pipe pressure at the remote locomotive (Figure B4), indicates the continuity of the brake pipe between the lead and remote locomotives.

Figure B3. Lead locomotive and end-of-train brake events during the undesired release of the air brakes and undesired emergency brake application in the Upper Spiral Tunnel (Source: TSB)

Figure B4. Remote locomotive and end-of-train brake events during the undesired release of the air brakes and undesired emergency brake application in the Upper Spiral Tunnel (Source: TSB)
