RAIL TRANSPORTATION SAFETY INVESTIGATION REPORT R19W0320

MAIN-TRACK TRAIN DERAILMENT

Canadian Pacific Railway Company
Freight train 516-398
Mile 48.86, Sutherland Subdivision
Near Guernsey, Saskatchewan
09 December 2019

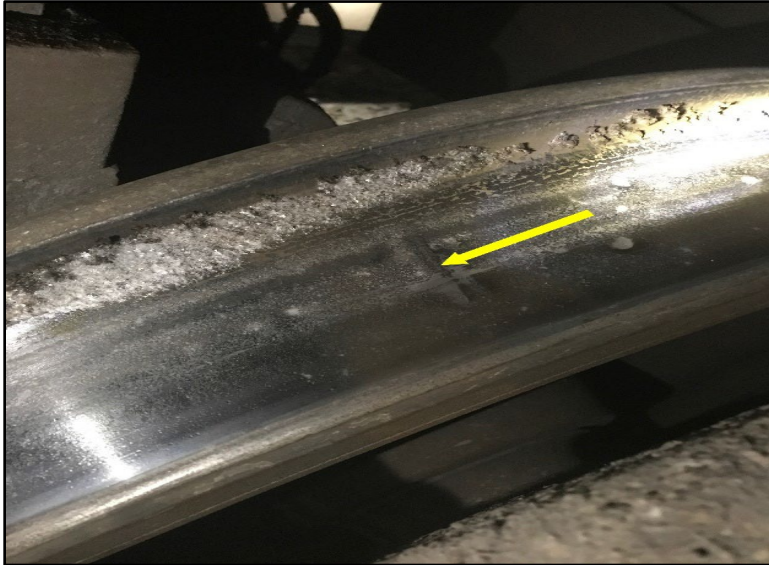
The first car in the train consist, a covered hopped car loaded with sand, had derailed but remained coupled to the head-end locomotive and traversed the crossing. All of the south wheels on the head-end locomotive exhibited transverse impact marks on the wheel treads (Figure 2).

Figure 2. Impact mark on the tread of the lead south wheel of the head-end locomotive (Source: TSB)

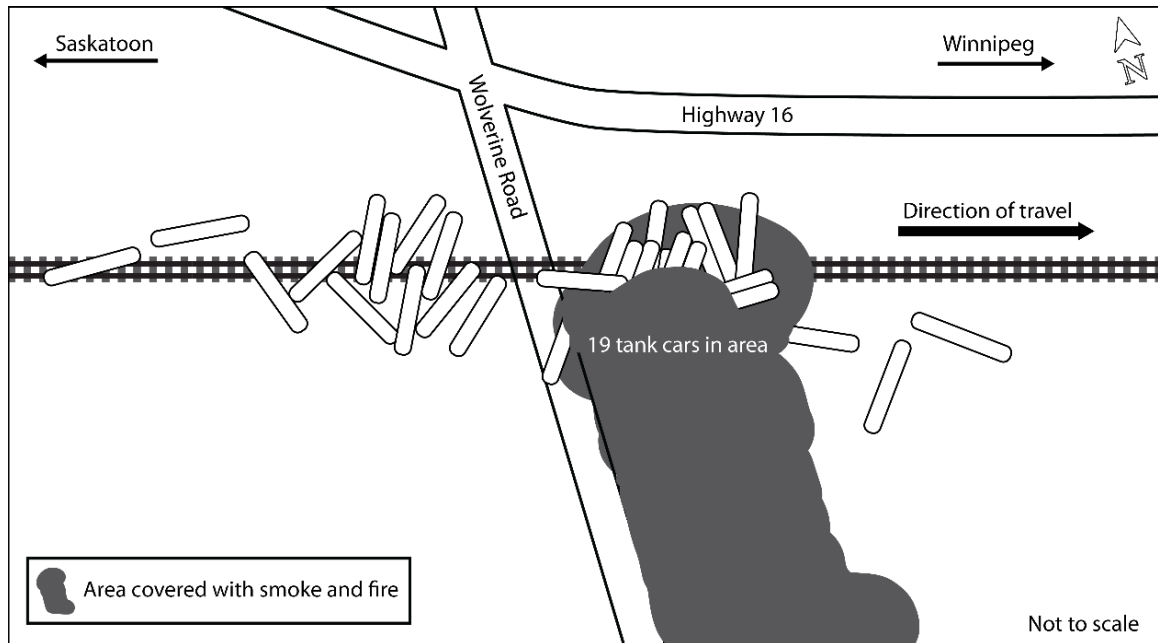
The 33 derailed tank cars (lines⁶ 2 to 34 inclusive in the train consist) were a mix of 9 DOT-117R and 24 jacketed Class 111 tank cars built to the CPC-1232 standard. During the derailment, the cars broke apart and came to rest in an east and west zone separated by Wolverine Road (Figure 3). A total of 20 of the 33 tank cars sustained breaches and released product.

Figure 3. Schematic of the derailed cars (Source: TSB)

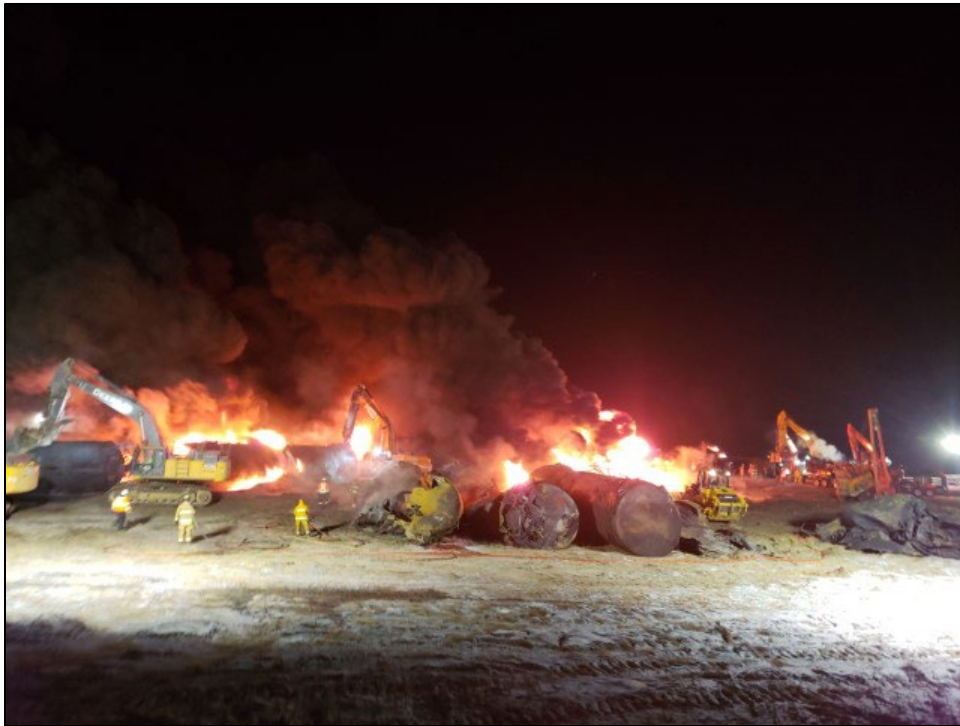
The first 21 tank cars (lines 2 to 22 inclusive) derailed east of the crossing and came to rest in various positions in a large pile-up over a short distance of about 500 feet. Most of these tank cars sustained breaches and released product. Due to the topography in the vicinity of the derailment, much of the released product flowed into a ditch created by the passive crossing, the highway, Wolverine Road, and the rail bed. The Wolverine Road embankment prevented the westward flow of the product, away from the main body of the derailment. This resulted in a significant portion of the released product settling under the derailed cars. The pooled product ignited and engulfed 19 of the tank cars in a large pool fire (Figure 4).

Figure 4. View of derailment site 18 hours after the accident (Source: TSB)

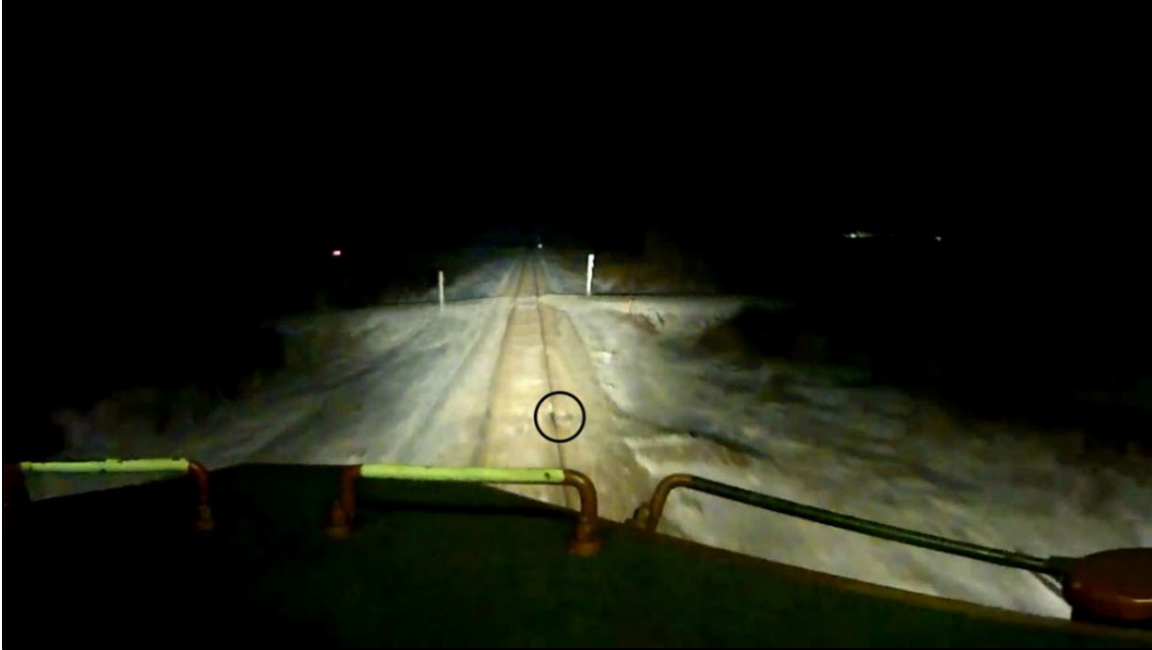
It was determined that the rail had likely broken under the passage of a previous CP train⁷ prior to the arrival of the occurrence train. As the locomotive wheels went over the gap, there was a noticeable vibration of the recorded image.

Figure 5. Still image captured from the forward-facing video camera on the head-end locomotive, showing a gap in the south rail (circled) (Source: Canadian Pacific, with TSB annotations)

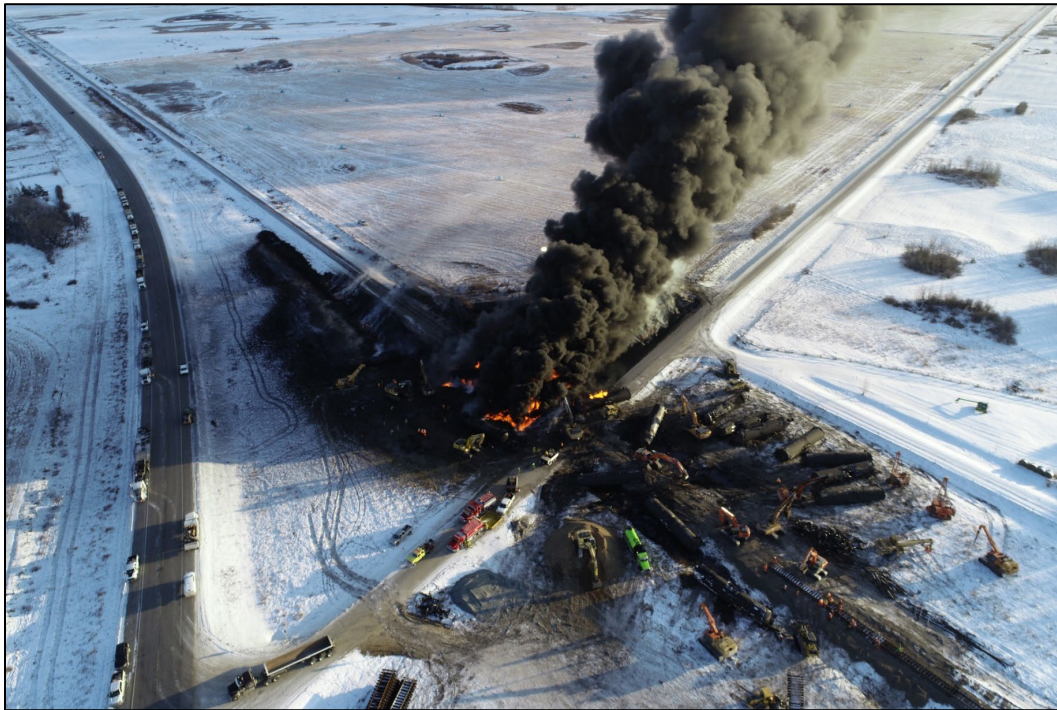
the DG release, Wolverine Road and nearby Highway 16 were closed in the vicinity of the derailment. Roadways were re-opened to vehicular traffic at about 1500 on 12 December 2019. The immediate emergency response focused on firefighting efforts. During the first 12 hours, firefighting was defensive, attempting to maintain control of the pool fire (Figure 6).

Figure 6. Aerial photo of the derailment site and pool fire, looking east, taken on 09 December 2022 (Source: Canadian Pacific)

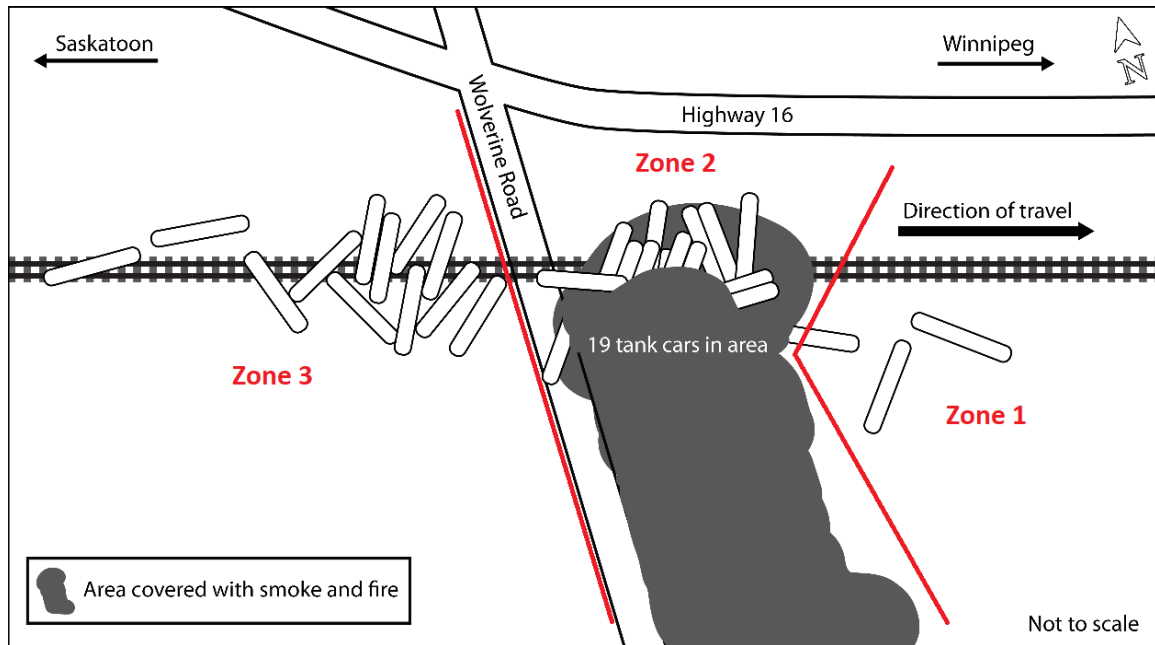
Figure 7. Accident site showing zones in the derailment area (Source: TSB)

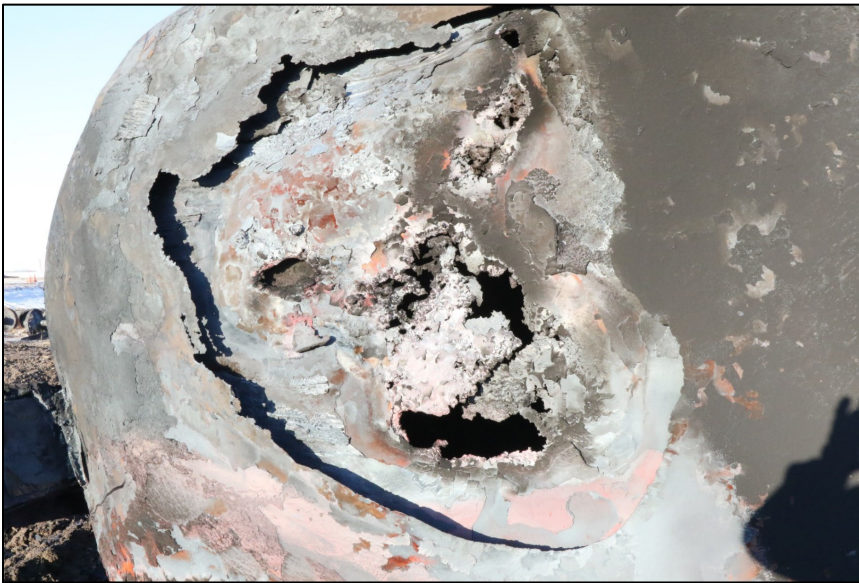
Several tank car shells, heads as well as wheels and axles of various cars were melted (figures 8 and 9). This indicated that the fire had reached temperatures in excess of 1340 °C, which is the minimum melting temperature of carbon steel.

Figure 8. Melted shell head of an unidentified tank car (Source: TSB)

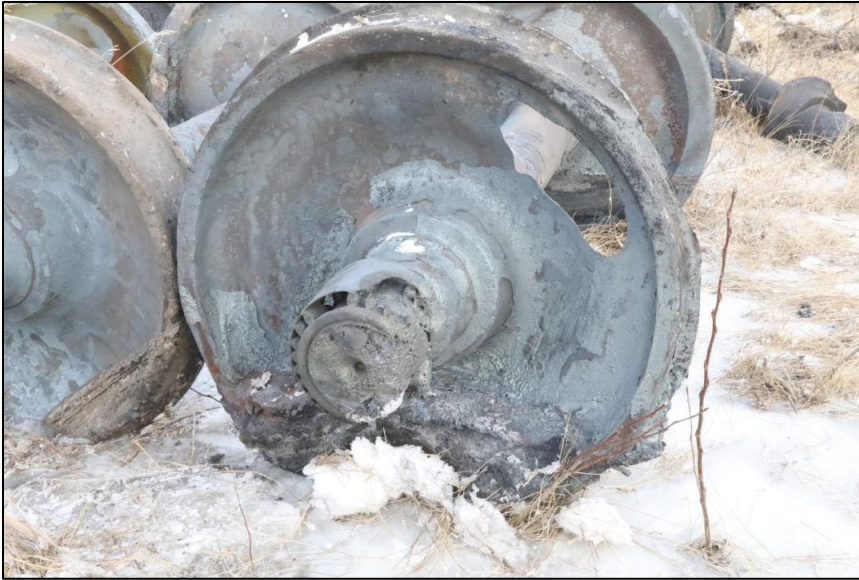
Figure 9. Unidentified melted wheel set from the fire (Source: TSB)

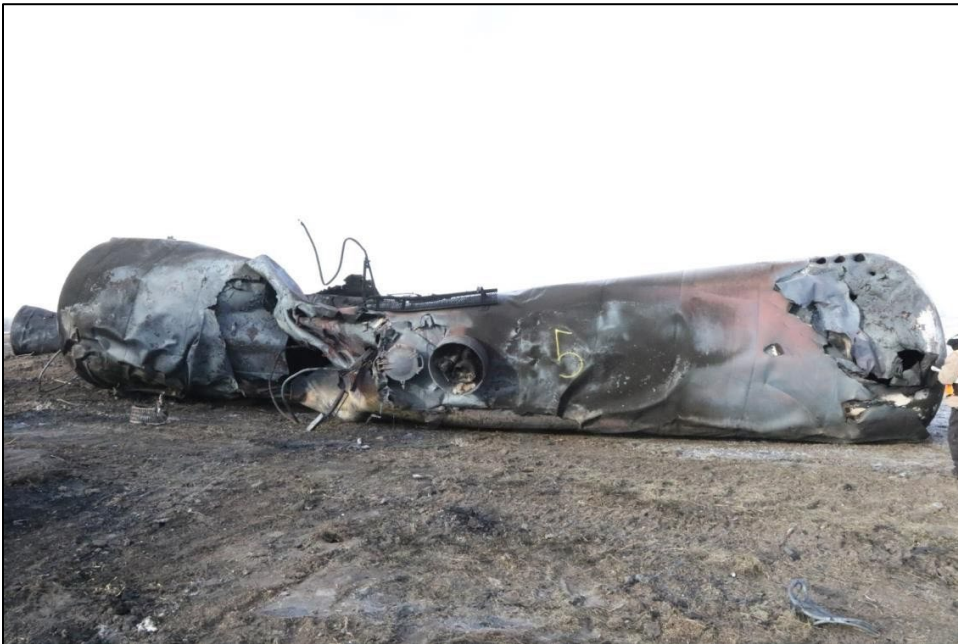
Although evidence of potential thermal tears was observed, the thermal tears could not be confirmed with any certainty due to the extensive tank car damage (Figure 10).

Figure 10. Severely damaged unidentifiable tank car with multiple breaches (Source: TSB)
