RAIL TRANSPORTATION SAFETY INVESTIGATION REPORT R21M0027

MAIN-TRACK TRAIN DERAILMENT

Canadian National Railway Company
Train B73041-15
Mile 18.9, Napadogan Subdivision
Pangburn Station, New Brunswick
21 August 2021

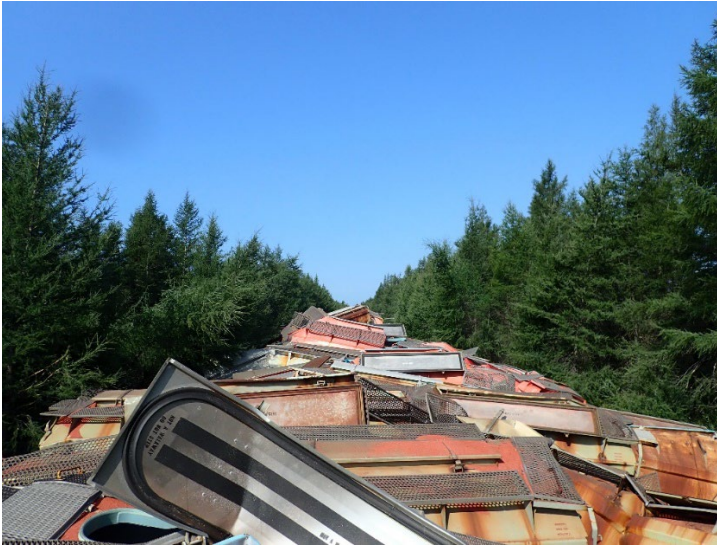
Figure 2. Derailed cars, facing west (Source: TSB)

- The first 2 derailed cars (positions 70 and 71) were upside down—the 1st to the north of the track, the other over the track bed.
- The next 2 derailed cars (positions 72 and 73) were upright, to the south side of the track.
- The remaining derailed cars were mostly perpendicular to the track bed, in a jackknife pattern over the top of the track bed.

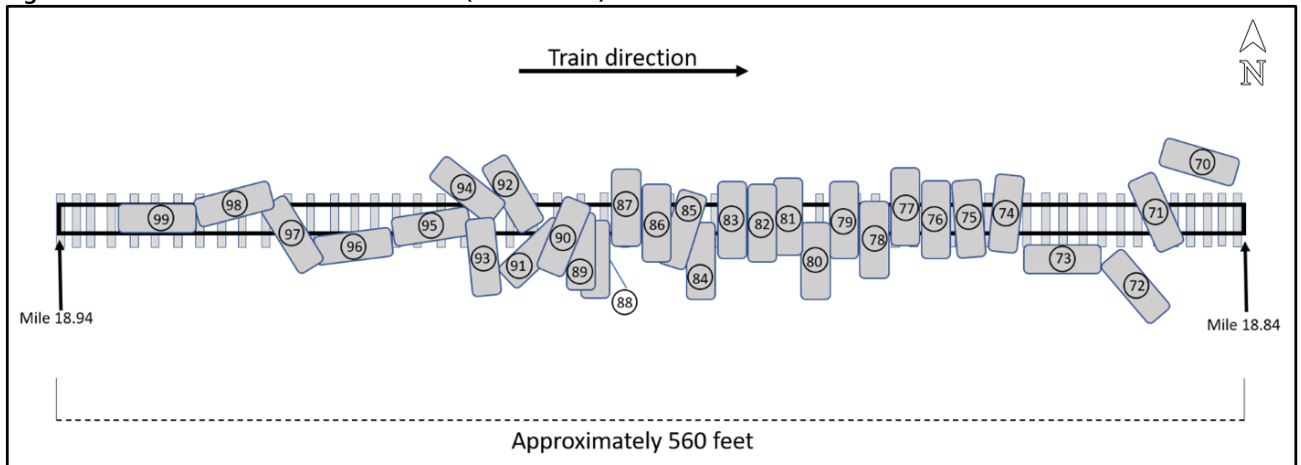
The derailed cars were in an area covering approximately 560 feet, starting at Mile 18.84 and extending to Mile 18.94 (Figure 3). They had come to rest in various positions along the right-of-way:

Figure 3. Schematic of the derailment site (Source: TSB)

Most of the derailed cars were in a jackknife pattern, indicating a possible sudden track failure. A piece of coupler that had broken off the 2nd derailed car (position 71) was found about 500 feet from the car's final resting position, which suggests that the car dropped off the track and travelled about 500 feet before coming to rest. This is consistent with the track having buckled under the train.

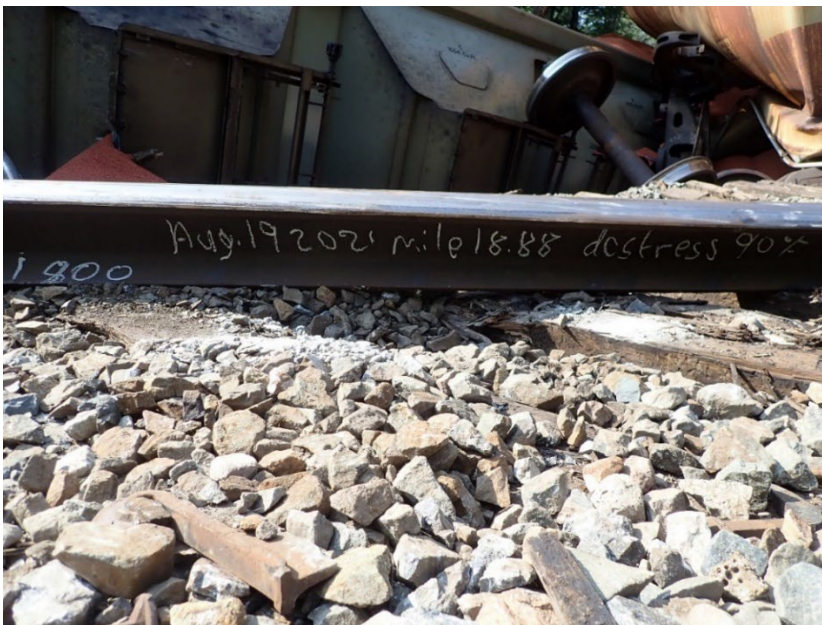
A piece that had broken off the coupler on the 2nd derailed car (position 71) was found at Mile 18.88, about 500 feet from the car's final resting position at Mile 18.84. The track structure under the derailed cars was completely destroyed. Some pieces of rail found in the wreckage had chalk marks, indicating that track work had recently been performed in the area. On a piece recovered from the north rail, the mark read "Aug. 19 2021 mile 18.85." On a piece recovered from the south rail, the mark read "1800 Aug. 19 2021 mile 18.88 distress 90 °F" (Figure 4).

Figure 4. Chalk mark on the south rail indicating that work had recently been performed on the track (Source: TSB)

On 19 August 2021, the work was completed to Mile 18.88 on the south rail and to Mile 18.85 on the north rail, with plans to return the following week. The location where the destressing work stopped was indicated by chalk markings on the rails.

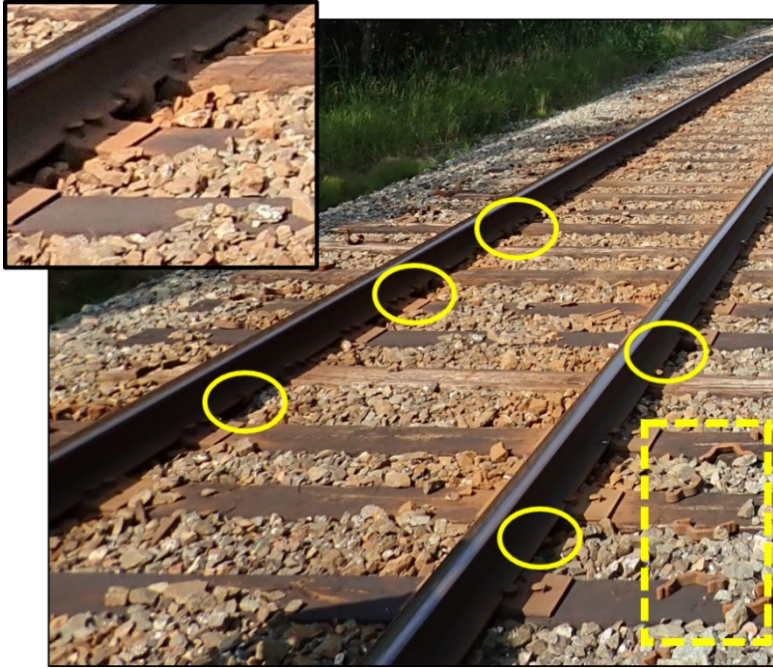
West of the derailment site, track anchors had shifted away from the ties, and there were signs of rail movement across the anchors and ties (Figure 5). On the ground, there were new anchors not yet installed. To the east, from Mile 18.2 to Mile 18.88, the installed anchors looked new, consistent with track work having been performed.

Figure 5. Picture of the track west of the derailment, showing anchors that had shifted away from ties (circled) and new anchors on the ground (rectangular outline), with inset showing enlarged view of shifted anchors (Source: TSB)

Track securement appropriate for the bog conditions had been done in the area, with longer ties used as a mitigation measure. However, there were signs, such as tie and anchor movement, that rail anchoring had degraded over time.

Degraded condition of rail anchoring on the non-destressed sections reduced the strength of the track and its resistance to movement.
