Solid waste  
disposal sites on  
federal properties  
in Quebec

Phase 2: Indian reserves

June 1984

LALONDE, GIROUARD, LETENDRE & ASSOCIATES LIMITED

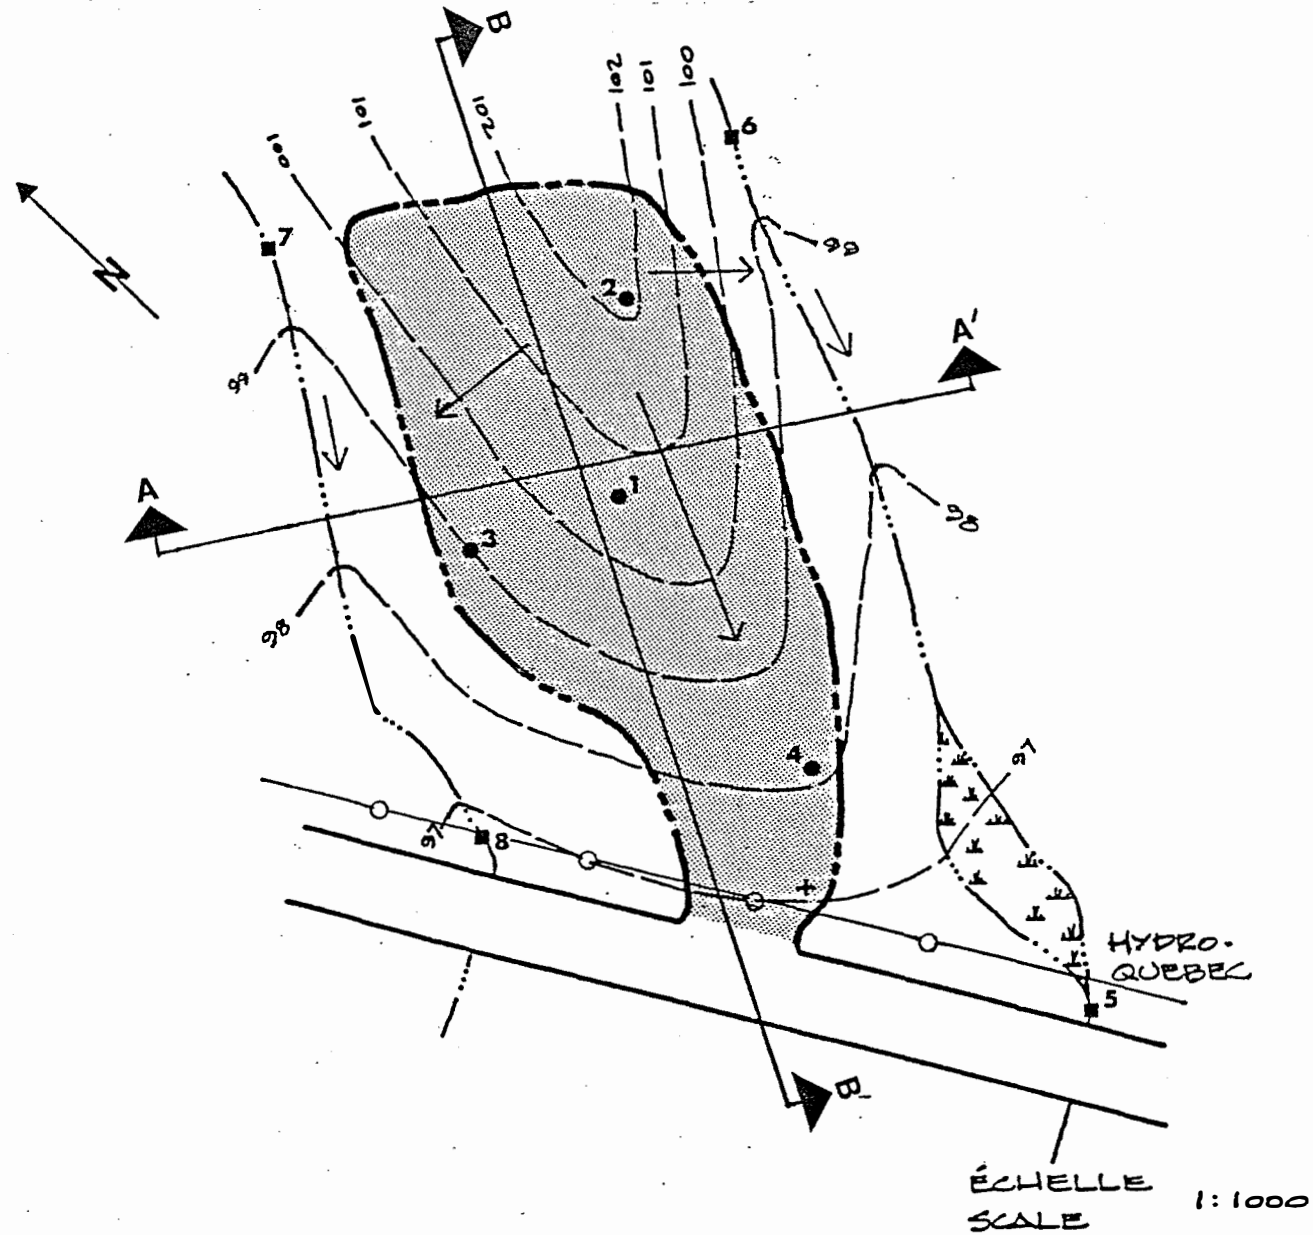
MISTASSINI - ANCIEN DÉPÔTOIR 02-01-01 OLD DUMP

The underlying ground is constituted of a thick layer of little permeable till. A portion of the waste is directly in contact with the water table. The leachate is mostly found in the two creeks bordering the site and flowing in a south-west direction towards Lake Mistassini, located about 200 m from the site.

Even though the site does not require immediate attention, it is recommended to make another quality control of the water in order to follow the evolution of the organic charge. Also, considering the doubtful water level surveys recorded in the boreholes, they should be taken again and the equipotential lines of the site sketch should be verified.

A few recommendations concerning the closing of the dump: first, a fence should be erected at the site entrance and "No Enter" and "No Salvage" signs should be posted; the metallic remains should be recovered or transported to an active site.

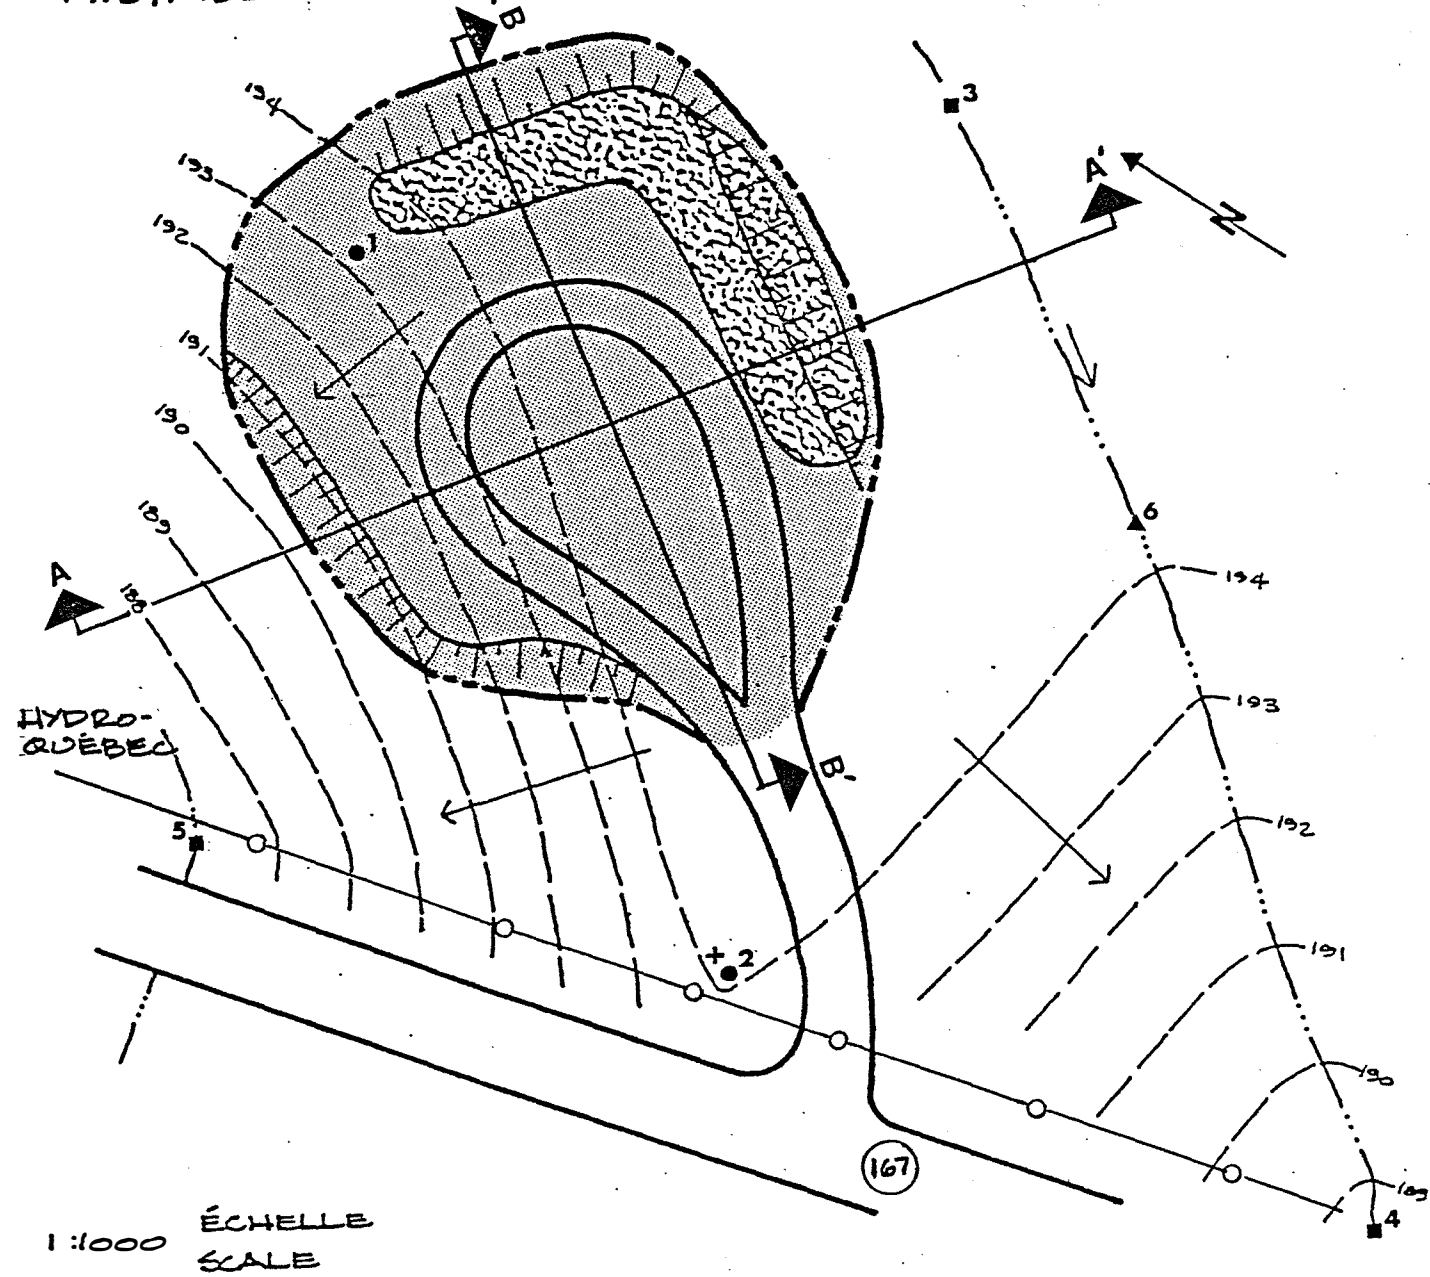
MISTASSINI - DÉPÔTOIR ACTUEL No 02-01-02 EXISTING DUMP

No problem as such is created by the use of two disposal methods (bank and trenches) but the recovering of waste is deficient, specially on the banks (recovered two times per year).

The site being located on sand and gravel and the water being at 4 m under the waste, it could be expected to find a relative contamination of the water table by infiltration through the waste (with an outflow at the north-western station #5) or by surface run-off towards the creek at the east.

The site was laid out on sand and gravel. The high water table is located about 4 m underneath the waste. On the east side, a creek drains part of the runoff coming from the site towards the south. Water that becomes contaminated by infiltration through the waste is discharged into the subjacent high water table which, at that place, flows in a north-west direction with a high hydraulic gradient.

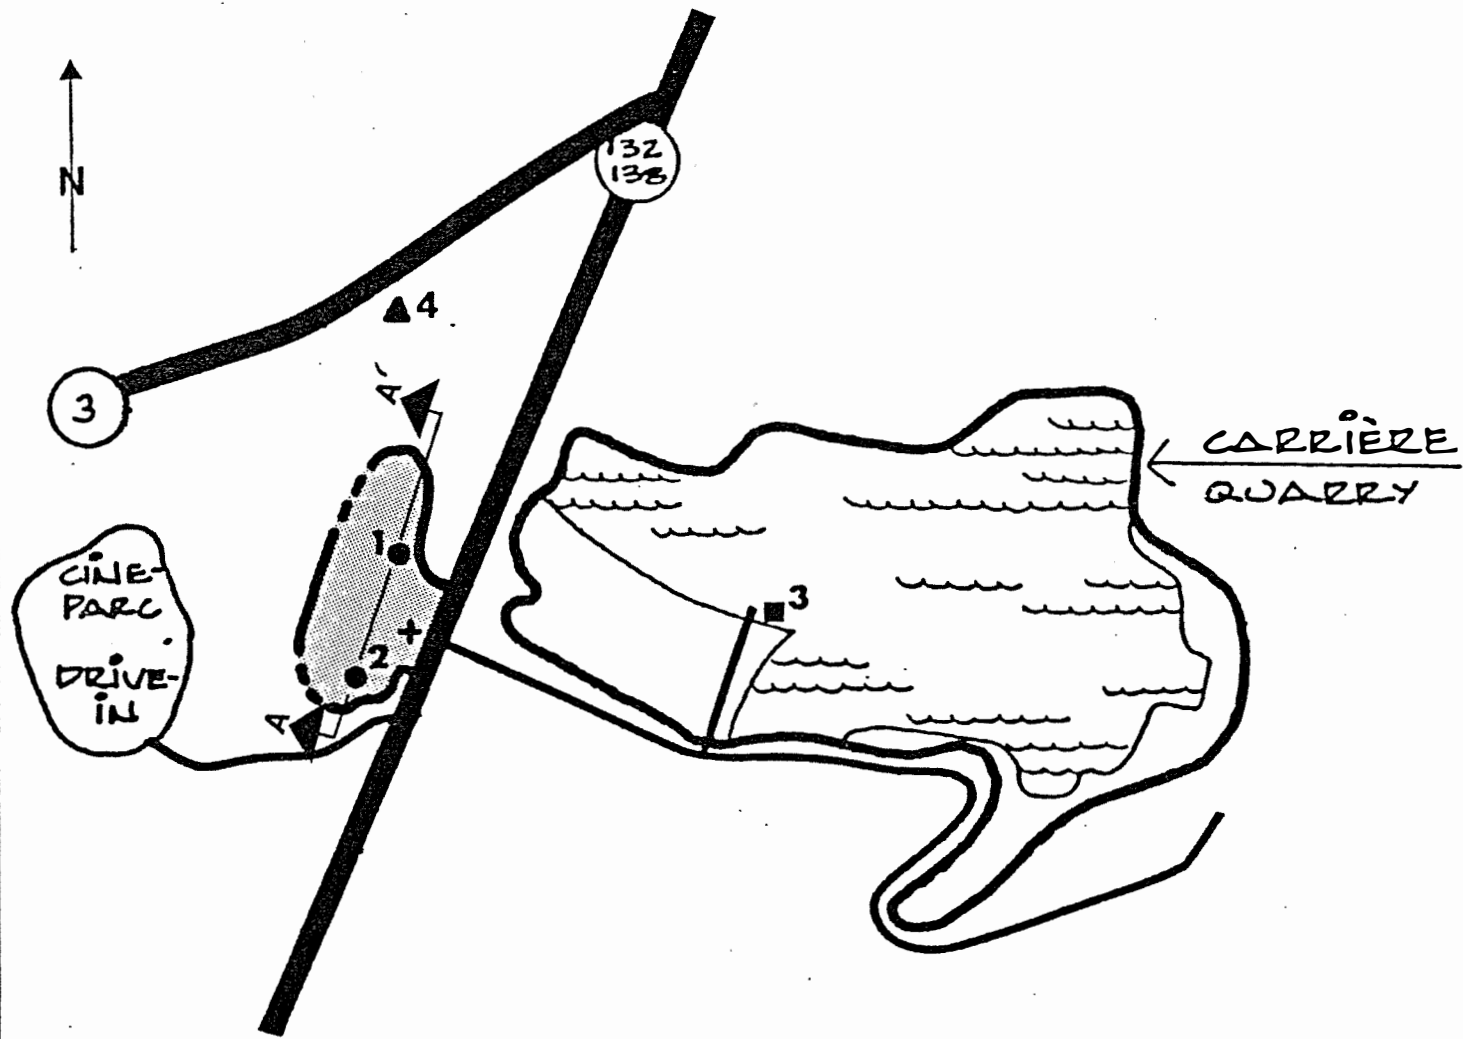
KAHUAWAKE - SITE MUNICIPAL No 06-01-01 MUNICIPAL SITE

The residents of the reserve deposit at the center of the site mostly domestic waste which is burned in the open. This combustion causes odors and smoke which can sometimes affect the visibility on the adjoining road. The wind also scatters papers and rubbish in the surroundings.

A small bulldozer driver, permanently on the dump, is used to push ashes and remains at the end of the site and to occasionally recover them with soil. In the northern part, the site is already full and the waste is 2-m thick while in the active southern part, burned material is 1-m thick. A shrubby and herbaceous vegetation is regenerating on the recovered section.

Site operation does not meet environmental standards. Waste cover is deficient and the combustion is unacceptable from a security and a pollution point of view. The site is well delimited by vegetation and a section of fence but this fence is too low to prevent papers from crossing over. It's access should be controlled when no guard is present.
