RAMEA, NEWFOUNDLAND - FISH PROCESSING PLANT

PRE-DESIGN STUDY

IMPROVEMENTS TO  
SALT WATER SUPPLY SYSTEM

January 19, 1973

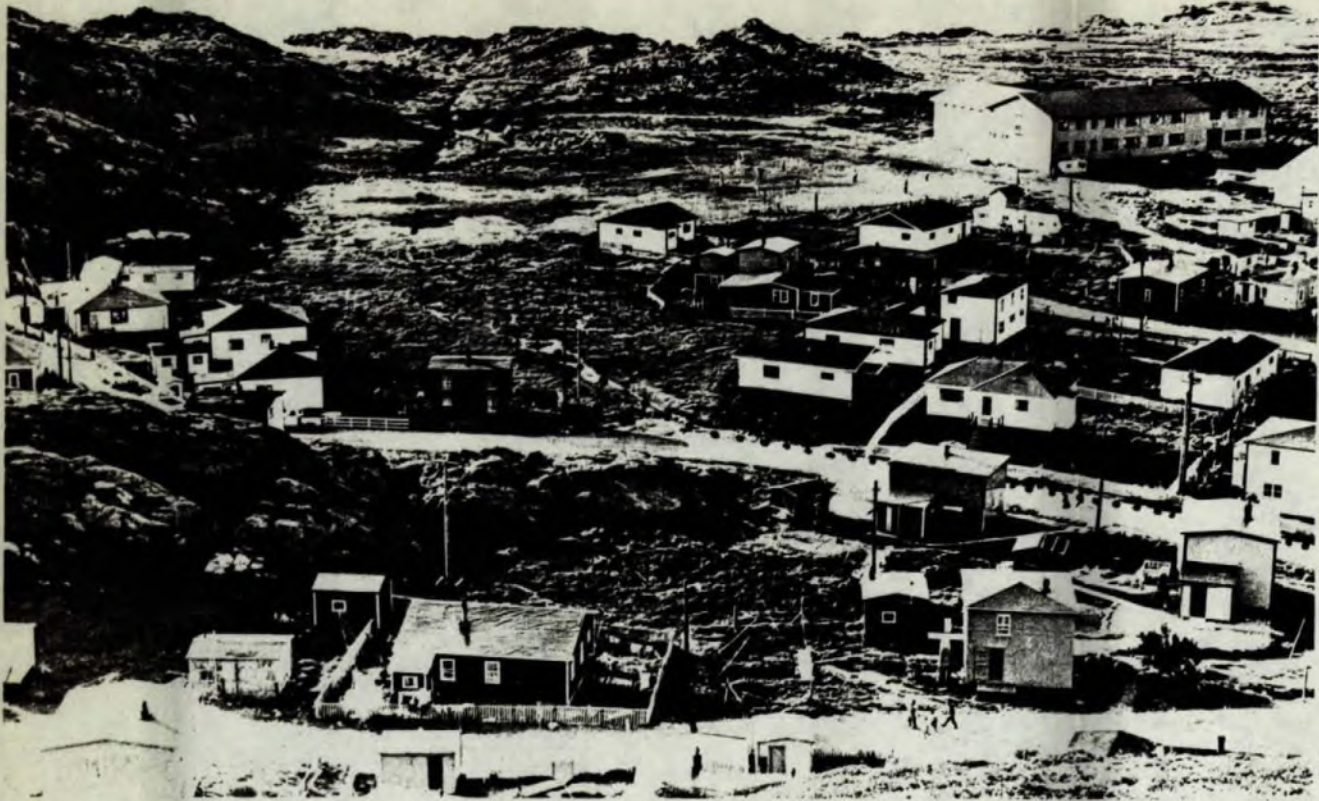
PHOTO NO. 1      General view of pipeline route through bog area and school yard.

Photo No. 1 shows a general view of the pipeline route - from the air outlet chamber at the highest pipeline elevation down to a few hundred feet from the fish plant. It was noted that the bog in the school yard area was being excavated and replaced with rock and till to provide an expanded school yard. As shown on Photo No. 2 no particular attention appears to have been taken to protect the pipe in this area. The equipment used in the excavating operation was a tractor-mounted

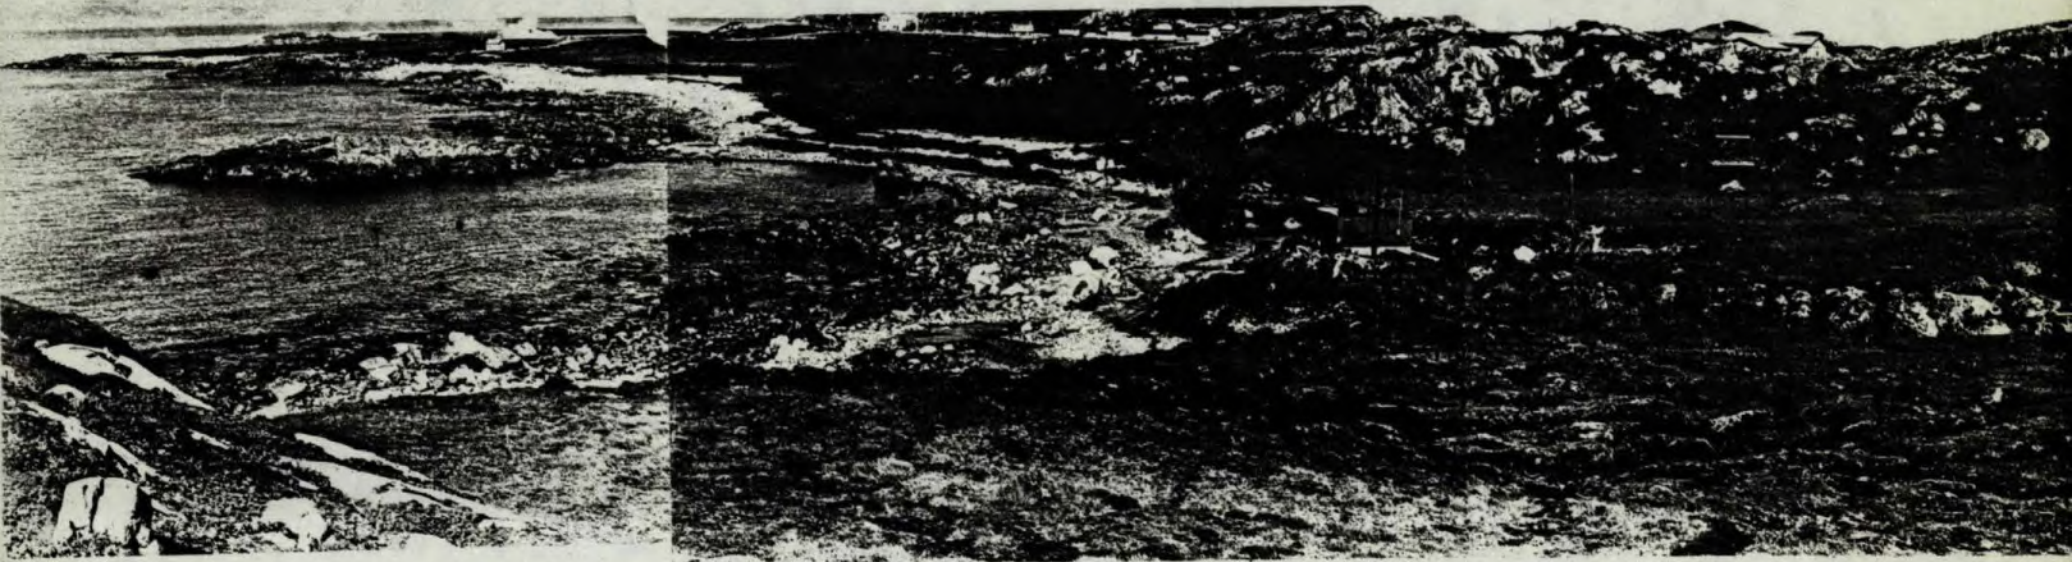
PHOTO NO. 3

Scheme No. 1 - Bog and beach area at low tide, showing effects of gravel excavation. Shape of original beach profile evident from beach in background.

A general view of Island Cove at low tide, and the pumphouse, is shown on Photo No. 3. The effects of the beach gravel

excavation are obvious. The sea water, under the normal weather and sea conditions, reaches the exposed bog at high tide, and any wave action whatsoever will dislodge substantial quantities of bog. Some of the bog particles will find their way into the intake and thus contaminate the water supply. Photo No. 4 clearly illustrates this bog erosion problem. Photo No. 5 shows a close-up of two of the pumps and some valving. The equipment appears in good condition.

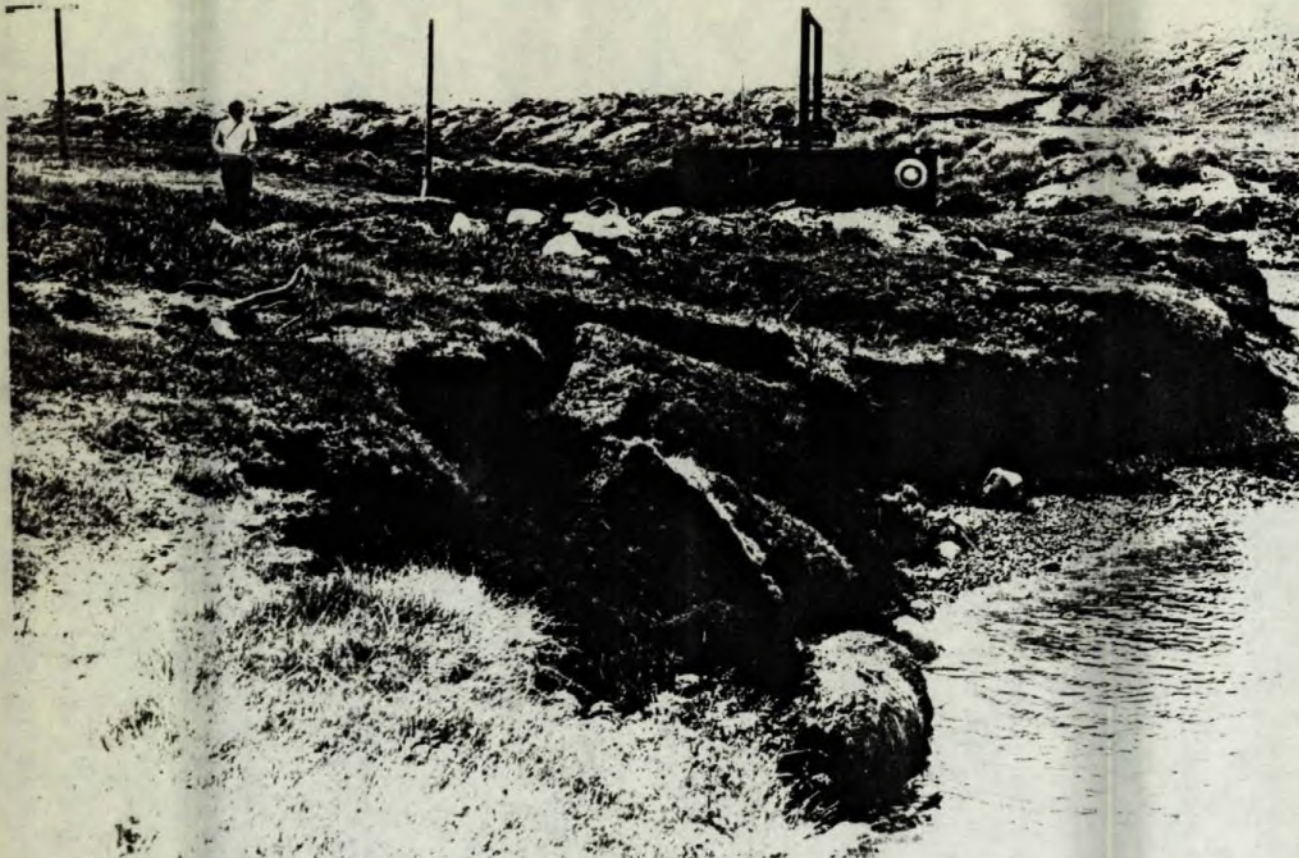
PHOTO NO. 4      Close-up of bog erosion at Island Cove. The edge of bog is only 15 feet from the pipeline at this point.

A section of the existing 8 inch polyethylene pipe, east of the existing pumphouse, is only about 15 feet from the eroding shoreline (see Photo No. 4). To ensure permanence of the system, a 200 foot long section would be relocated away from the shoreline, as shown on Dwg. No. 6017-4, "SCHEME No. 1 - DETAILS."

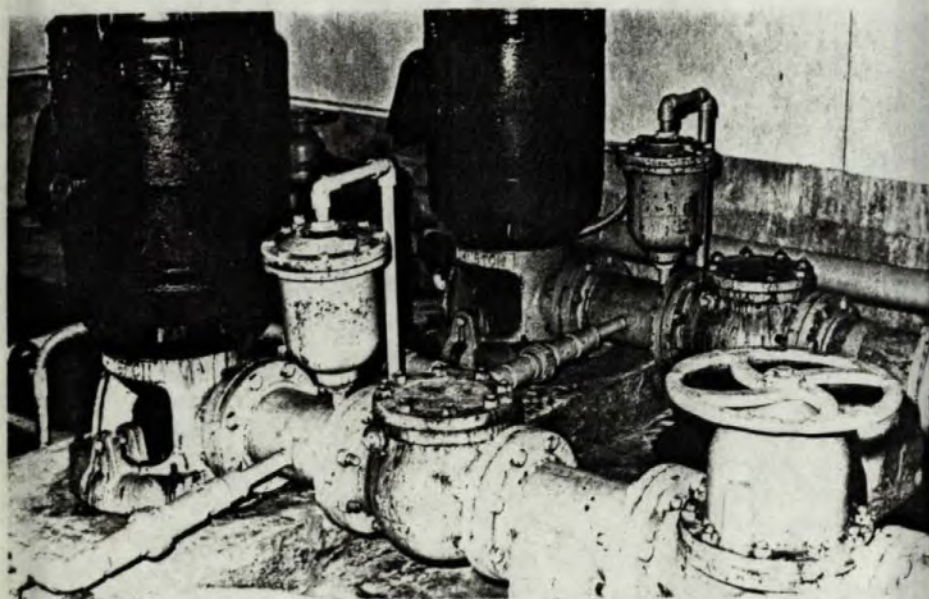
PHOTO NO. 5      Close-up of two pumps and equipment in the pumphouse.

Further to our Site Visits, Mr. K, McCarthy (CAWSA) has had the existing pumps and motors for the Island Cove installation dismantled for inspection. In his opinion, they are in good condition. However, this will not preclude our recommendation, as discussed more fully later, that in the detailed design stage and as part of the field survey program, a mechanical/electrical inspection be carried out to determine the extent of refurbishing required to make sure the equipment is sound.

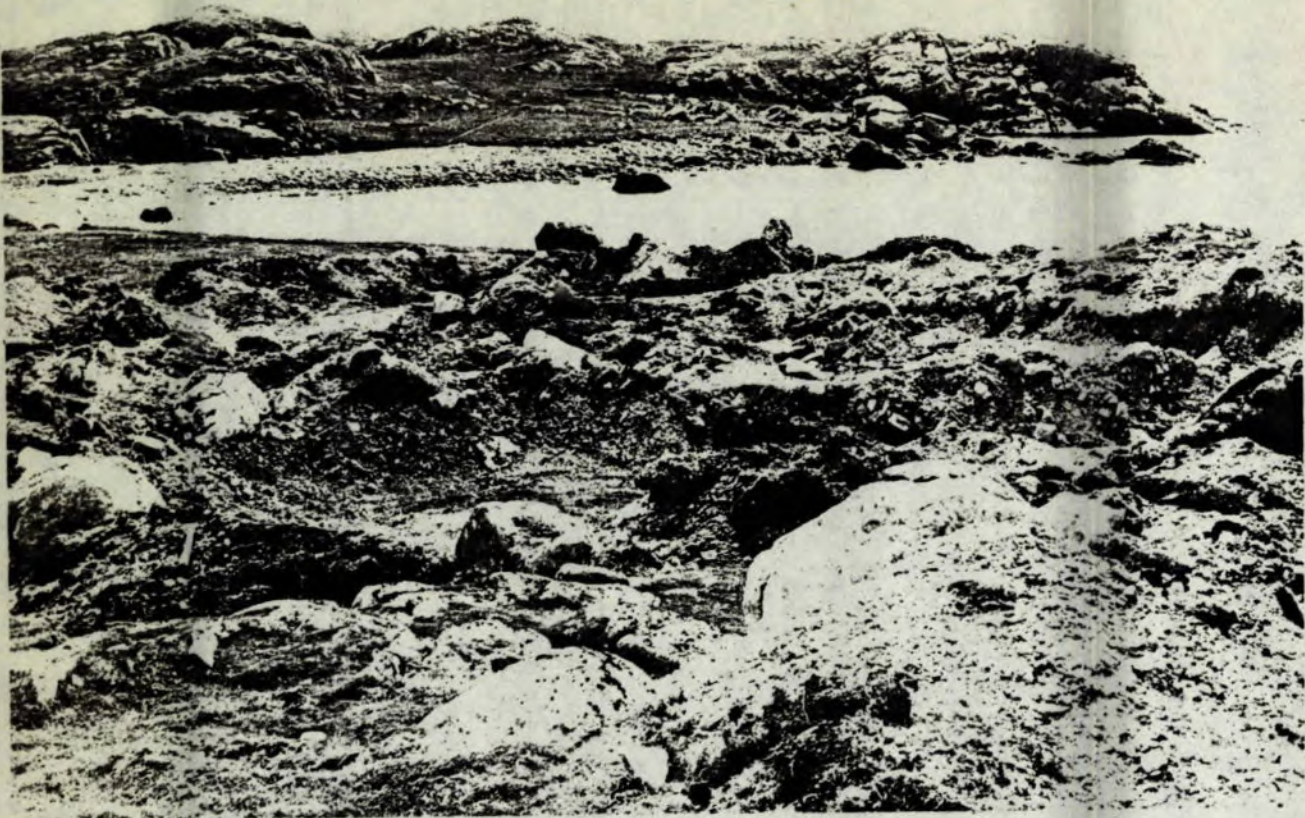
PHOTO NO. 6

General view of Muddy Hole Cove showing effects of gravel mining (foreground) and original stable beach (background).

We recommend that all gravel mining be prohibited in the Muddy Hole Cove shoreward of the runoff diversion dyke. We also recommend that prior to the design and contract document stage the following be carried out:

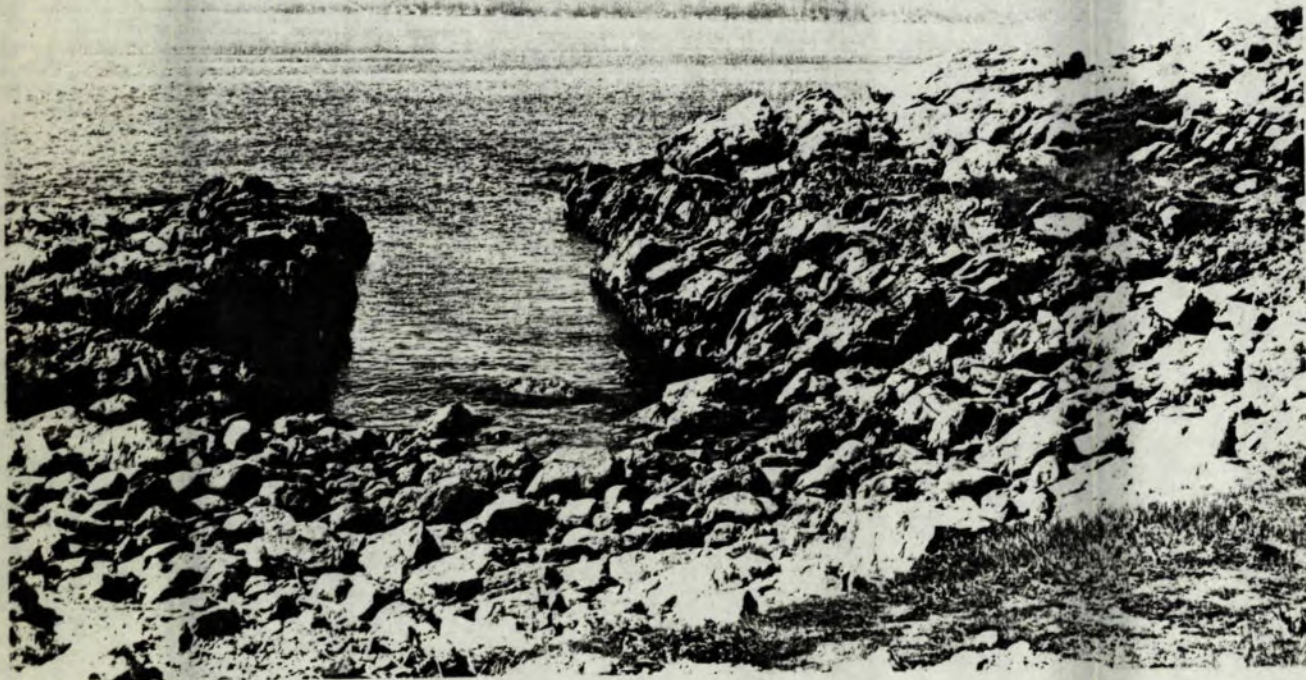
PHOTO NO. 7

View of existing inlet channel for Scheme 2, as seen from proposed pumphouse location. Excavated rock to be dumped into the low section at left.

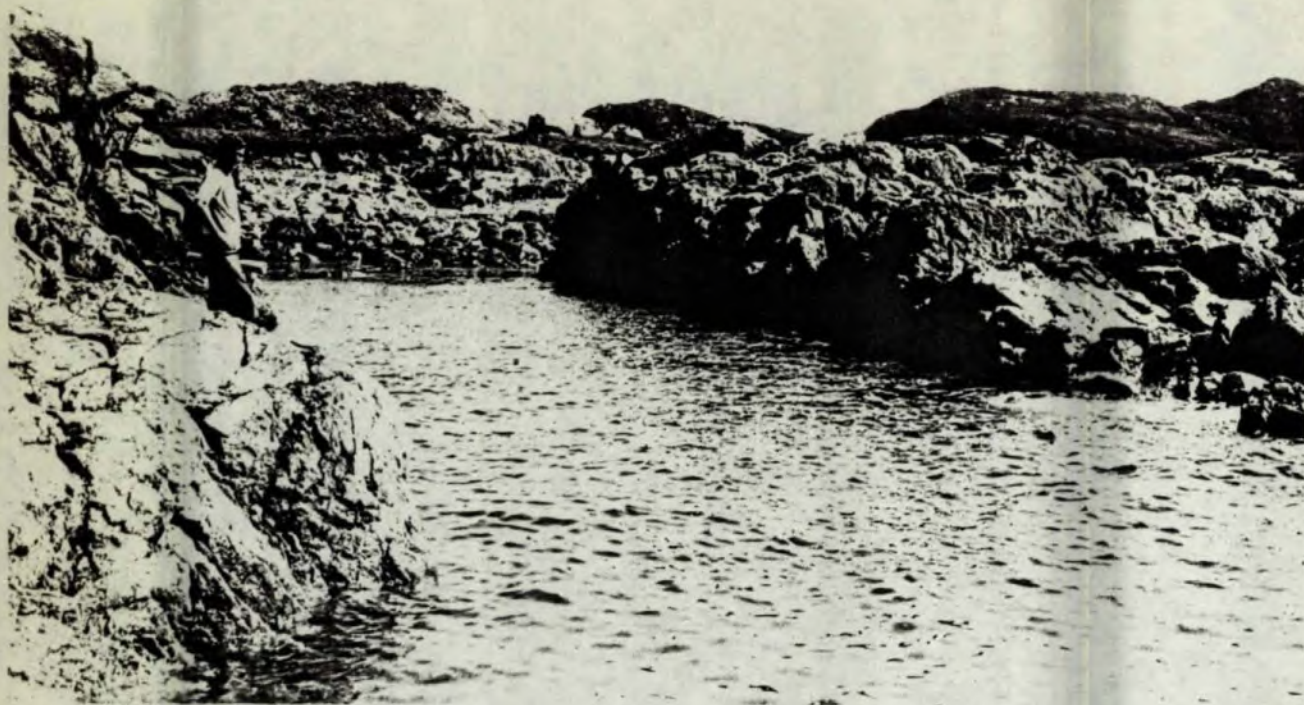
PHOTO NO. 8

View of shoreline at existing inlet channel for Scheme 2. The proposed pumphouse location is on high ground at end of channel.

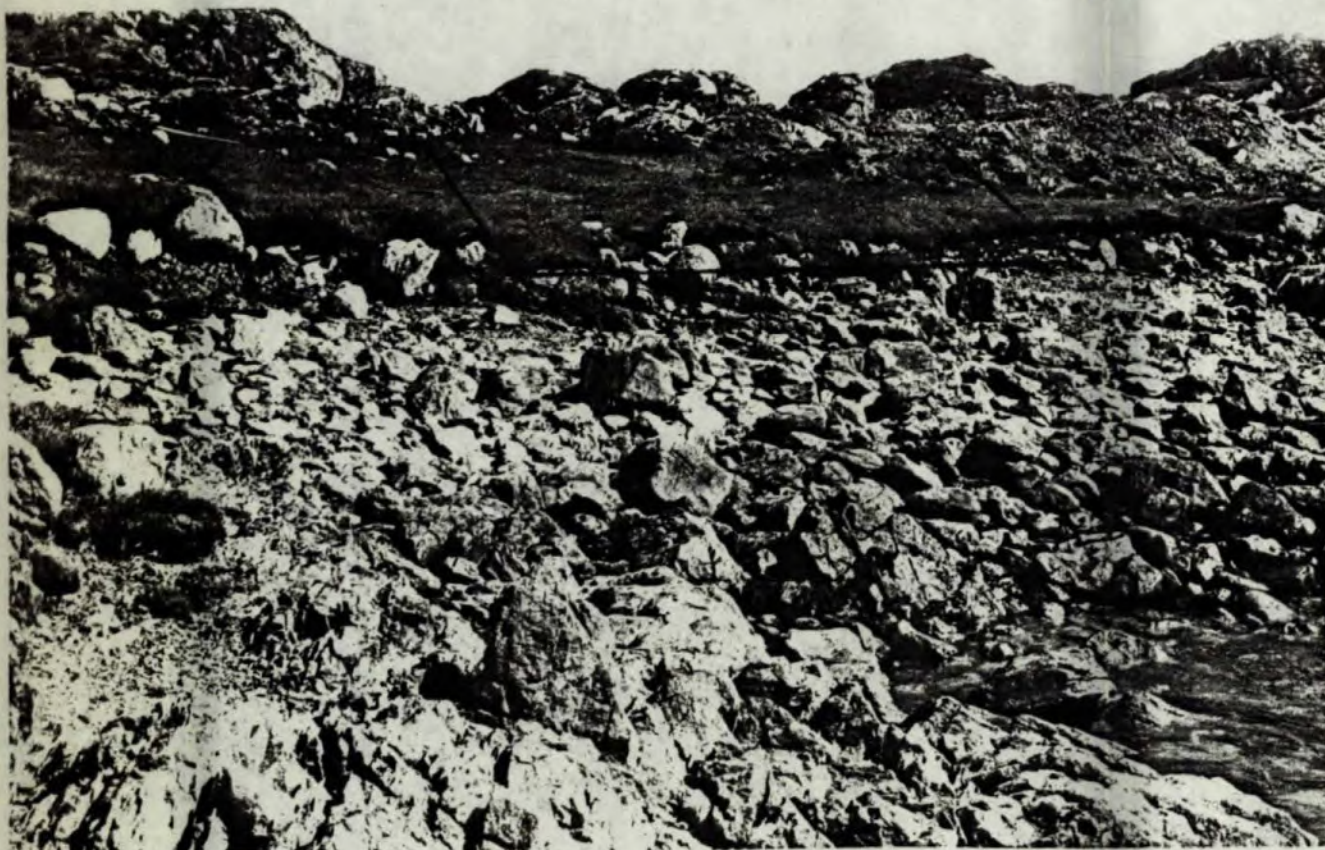
PHOTO NO. 9

Close-up of shoreline and pumphouse location for Scheme 2. The inlet channel would be extended to the pumphouse wall at the edge of the grassed area.

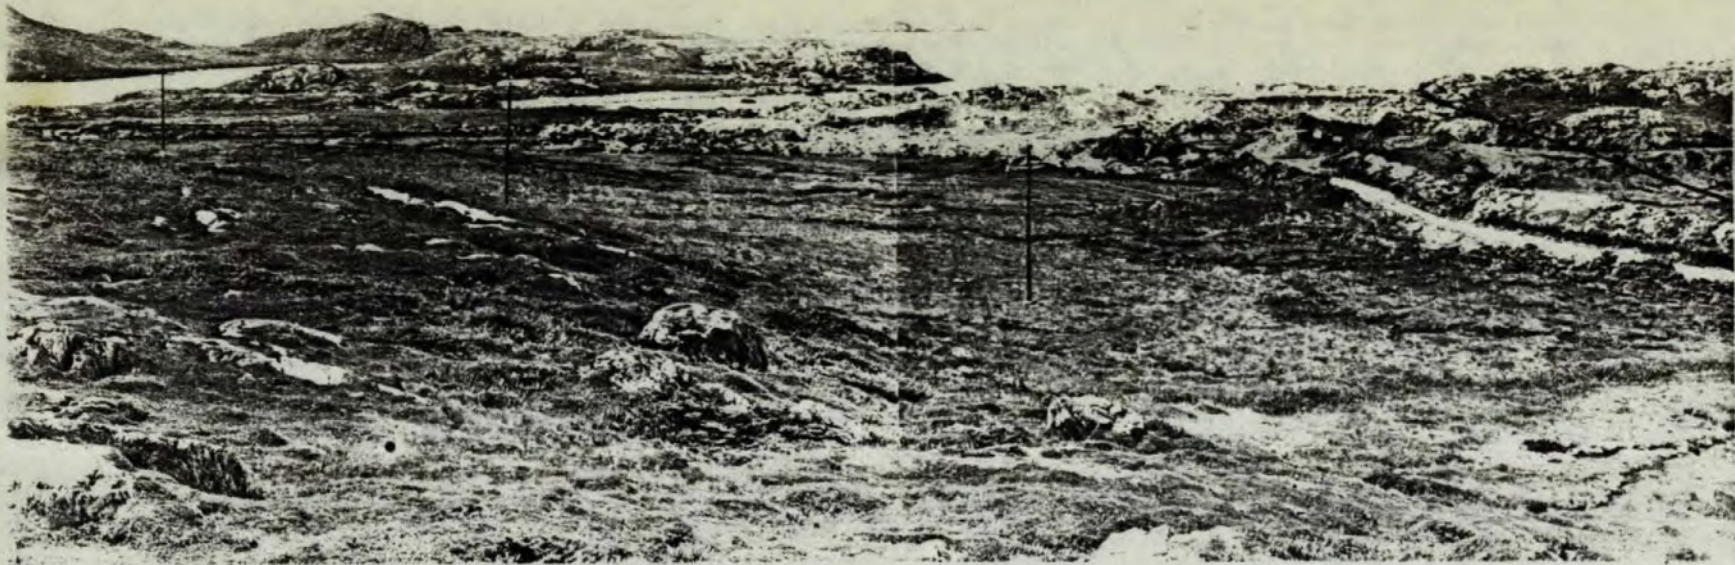
PHOTO NO. 10

View of bog area requiring containment - Scheme 2. The pipeline would pass between the roadways at upper right.

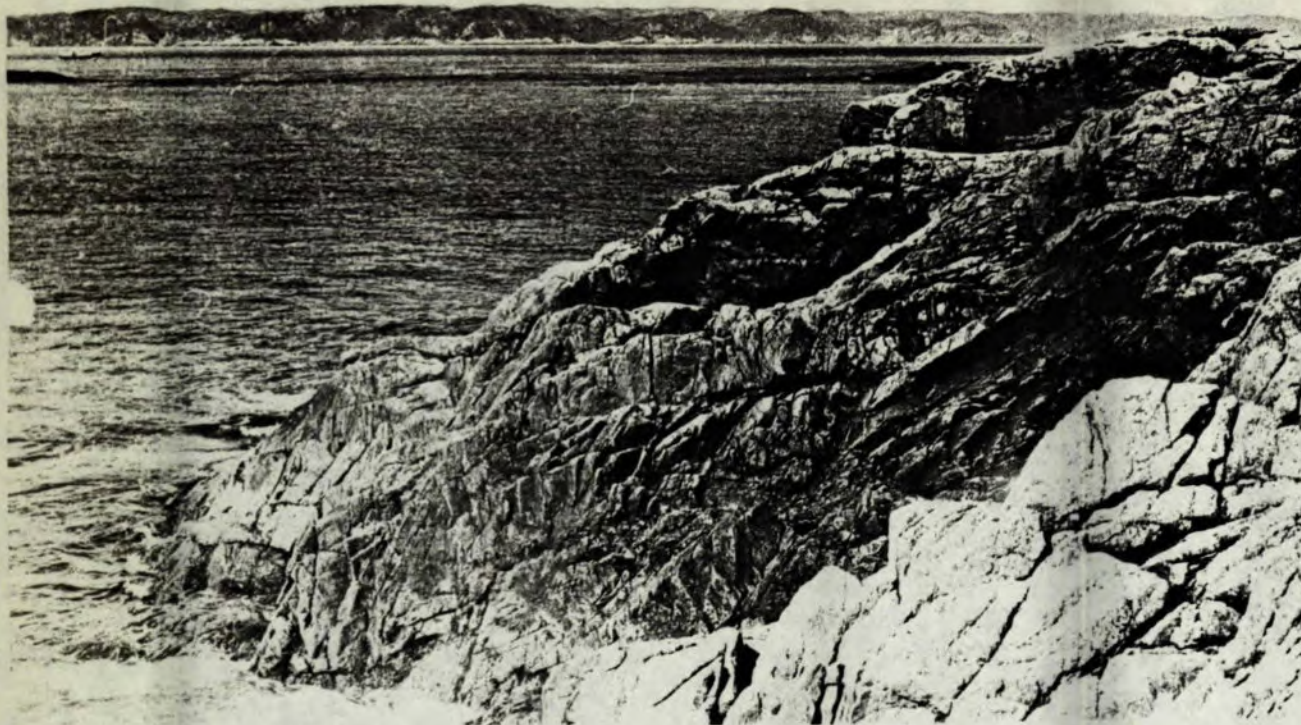
PHOTO NO. 12      General view of exposed rock west of Island Cove.

We also investigated the possibility of building a pump well in the rock on the east side of Muddy Hole Channel and blasting an intake from there out to deeper water. As is evident from Photographs No. 12 and 13, the rock is layered and fractured. In order to do underwater blasting in this type of rock it would be necessary to either carry out extensive grouting or work under compressed air, but which may also require some grouting. In any event, the cost would be very high and we, therefore, do not recommend this approach.

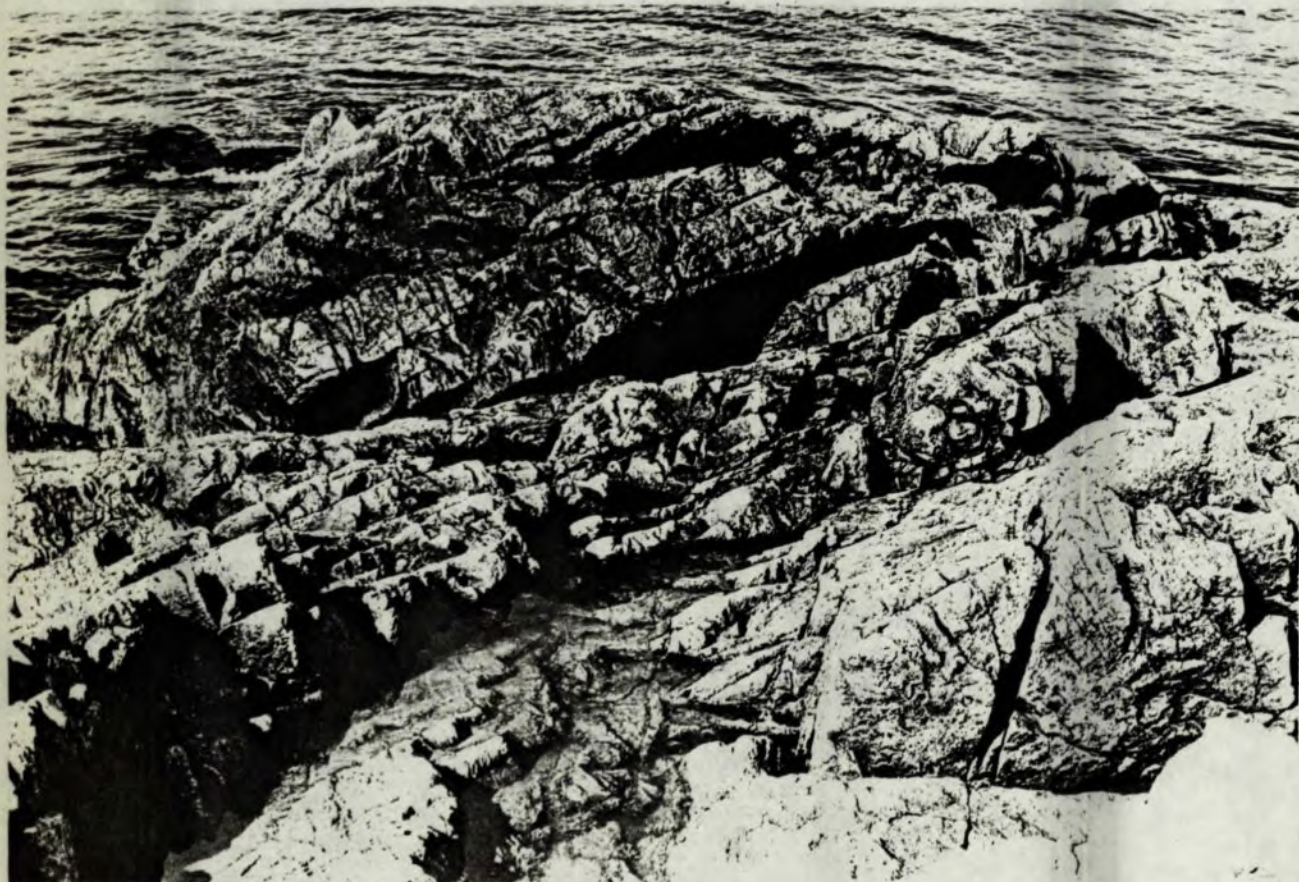
PHOTO NO. 13      Close-up view of the exposed rock showing thin layers and fractures. This type of rock would not easily yield large blocks suitable for armour stone by blasting.

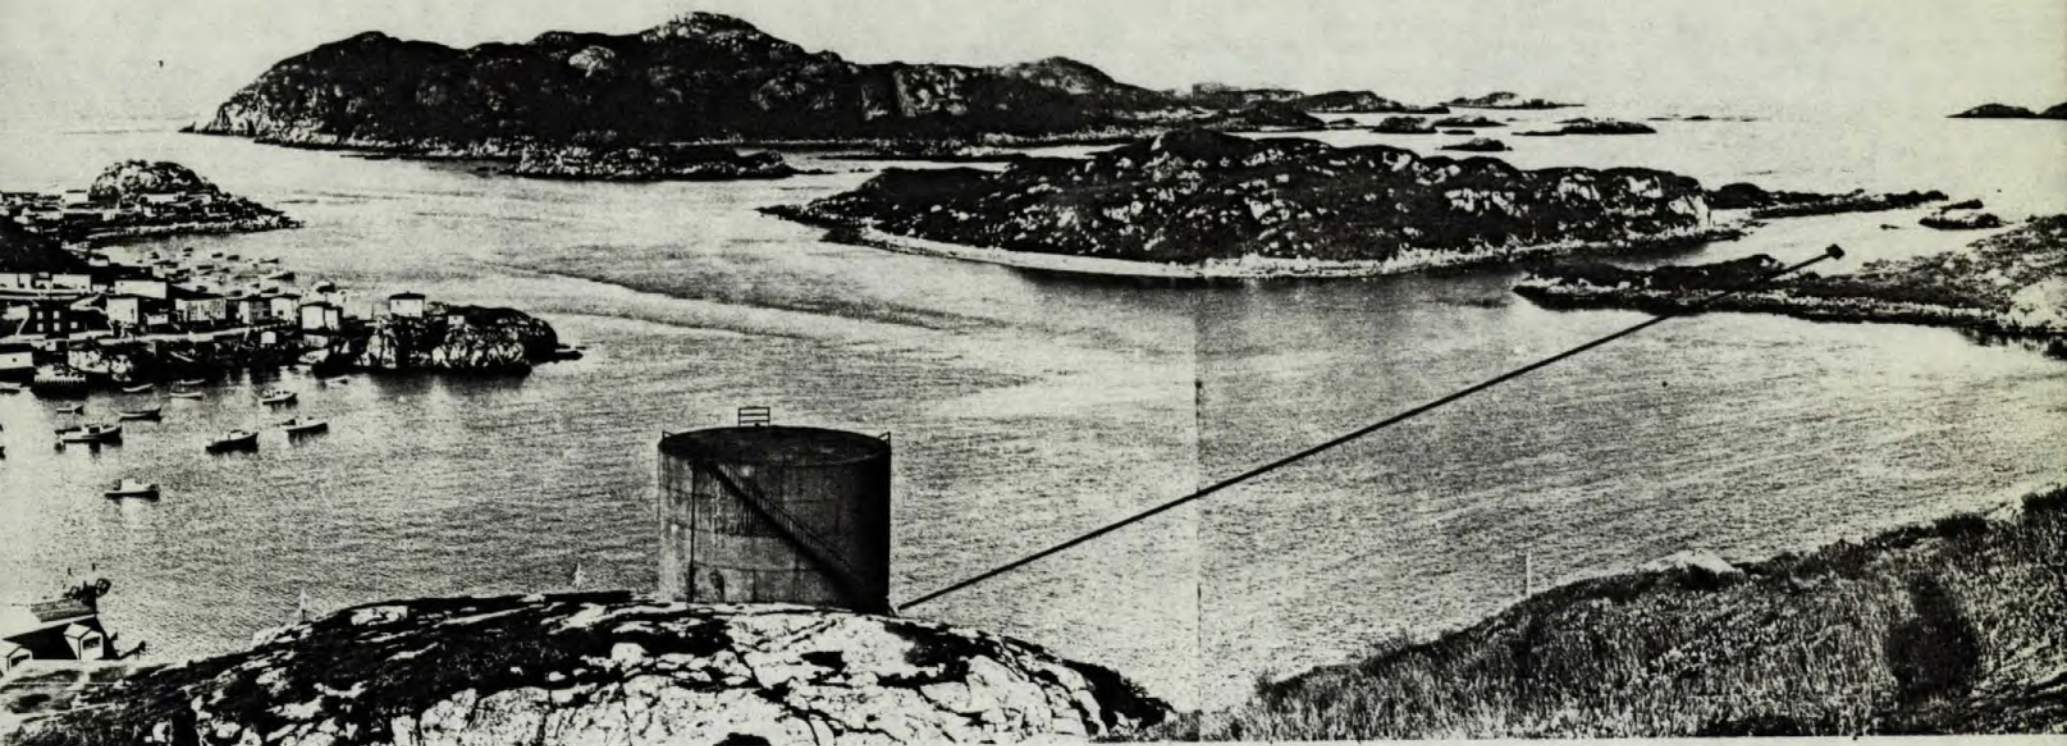
PHOTO NO. 14

General view of pipeline route for Scheme 3. The pumphouse would be located at the fish plant partly visible in the lower left.

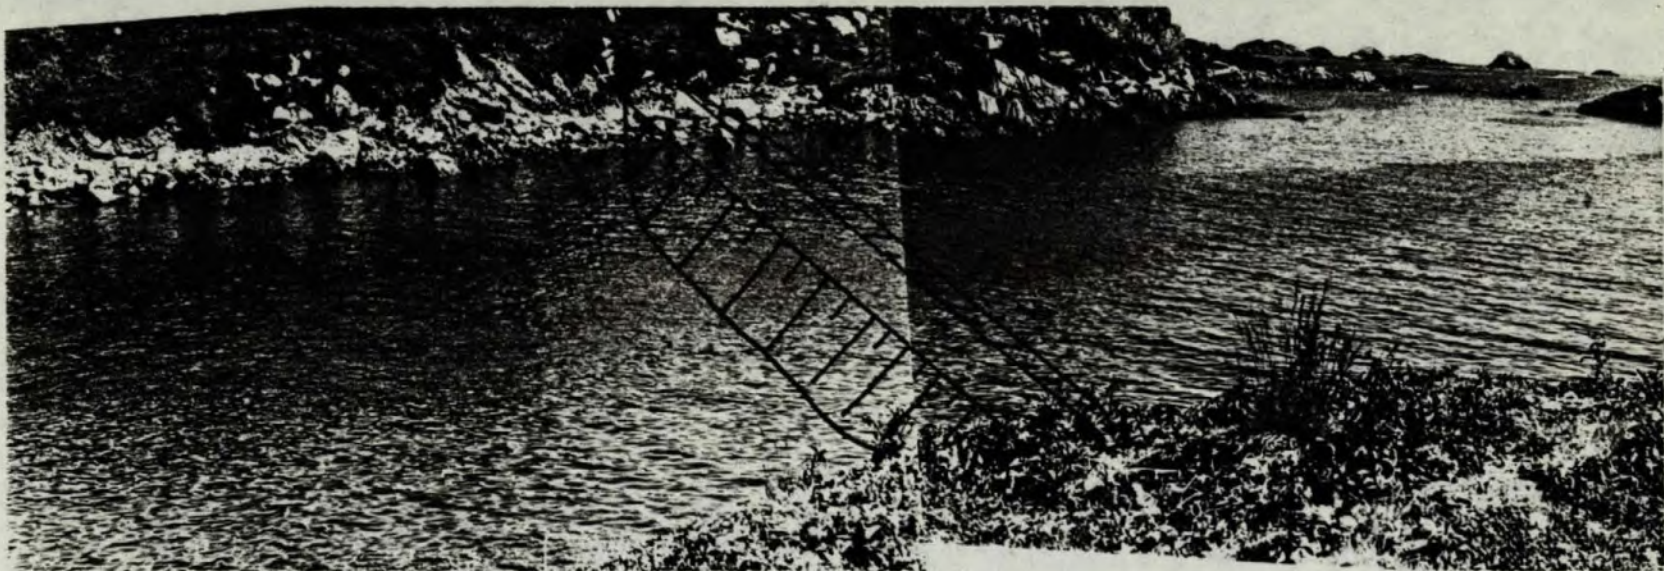
PHOTO NO. 15

View of narrow channel between Middle (or Puffin) and Harbour Islands.  
A dam might be required to close this gap for Scheme 3.
