Test Report

Intermediate Bulk Container Life Extension Research

Prepared for: Transport Canada
330 Sparks St.
Ottawa, ON K1A 0N5

Project: A1-019731
Report number: AST-2021-0019

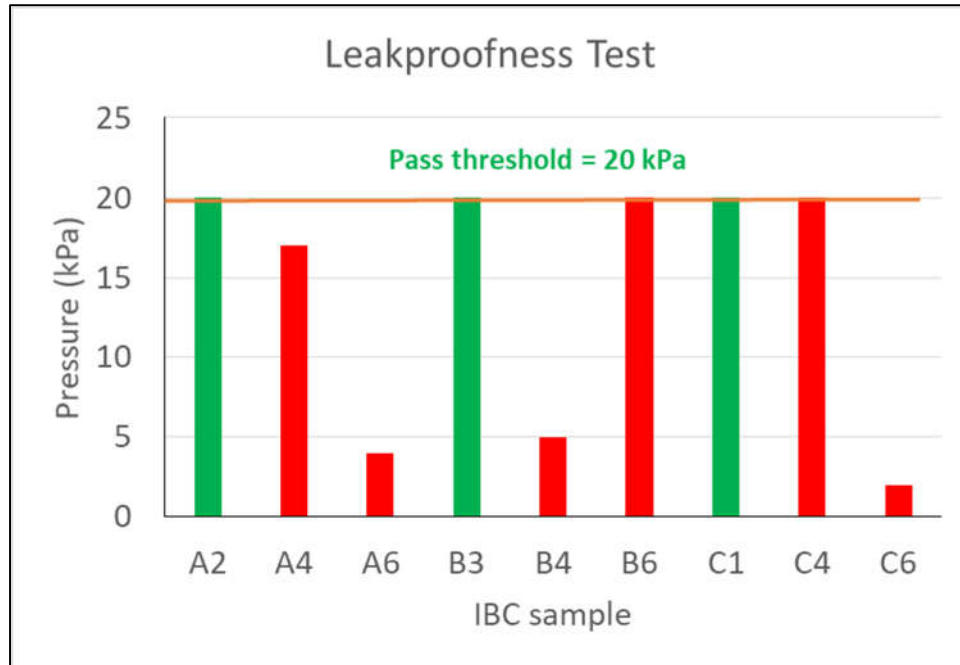
Figure 1: Initial results of leakproofness test prior to any modification

Maximum pressures and pass/fail results observed in the leakproofness tests are shown in Figure 1. Detailed results from the leakproofness tests are given in Table 9. Initial leakage pressures and location are specified in addition to any subsequent leakage and location after action was taken to remedy the initial leakage, where applicable.

C6	2	Both 2-in. closures	20 kPa	Main 6-in. closure.	Leakage past two 2-in. closures at 2 kPa. Evidence of chemical leakage on bungs was observed. Replaced with spare bungs and test continued, with leakage at pressure past closure. Re-torqued the closure to 136 N-m and leak still audible at closure at 20 kPa.	Fail

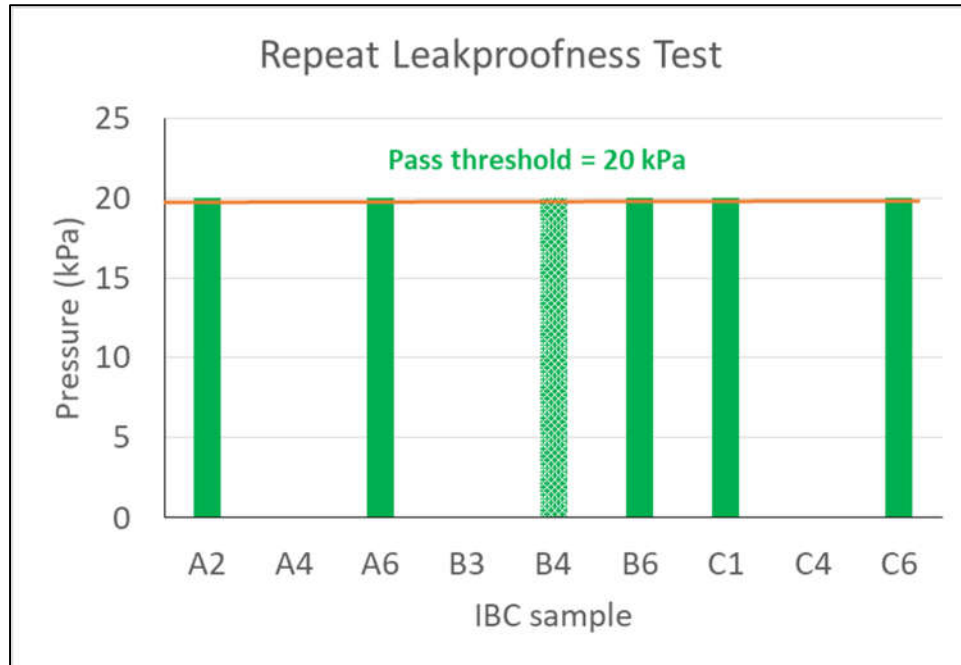
Figure 2: Results of repeat leakproofness test

Maximum pressures and pass/fail results observed in the repeat leakproofness tests are shown in Figure 2. All six IBCs tested were ultimately able to pass the leakproofness test, with only one of the six requiring additional torque on the closure to do so.

IBCs A2 and A6 passed the leakproofness test with new gaskets installed on the closures with 102 N-m (75 lbf-ft) of torque.

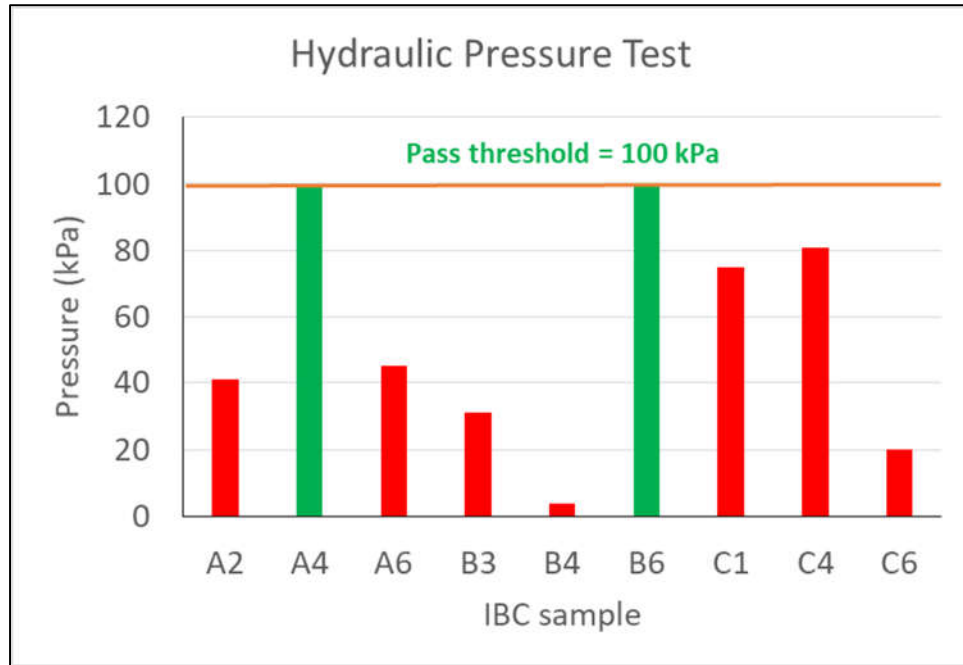
Figure 3: Hydraulic pressure test initial leakage pressures and pass/fail results observed

Maximum pressures and pass/fail results observed in the hydraulic pressure test are shown in Figure 3. Detailed results from the hydraulic pressure tests are summarized in Table 10.

IBC	Initial leakage		Subsequent leakage		Comment	Pass / fail
	Pressure (kPa)	Location	Pressure (kPa)	Location		
A2	41	Closure	34	Closure	Leakage past the closure observed at approximately 41 kPa. Closure tightening to 136 N-m resulted in leakage at 34 kPa.	Fail
A4	None detected	NA	None detected	NA	No leakage at 100 kPa. Test was extended to observe pressure stability. Note that quick pressure drops were observed during the testing. It is believed this is due to the frames suddenly relaxing or moving such that the walls expand and reduce pressure. No leaks were found.	Pass
A6	45	Closure	45	Closure	Leakage past the closure observed at approximately 45 kPa. Closure tightening to 136 N-m did not stop the leak.	Fail

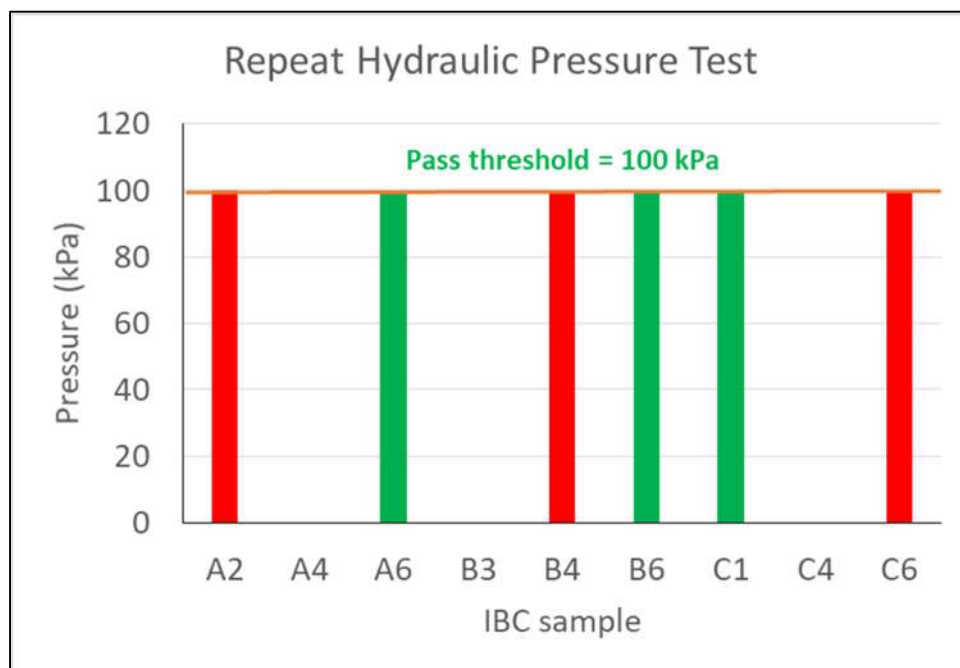
Figure 4: Results of repeat hydraulic pressure test

The hydraulic pressure tests were repeated on six of the IBCs that failed the initial hydraulic pressure test, with closures that had new gaskets installed. Maximum pressures and pass/fail results observed in the hydraulic pressure test are shown in Figure 4. Detailed results from the hydraulic pressure tests are summarized in Table 11.

IBC	Original pass / fail	Comment	Repeat pass / fail
A2	Fail	Leak at bottom closure, handle opened	Fail
A6	Fail	No leakage with new gasket	Pass
B4	Fail	Leak through body of tank	Fail
B6	Pass	Initially failed with dry gasket	Pass
C1	Fail	No leakage with new gasket	Pass
C6	Fail	Leak past seal	Fail

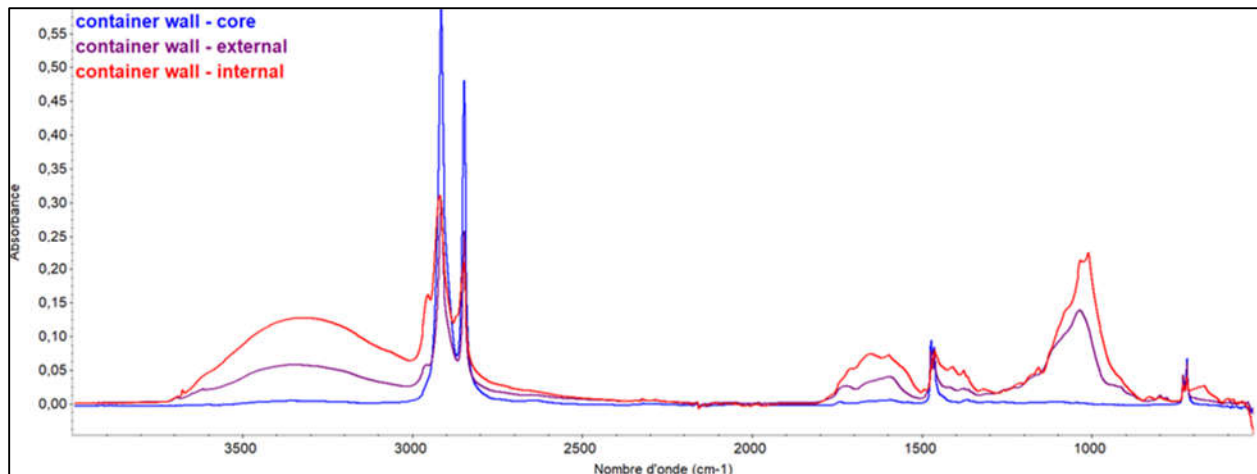
Figure 6: FTIR spectra of the core, internal surface and external surface of the inner bottle wall

Internal and external surfaces, in comparison, show strong oxidation. This oxidation can be seen by the presence of O-H (hydroxyls) bands at $3,400\text{ cm}^{-1}$, C-O (ethers) bands at $1,100\text{ cm}^{-1}$, and C=O (esters and ketones) bands at $1,700\text{ cm}^{-1}$. The shoulder on the left of the $2,900\text{ cm}^{-1}$ C-H band is the sign of a loss of symmetry in the backbone, proof of oxygen grafting.

Both surfaces were exposed to strong oxidation, probably due to exposure to water or stronger oxidizing agents for the internal surface, and ultraviolet and water exposure on the external surface. Such a level of oxidation is not surprising, nor dangerous, considering the thickness of the walls. Oxidized PE will lose mechanical properties and eventually start to degrade slightly, but as long as the core of the wall is not exposed, no significant failure is likely.

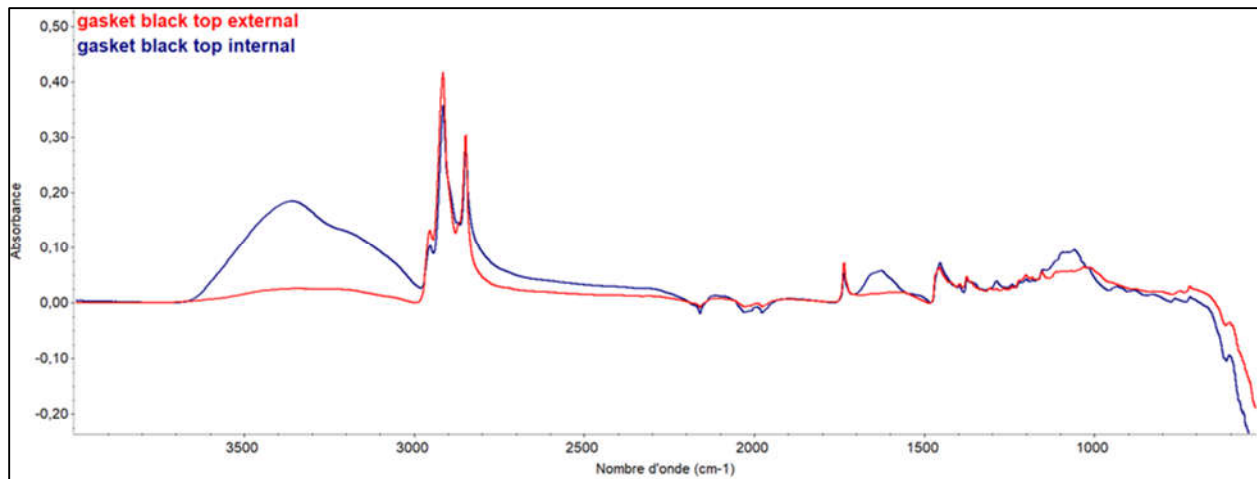
Figure 7: FTIR spectra of the exposed (external) and protected (internal) surfaces of the black top gasket (Manufacturer B)

The black closure gasket (Manufacturer B) exhibits considerably less hydroxyls on the exposed surface in comparison to the protected internal surface. This could possibly indicate drying or degradation of the surface exposed to the IBC for closure. If this modification cannot be quantitatively expressed, such significant modification of the chemical structure has to be further analysed.

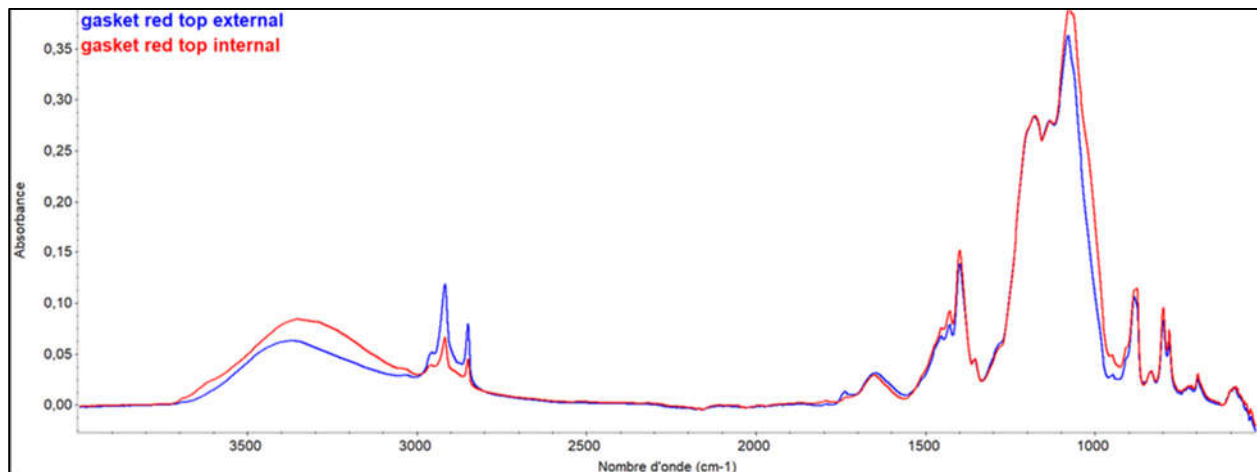
Figure 8: FTIR spectra of the exposed (external) and protected (internal) surfaces of the red top gasket (Manufacturer A)

The red closure gasket (Manufacturer A) does not exhibit any kind of chemical modification on any surfaces and was barely modified from a chemical point of view.

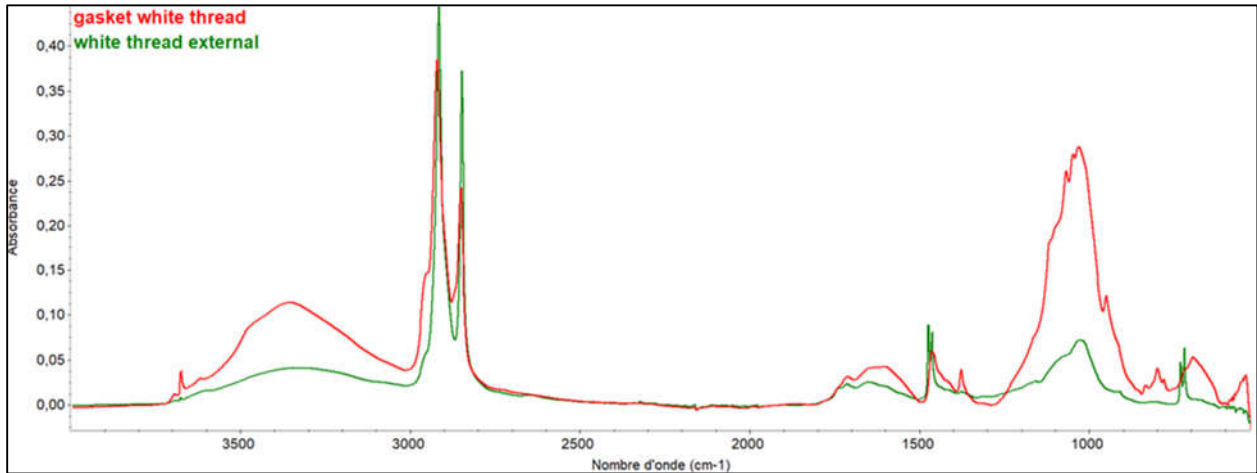
Figure 9: FTIR spectra of the 2-in. bung surface and gasket

The chemical structure of the Manufacturer C 2-in. bung was identified as oxidized polyethylene, with the absorption bands shown in Figure 9. The oxidation state is comparable with the external surface of the container walls.

Although the seal is more complicated to analyse, the structure seems to correspond to a highly oxidized rubber, probably polyethylene propylene diene. The exact initial composition is difficult to estimate as the oxidation state is very advanced. A seal in such condition should be replaced, as the oxidation will lead to disintegration and porosity.

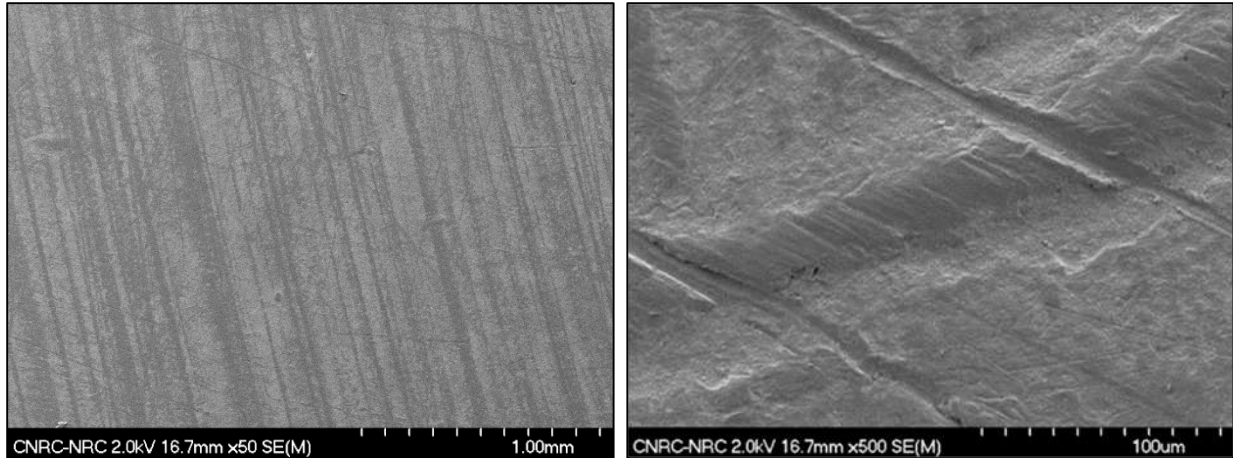
Figure 10: Manufacturer A container SEM images taken at x50 (L) and x500 (R)

Analysis of the SEM images taken of the external wall of the Manufacturer A container as shown in Figure 10 indicates considerable directional scratching which could be due to the handling or the production of the part. None of the scratches have led to any deep cracks and only negligible damage is visible. From a micro analysis point of view, the surface is still in perfect shape.

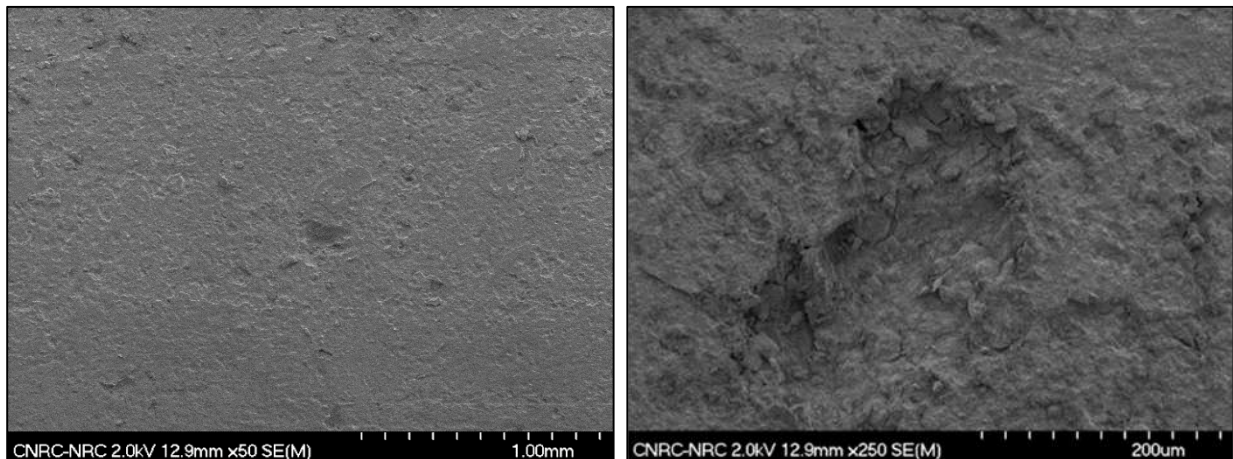
Figure 11: Manufacturer B closure gasket SEM images taken at x50 (L) and x250 (R)

Analysis of the SEM images taken of the Manufacturer B container closure gasket as shown in Figure 11 indicate that the surface is still homogeneous with only slight drying and damage visible. Some holes can be seen and close ups show irregular surfaces, signs of slight drying and tearing of the thermoset elastomer material. No clear traces of disintegration can be detected.

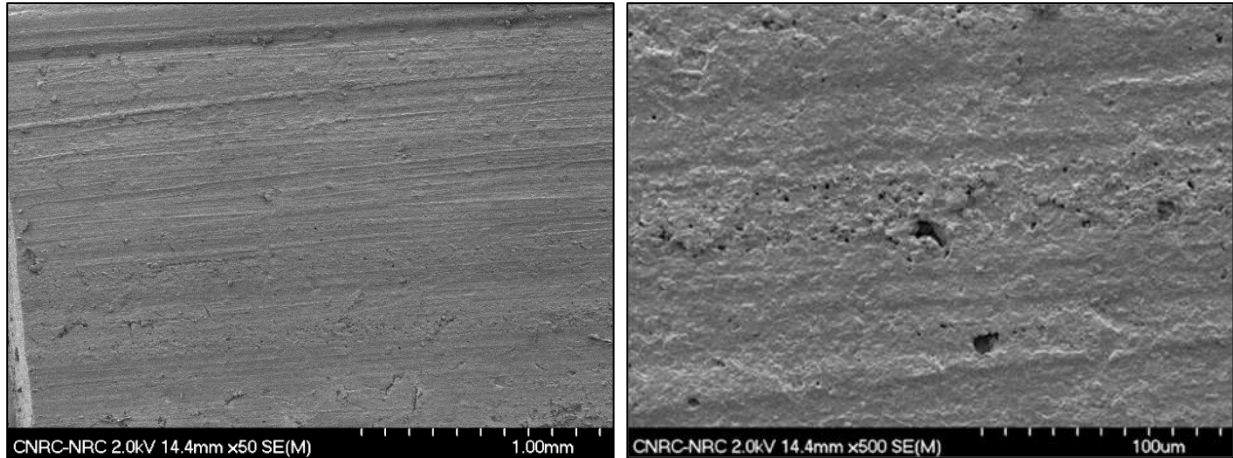
Figure 12: Manufacturer A closure gasket SEM images taken at x50 (L) and x500 (R)

Analysis of the SEM images taken of the Manufacturer A container closure gasket as shown in Figure 12 indicate that the surface of this gasket is relatively similar to the Manufacturer B container closure gasket, however with one difference. The Manufacturer A container closure gasket contains small porosities which can be detected on the bottom part of the ring structure (close to the internal radius), possibly due to the handling of the gasket after the removal from the top (extension). No disintegration can be seen around the porosity, which would support the hypothesis of the damage having occurred post removal. Other than these specific damages, the surface appears to be in good shape.

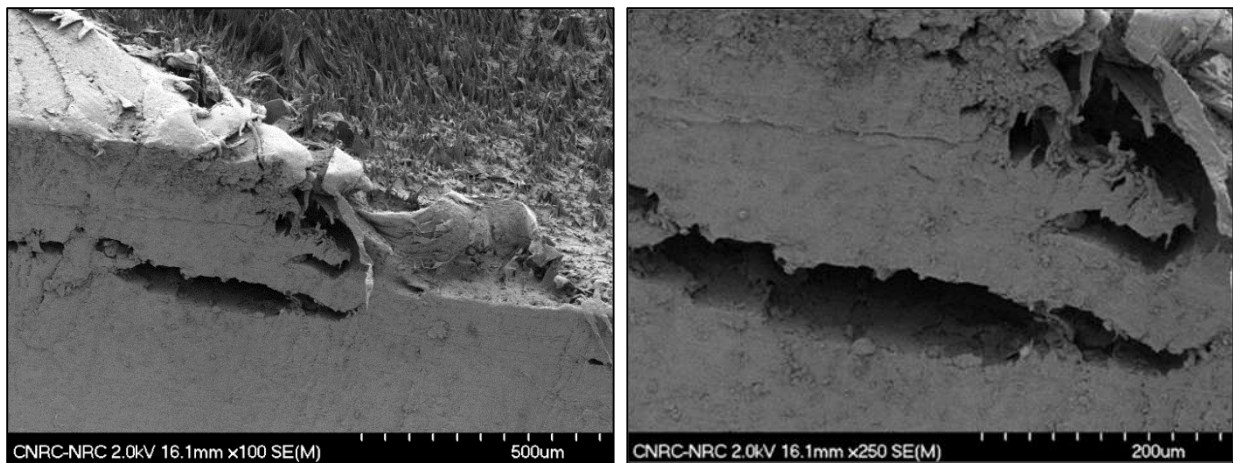
Figure 13: Manufacturer C 2-in. bung SEM images taken at x100 (L) and x250 (R)

SEM images of the damaged 2-in. bung collar from the Manufacturer C IBC as shown in Figure 13 were taken in the proximity of the failure location. The “hairy” surface is typical of a strong pulling of a polymer plastic part, with a large chunk of polymer being removed (large cracking) at this location. The force was perpendicular to the surface, and the “hairs” are the result of the mechanical separation of strongly intricate polymer chains. Close ups show that below those surfaces, additional cracks are clearly visible and are proof of a general failure of the structure under constraints. Such failure is not due to degradation of the polymer but to an excessive tightening of the thread (pressure applied on the collar) either repeatedly or for a long duration.

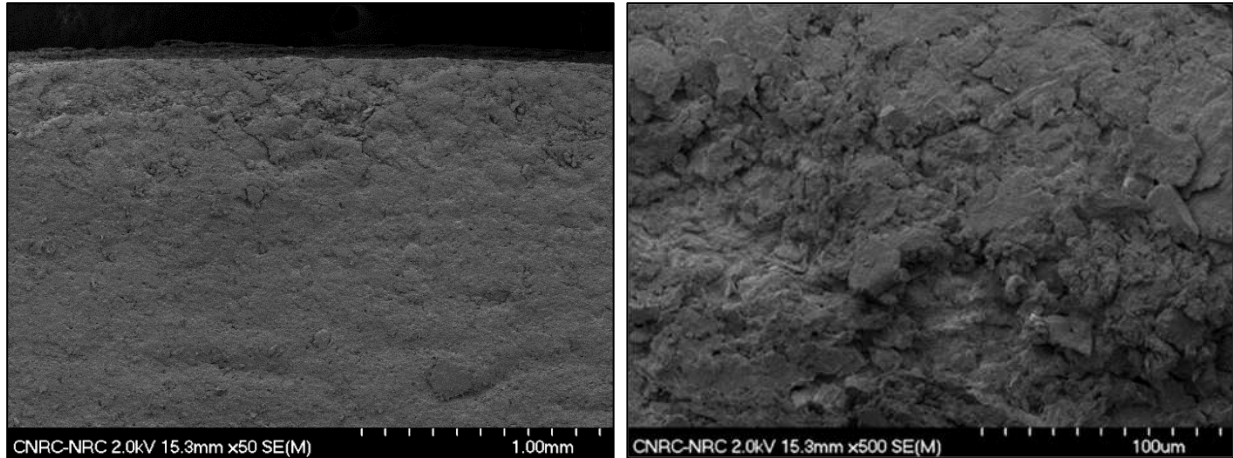
Figure 14: Manufacturer C 2-in. bung gasket SEM images taken at x50 (L) and x500 (R)

SEM images of the damaged 2-in. bung seal from the Manufacturer C IBC shown in Figure 14 indicate significant drying and signs of disintegration. Large parts, especially on the edges, tend to degrade due to oxidation of the rubber structure, leading to a weakening of the thermoset network and the disintegration. As a result the seal will stiffen to an extent and lose its capacity to seal, which perhaps explains why more strength was required to seal the part, resulting in damage to the bung.
