REPORT
OF
THE BOARD OF INQUIRY
into the accident at
Toronto International Airport,
Malton, Ontario,
to Air Canada DC8-CF-TIW aircraft
on July 5, 1970
held before
The Honourable Mr. Justice Hugh F. Gibson,
Commissioner.

T A B L E O F C O N T E N T S

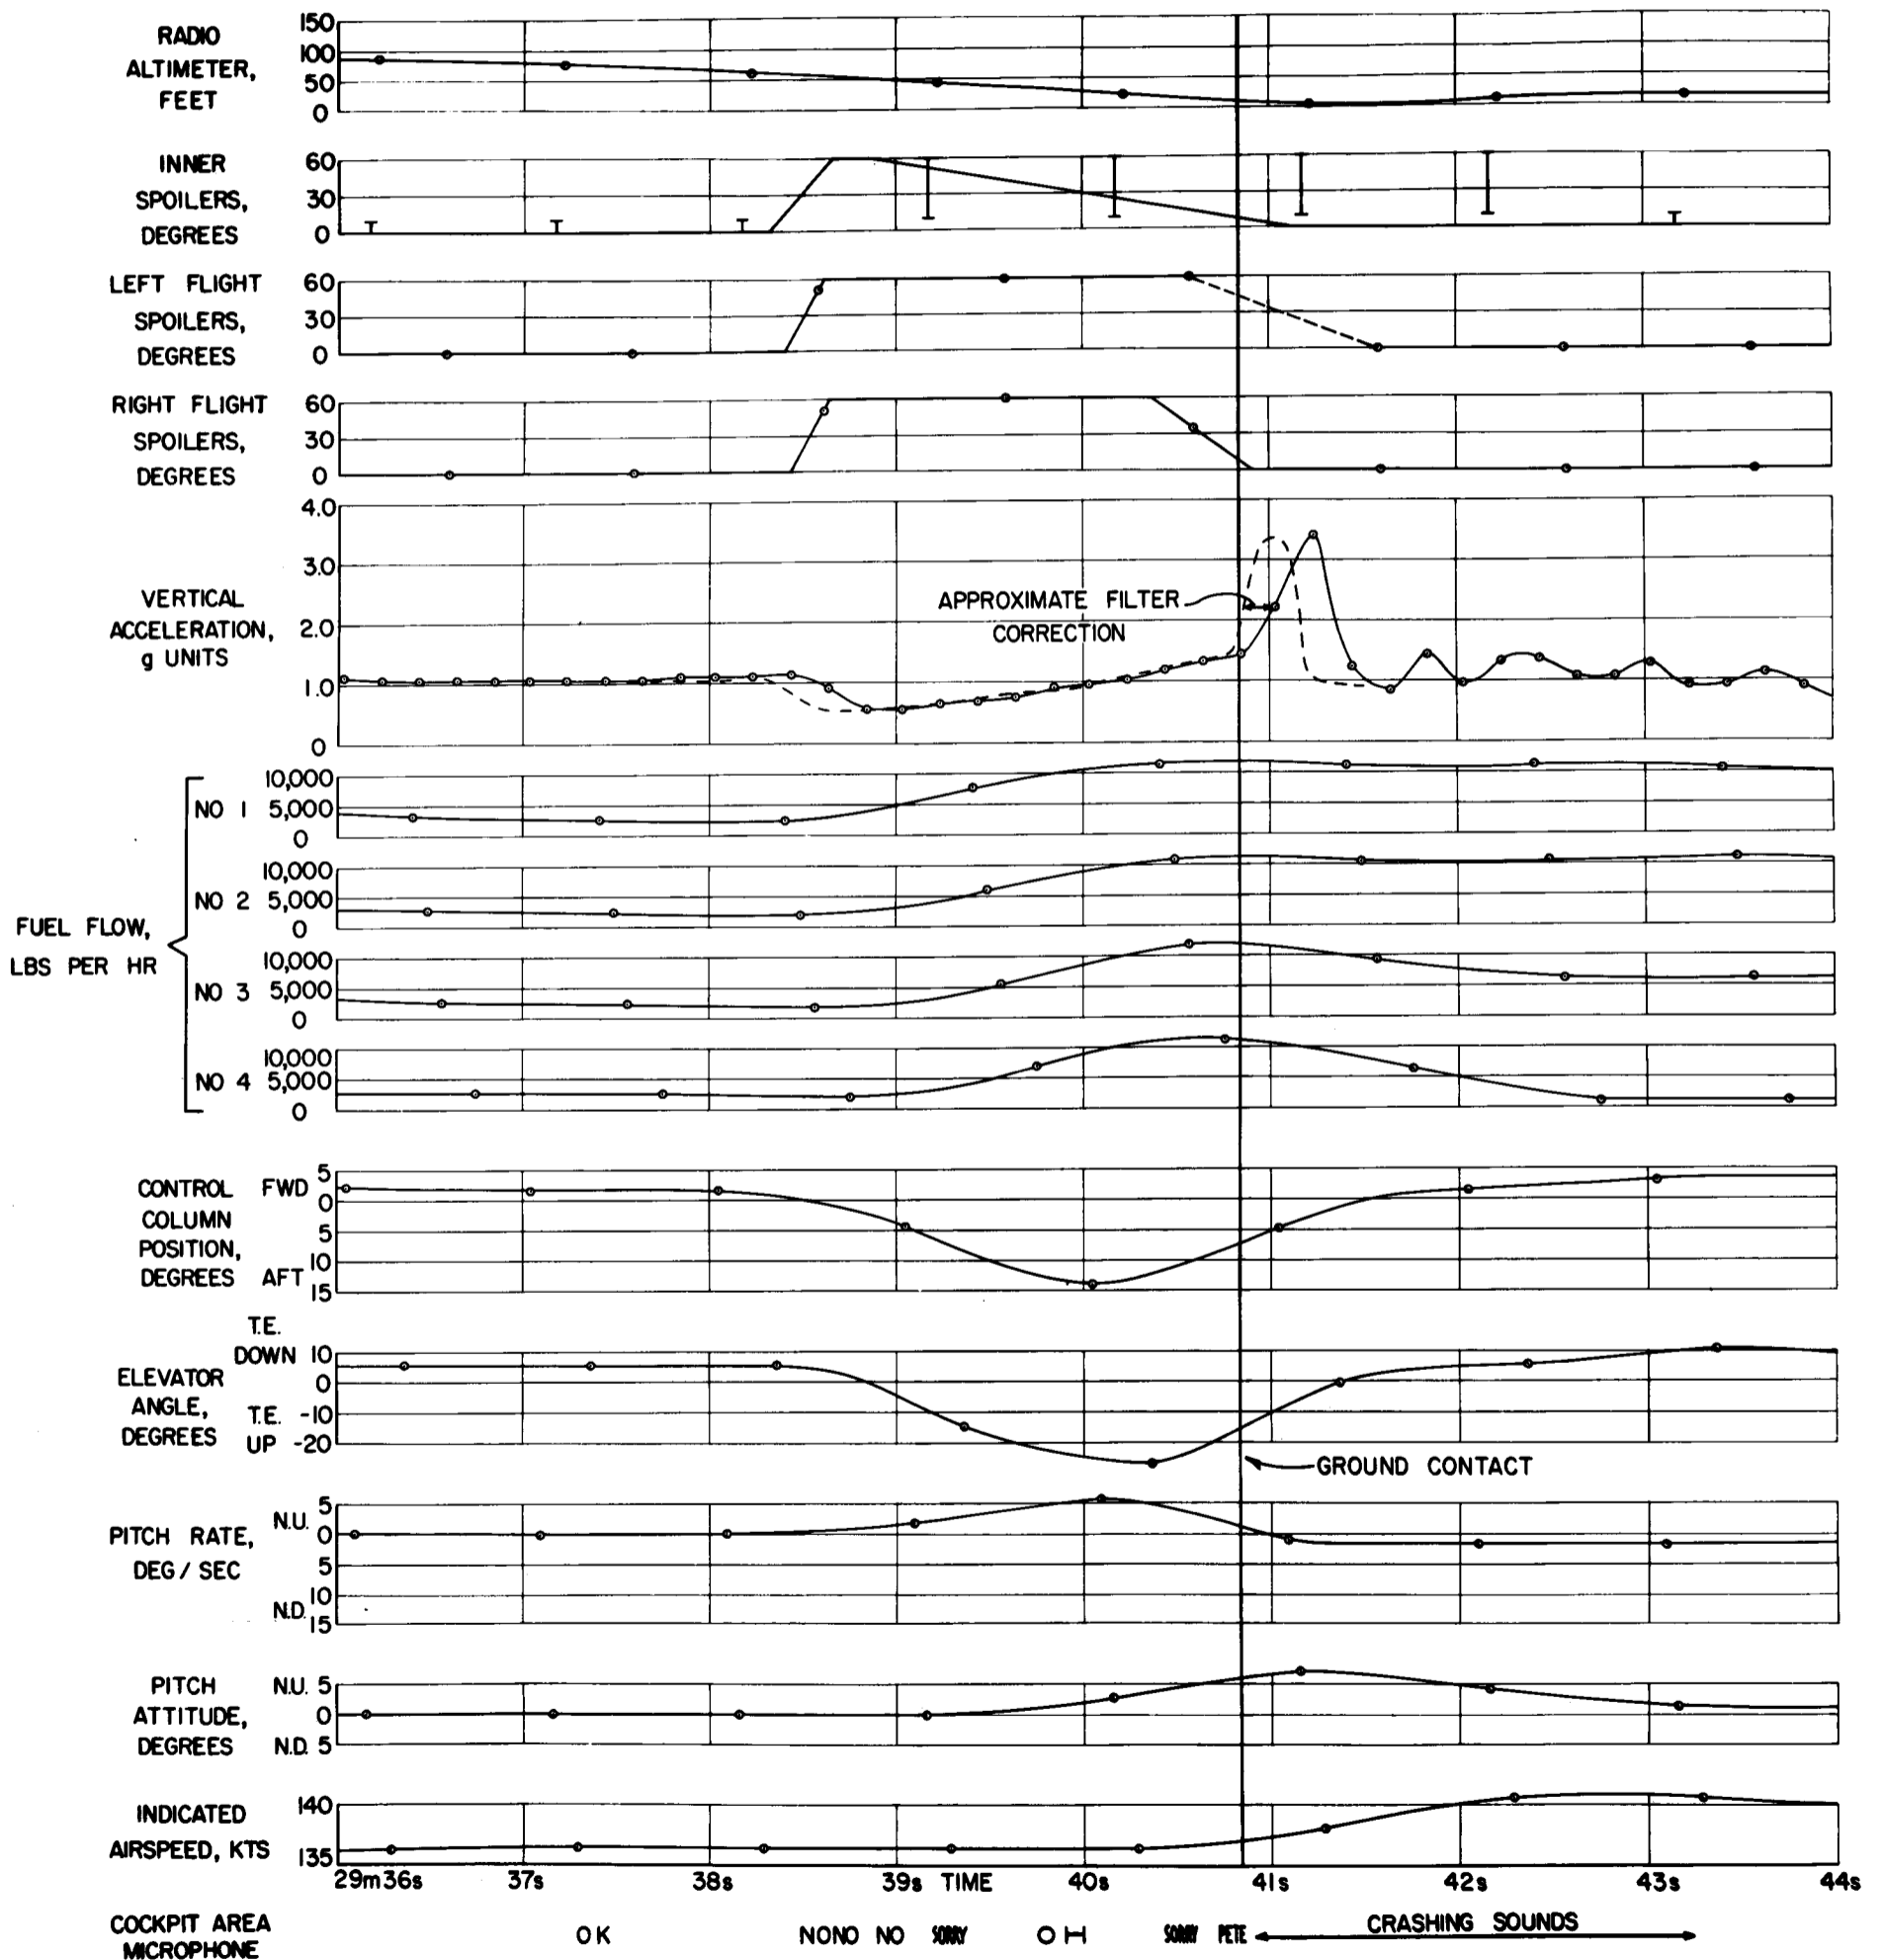
SCHEDULE 4 OF APPENDIX D

Immediately thereafter the First Officer instead of arming the ground spoilers by lifting up the knob of the spoiler actuating lever, pulled the lever aft to the aft extend position, which caused the ground spoilers to be deployed immediately thereafter. As a result, the aircraft lost lift immediately and developed a vertical acceleration of approximately (-) $\frac{1}{2}$ g.

VARIATION OF CRITICAL PARAMETERS DURING SPOILER DEPLOYMENT AND TOUCHDOWN WITH SYNCHRONIZED VOICE INFORMATION

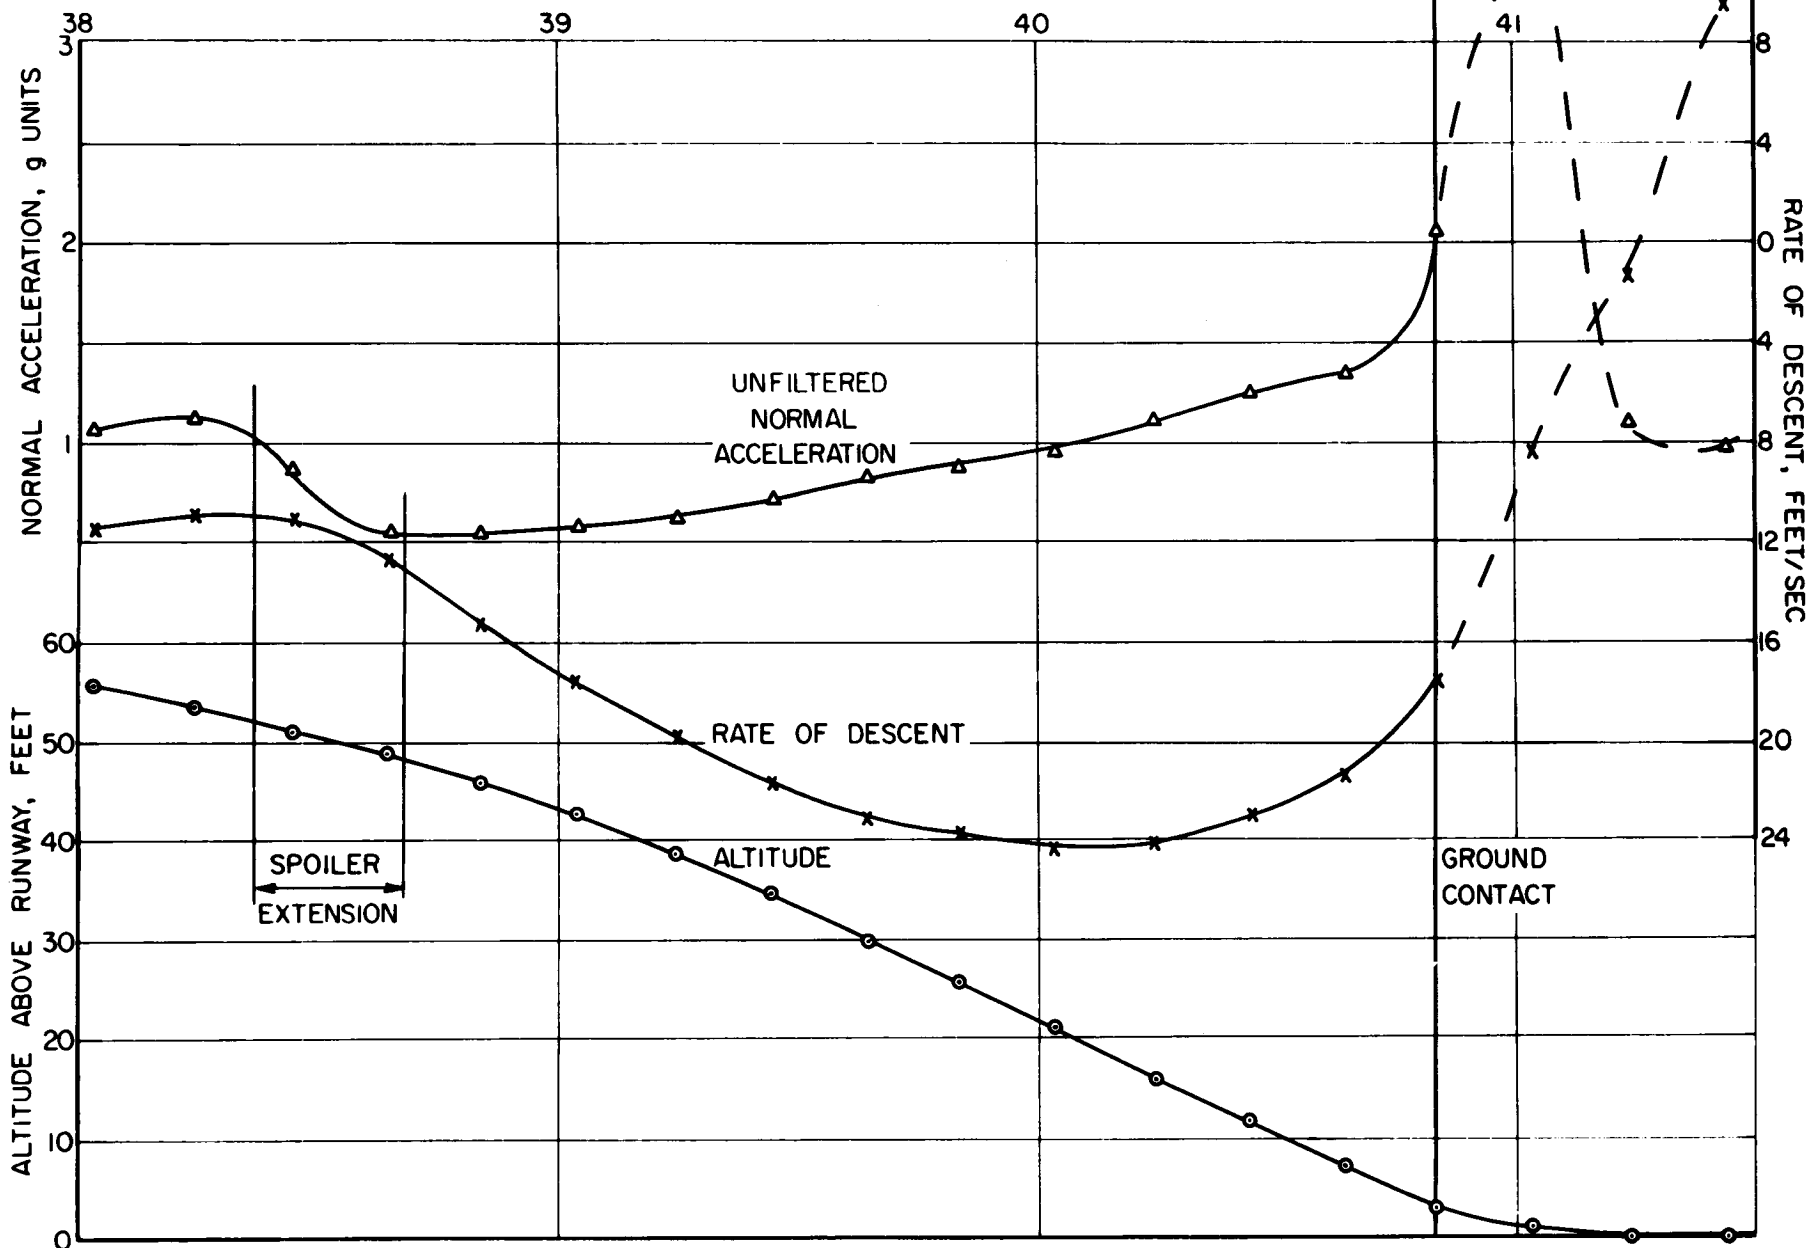
To consider the sequence of events in more detail, the first contact with the runway was made by the main wheels of the undercarriage on the right-hand side of the aircraft at a (vertical) velocity of approximately 18 feet per second. The oleo unit¹ on this side was damaged when the piston

DETERMINATION OF RATE OF DESCENT AT TOUCHDOWN

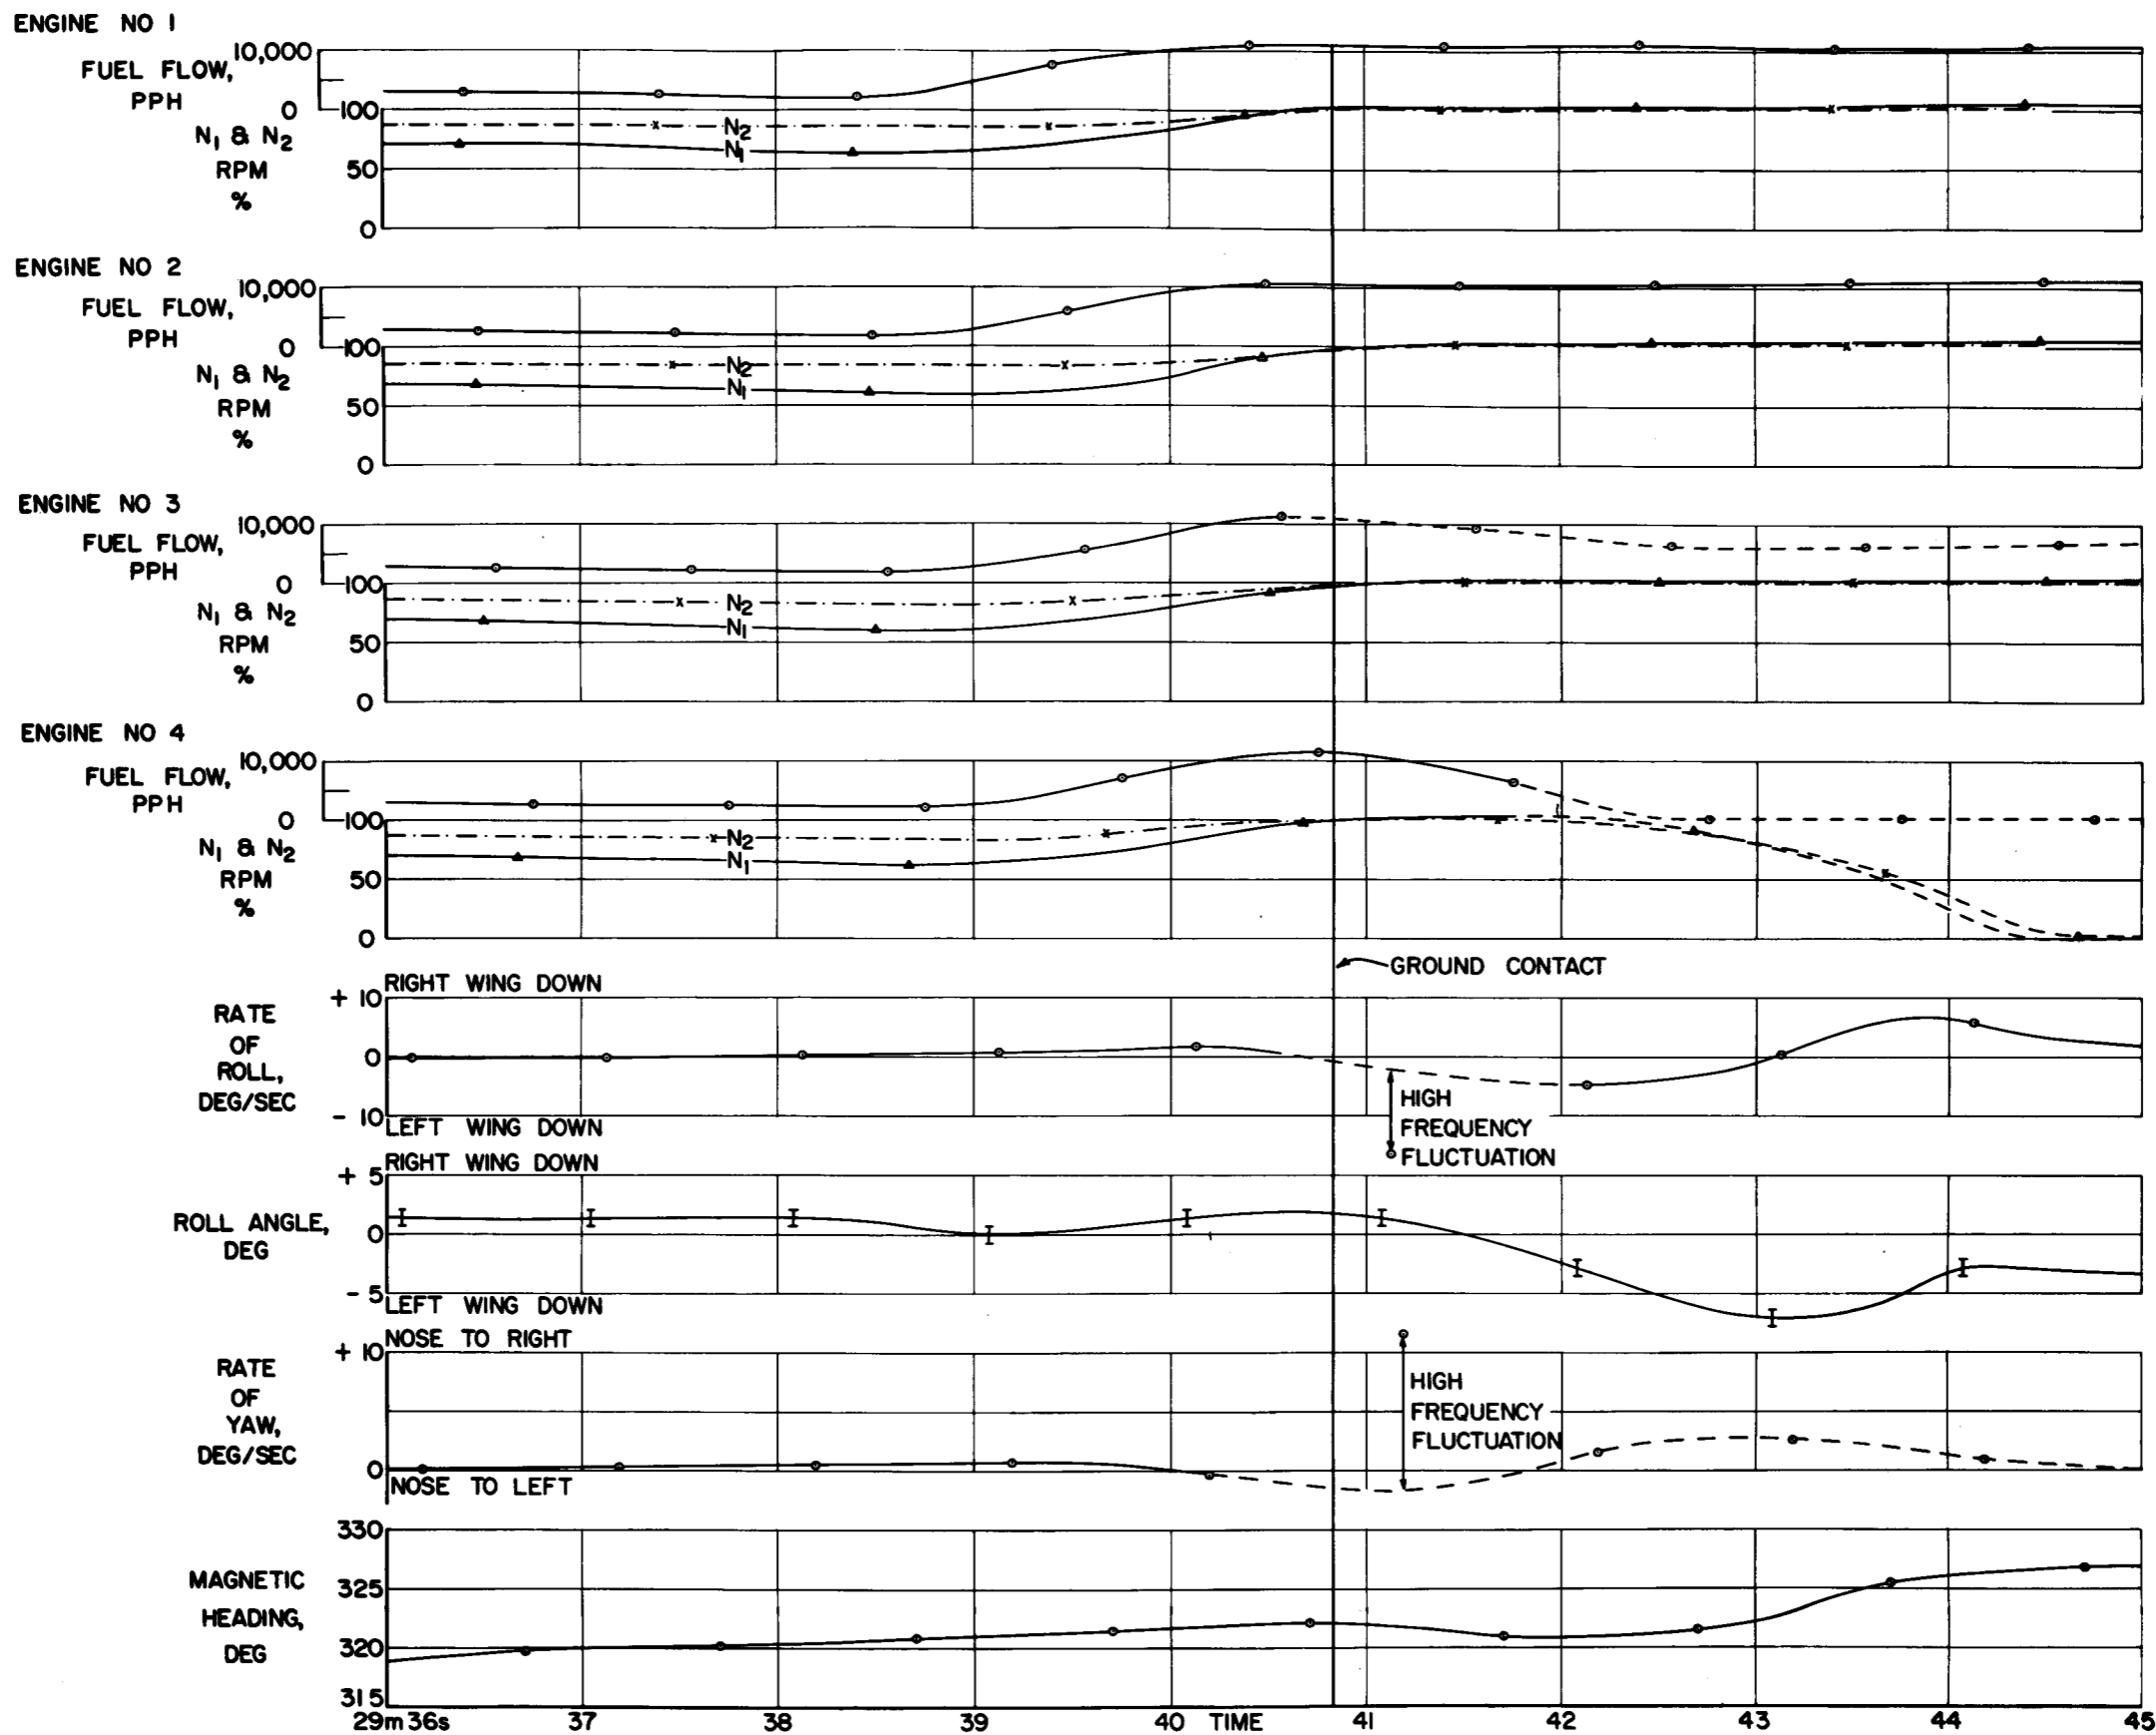
SCHEDULE 6 OF APPENDIX D

ENGINE, ROLL, AND YAW DATA DURING SPOILER DEPLOYMENT AND TOUCHDOWN

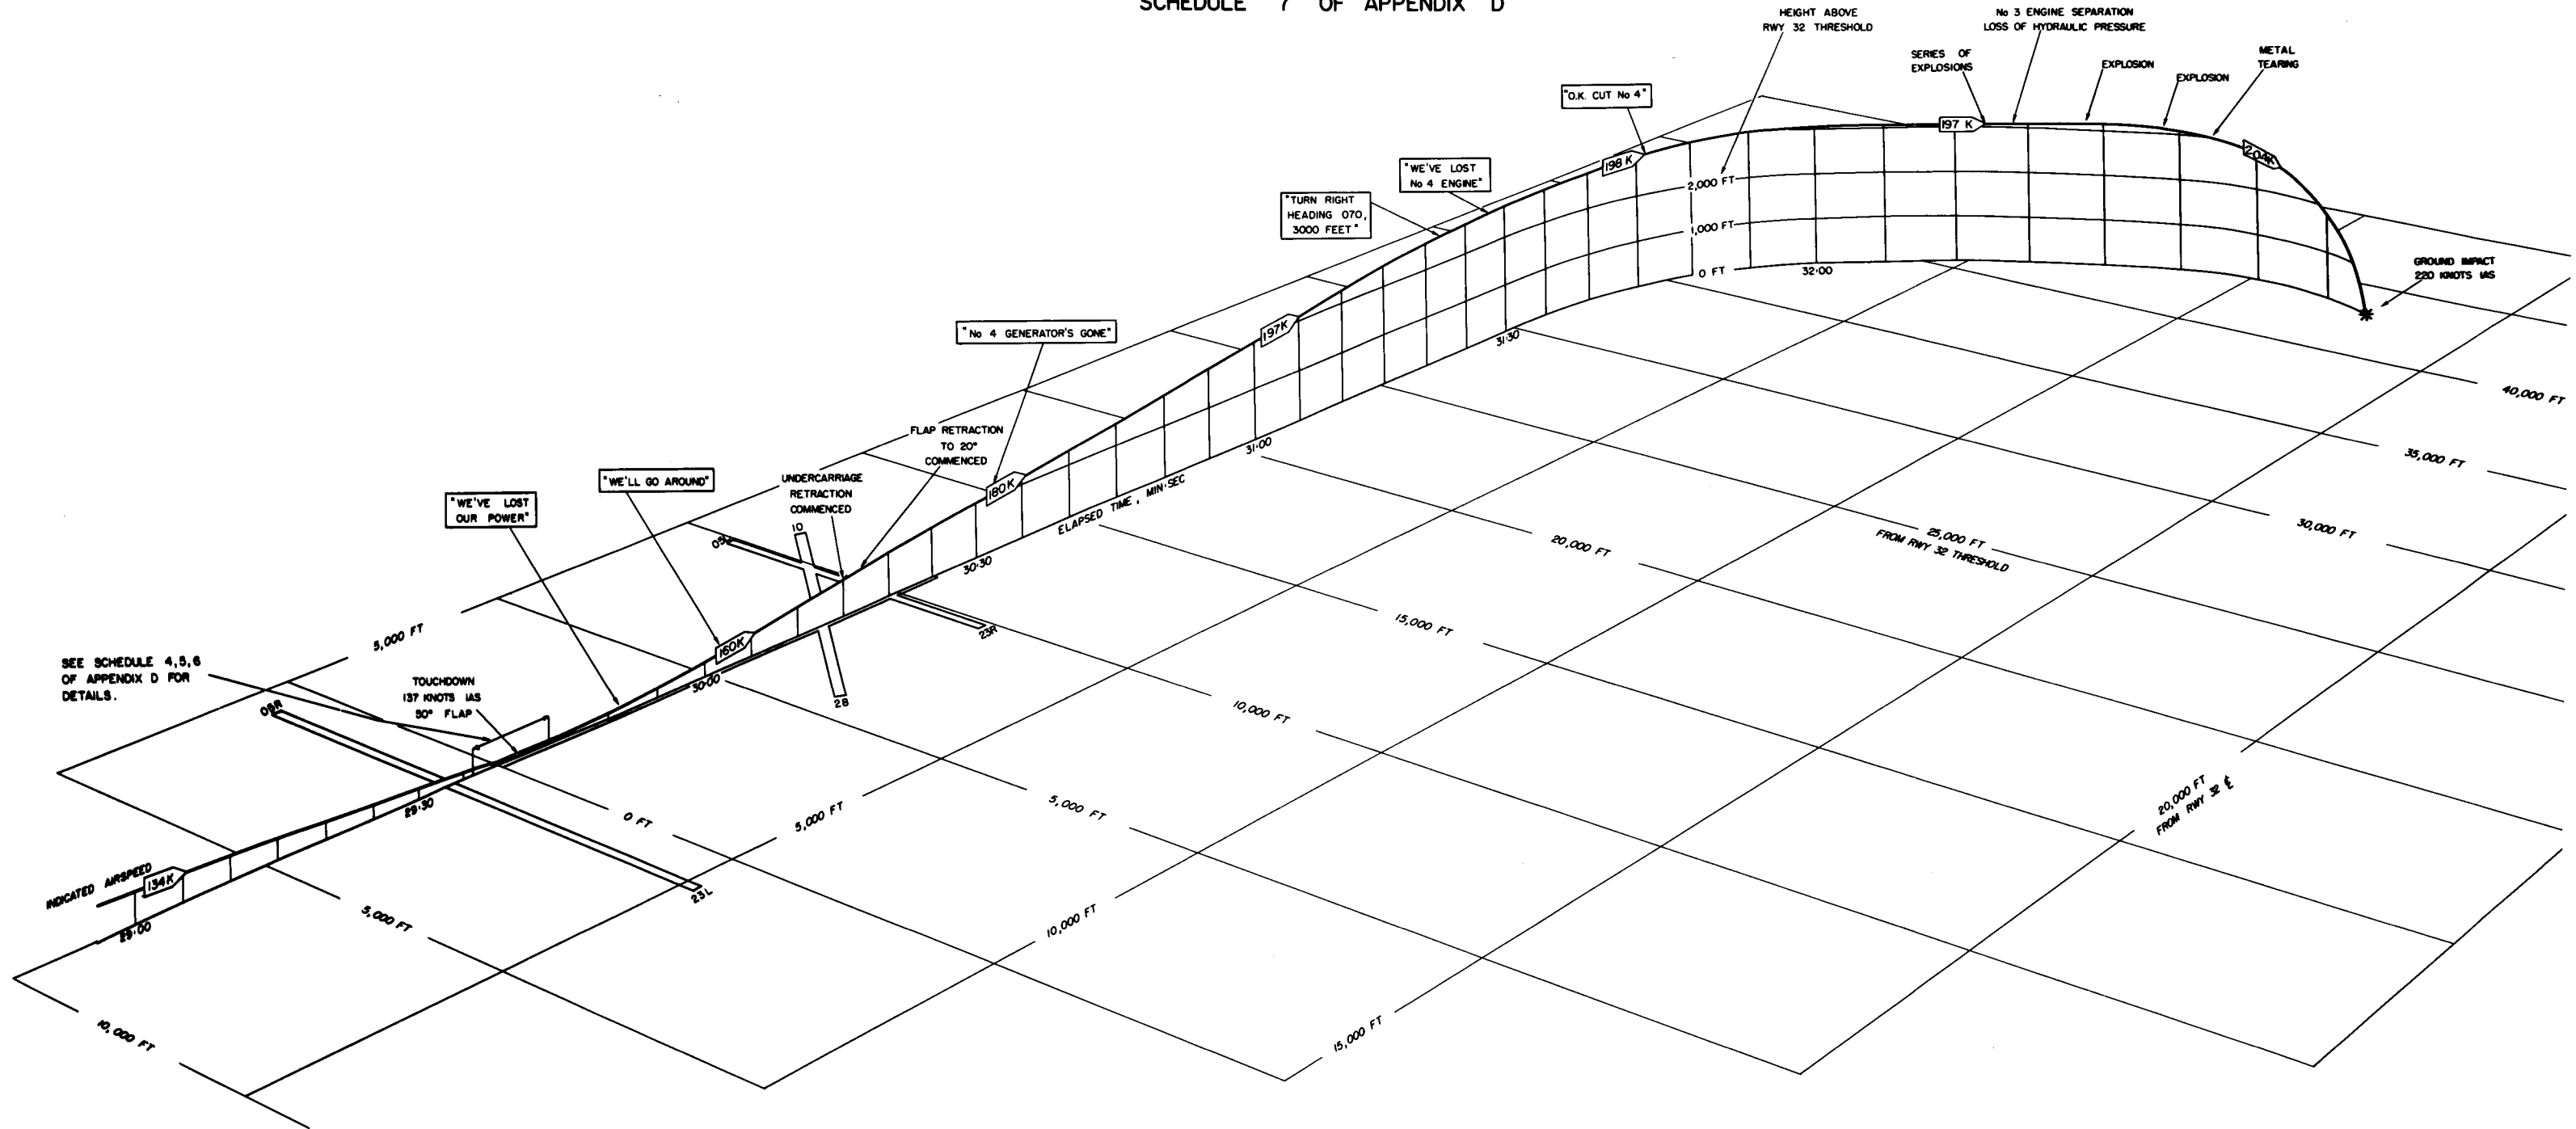
SCHEDULE 7 OF APPENDIX D

RECONSTRUCTION OF CF-TIW FLIGHT PATH AND EVENTS FROM THE FLIGHT RECORDER

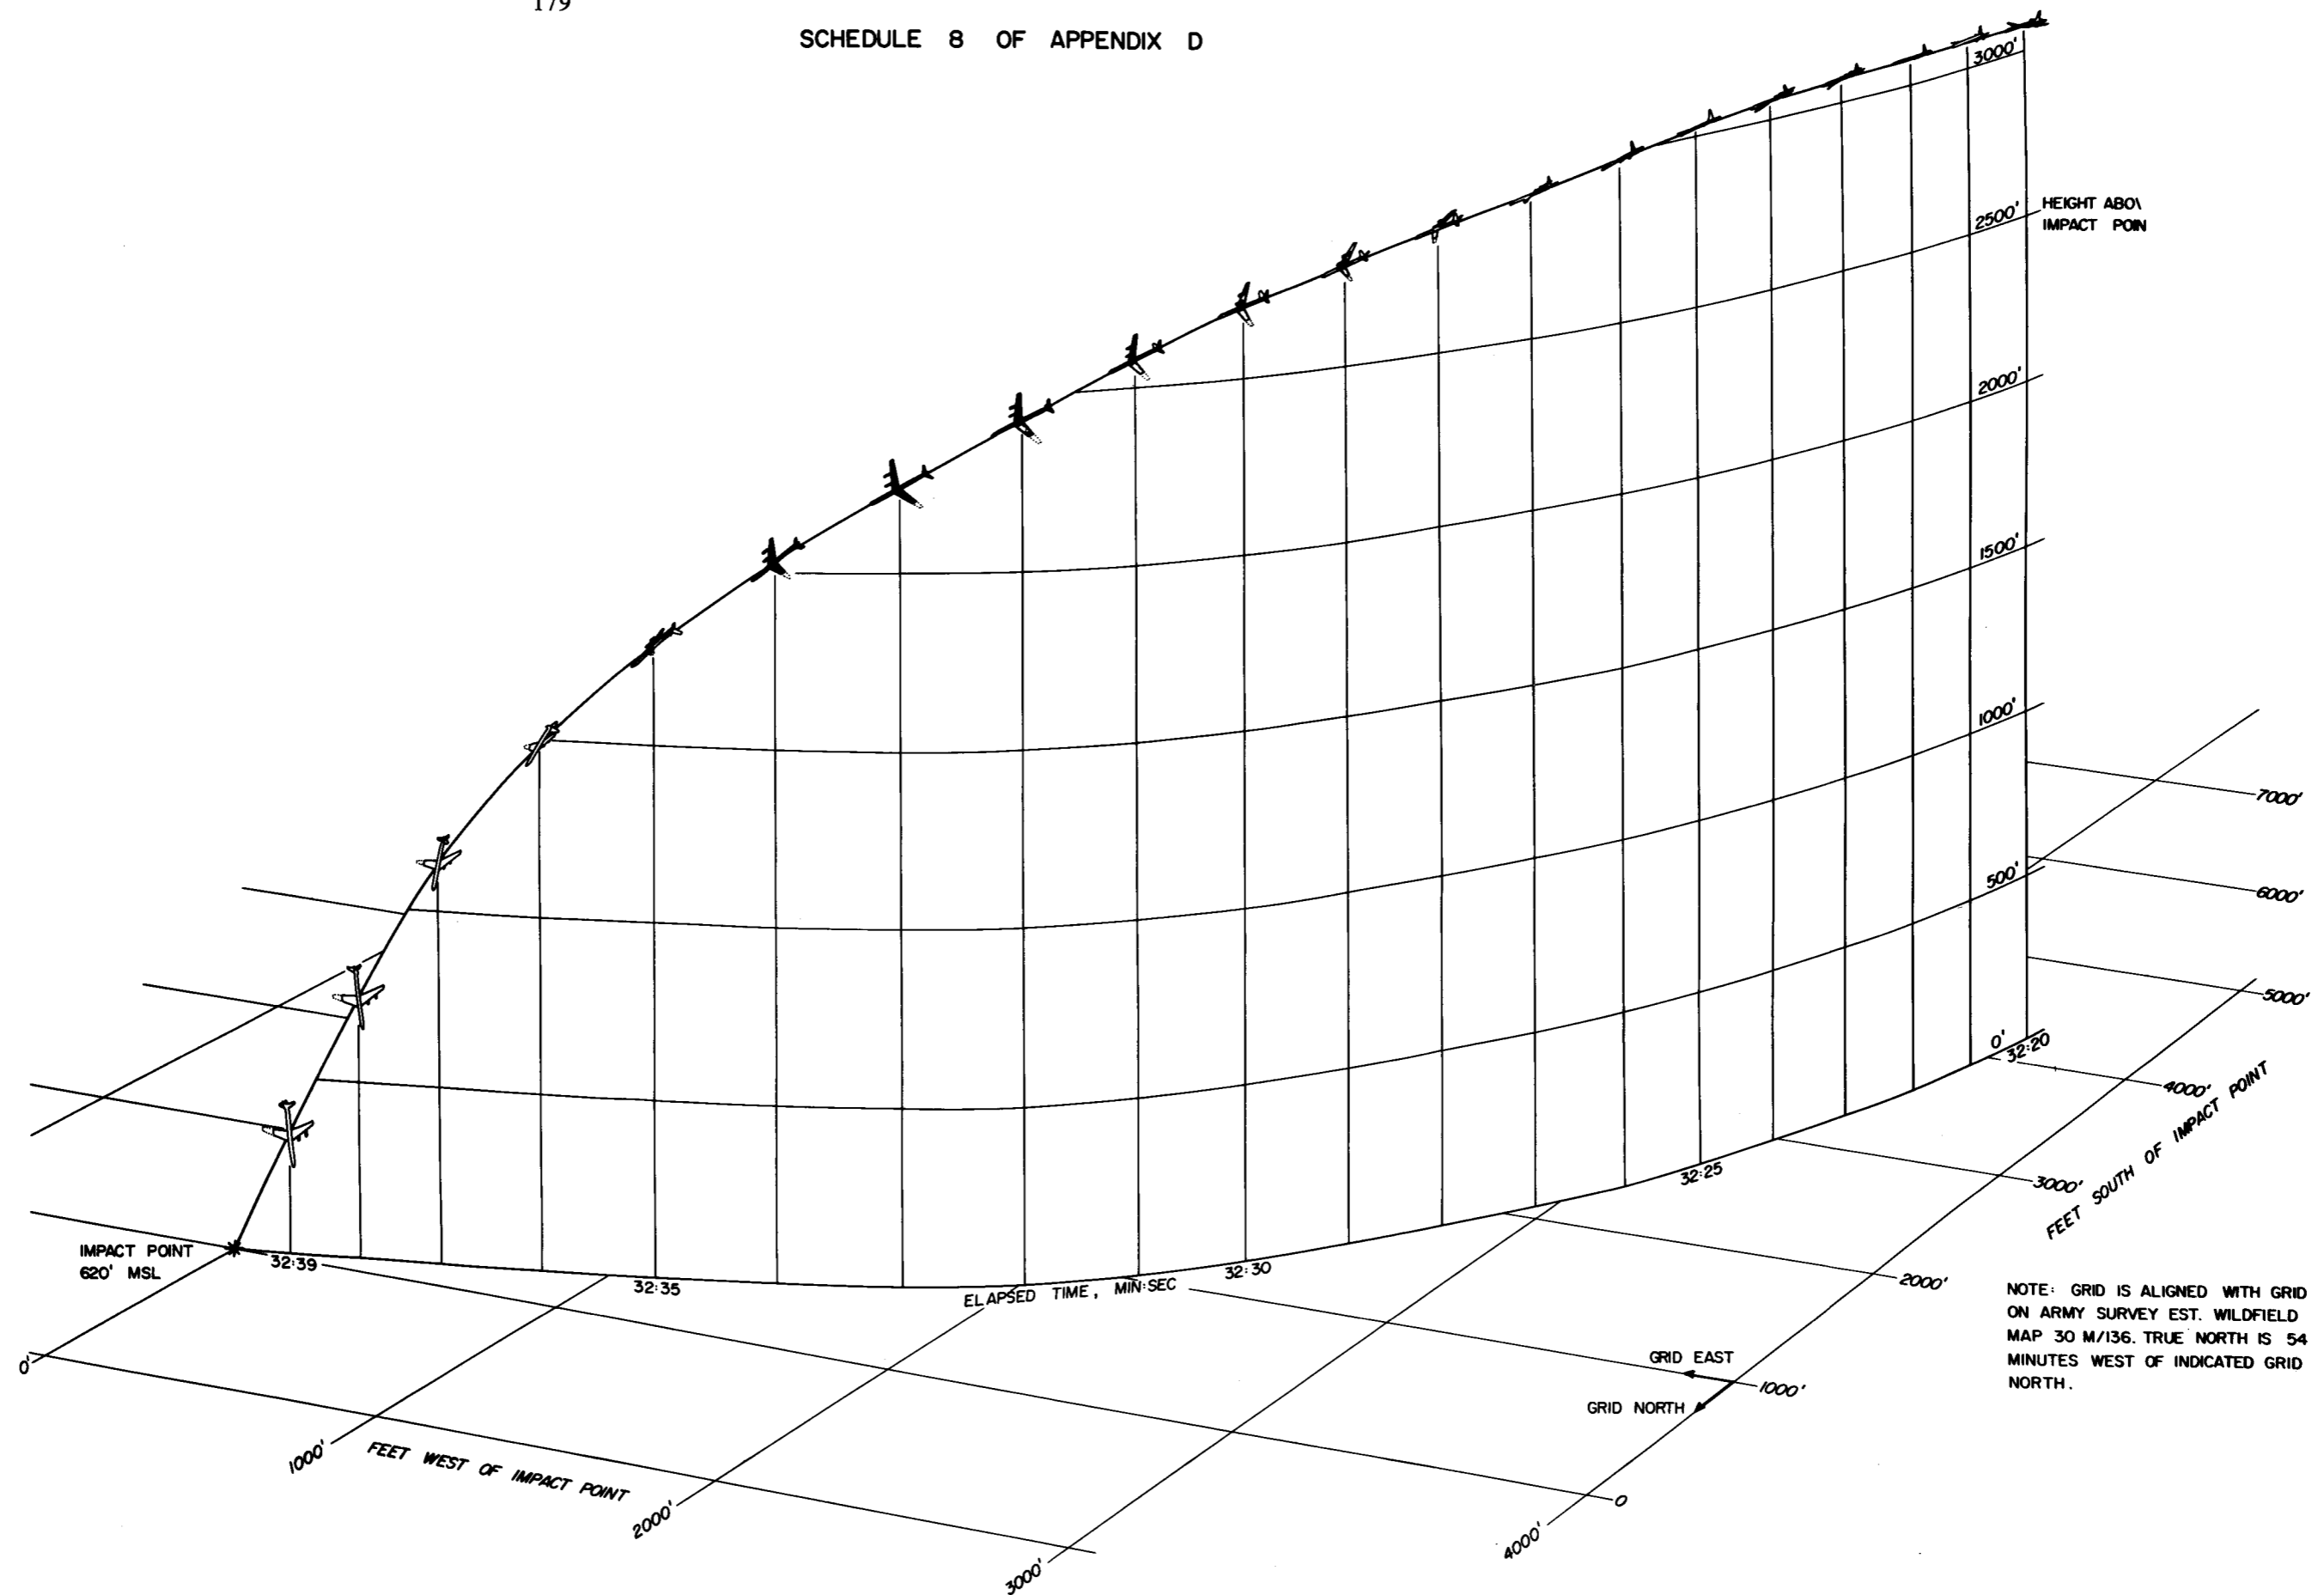
SCHEDULE 8 OF APPENDIX D

RECONSTRUCTION OF CF-TIW MOTION IN THE LAST 19 SECONDS BEFORE IMPACT

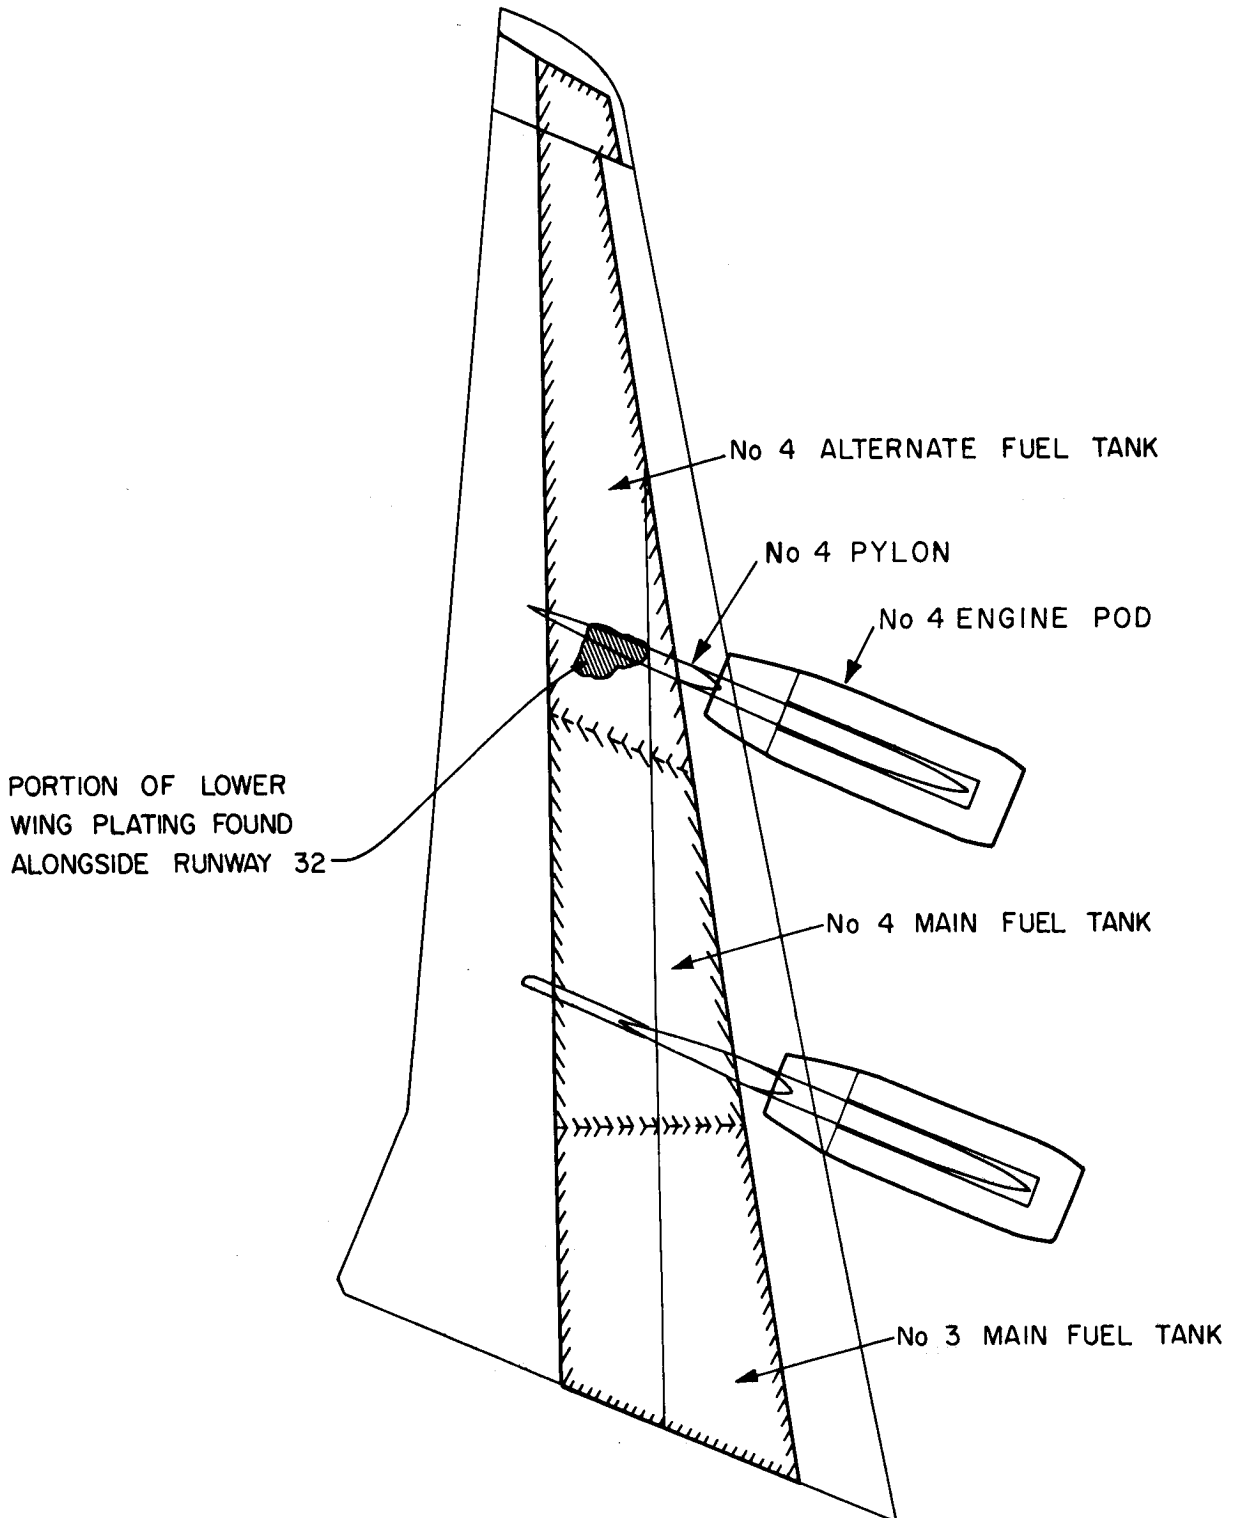
SCHEDULE 17 OF APPENDIX D

A heavy landing, with sufficient force to mark the runway at the point of contact of the wheels and tail bumper, caused number 4 engine pod, pylon and a portion of lower wing plating to break away from the aircraft (see Schedule 17 of Appendix "D"). There was fire on the ground, and fuel was observed streaming from the right wing in the climb segment of flight following the touch down. Fire and smoke were observed in the right wing during the climb. Approximately

¹ "g" is the acceleration due to gravity. 5 g, measured at the aircraft centre of gravity, implies a force equal to 5 times the weight of the aircraft. 7 g at an engine pod implies a force of 7 times the weight of the engine pod on the attachment brackets.

The design philosophy of this aircraft included provisions for the separation of the engine pod and pylon from the aircraft structure when vertical loads of 7 g were experienced. This is accomplished by stressing the pylon-to-wing attachments so that the (shear) bracket at the front spar fails first, under vertical load, followed by a progressive failure of the bolts, front to rear, in the horizontal (thrust) attachment (see Schedule 18 of Appendix "D"). Unfortunately, in this accident the horizontal attachments did not perform in the manner prescribed. Some of the bolts at the rear did not fail, in sequence, and, as a result loads were transmitted to the wing which caused a portion of the wing plating - which is also the floor of the number 4 (alternate) fuel tank - to be carried away with the engine pod and pylon. From the evidence, it has been suggested that the number 4 pod did not fail directly downwards, a side component of the forces twisted the pylon to the right, and prevented the attachments from failing cleanly. As a result, a hole approximately four feet long and two feet wide forward, increasing to four feet at the rear, was left in the bottom of the wing plate of number 4 alternate fuel tank.

EXTRACT FROM ENQUIRY EXHIBIT 28 SHOWING PORTION OF LOWER RIGHT WING PLATING OF CF-TIW WHICH FAILED AT THE PYLON ATTACHMENT

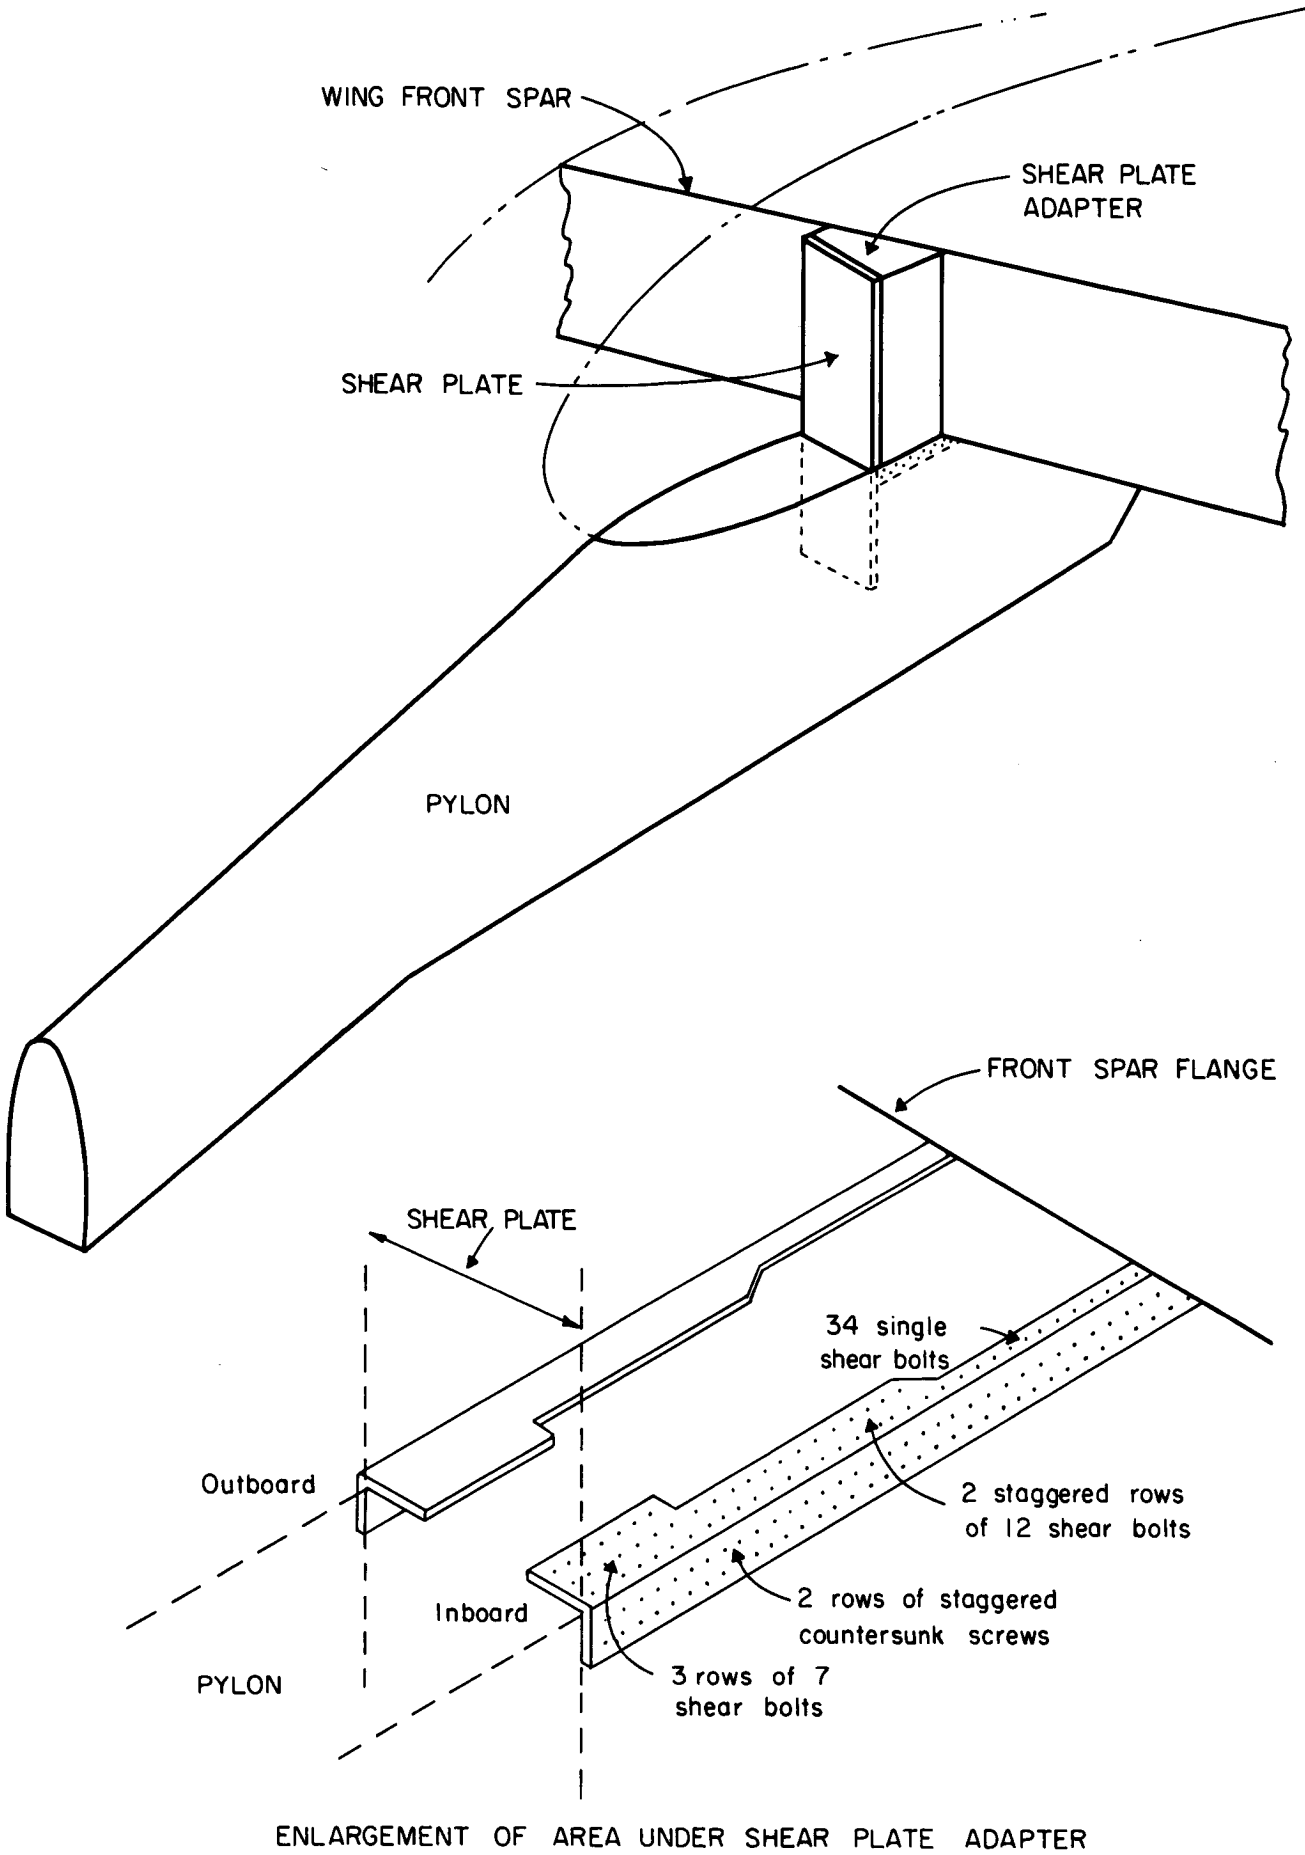
SCHEDULE 18 OF APPENDIX D
SKETCH OF DETAILS OF PYLON TO WING ATTACHMENT FITTINGS

These numbers are consistent with the evidence on the sequence of failures in the structure, and a statement by the manufacturer on the loads required to fracture the engine pylon-to-wing attachments, in that the attachments of number 4 pylon fractured completely and those of number 3 pylon

were severely damaged in the landing touch down.

² The evidence from the wreckage showed that the vertical shear attachments of this engine were seriously damaged in the first landing impact.
